MICRO-ARC DETECTION AS PART OF YOUR AMI SYSTEM

Southeastern Meter School Module 400

PSEG LONG ISLAND CASE STUDY

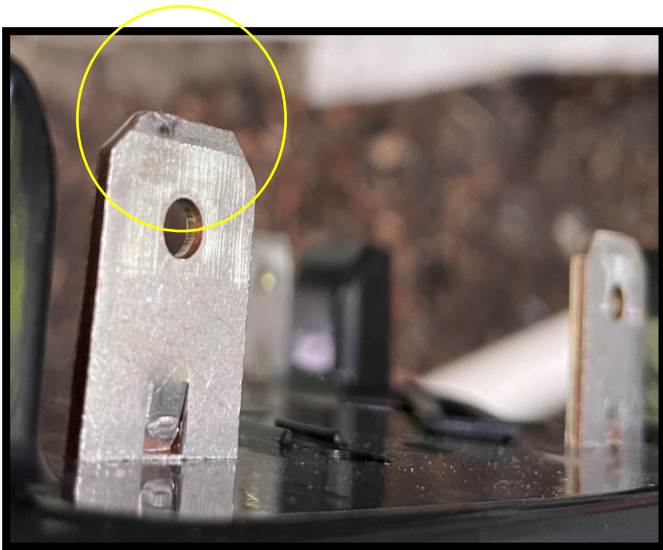
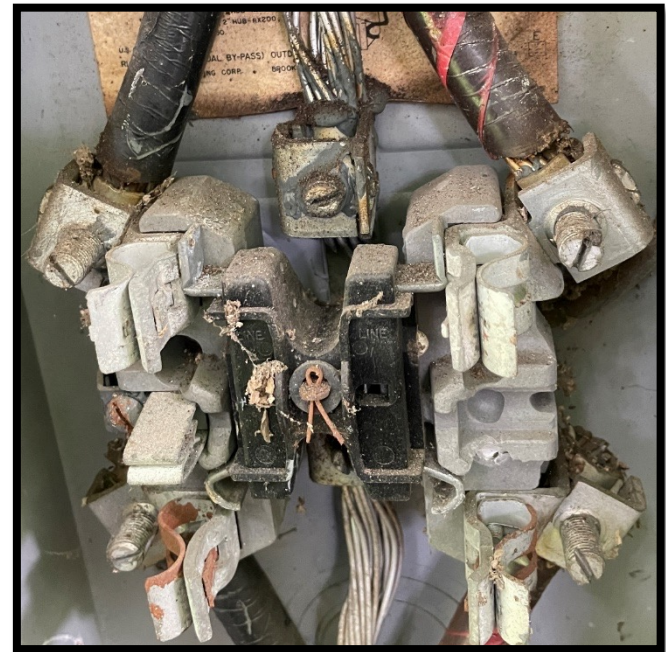
METER 51****48 – DISCOLORATION ON METER BLADE

- Days on report with >100 Max Arc Count: 16
- Average arc count: 160
- Max Arc Count: 320
- Arc Sense Priority Level 3

- No previous reports of overheating or rise in temperature
- Pitting on meter blade
- Meter pan did not show any signs of damage or excessive weathering

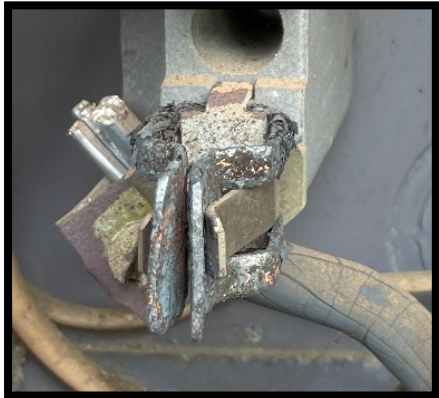
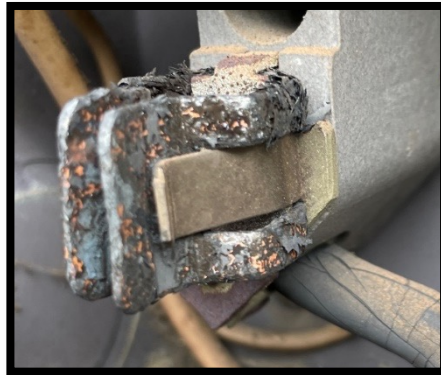
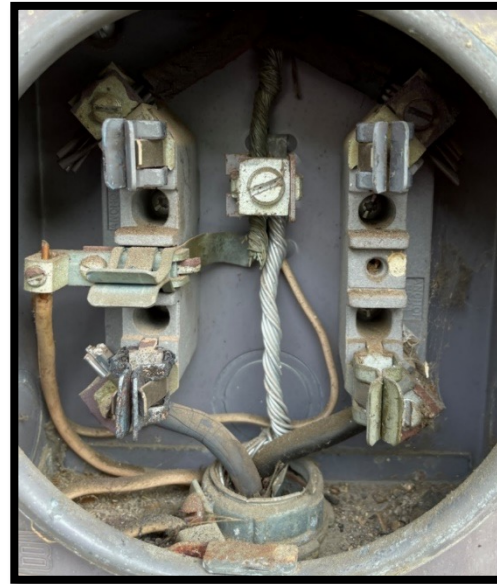
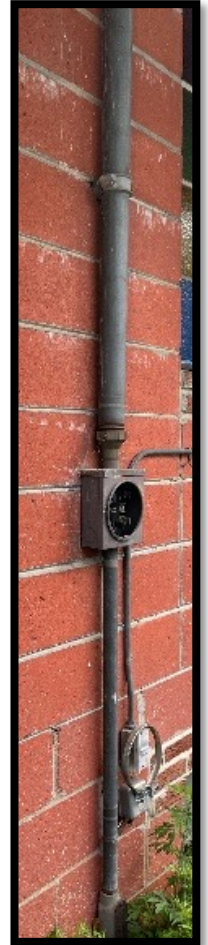
METER 51****18 – HIGH TEMPERATURE ALERTS

- Originally a non-Arc Sense meter was at property
- Meter was reported by Analyst to indicate high temperature alerts
- Arc Sense meter was installed in Spring 2022 after high temperature alerts
- Arc count and temperature readings were high enough to warrant investigation
- Found brittle jaws inside meter pan; meter pan was replaced as a result

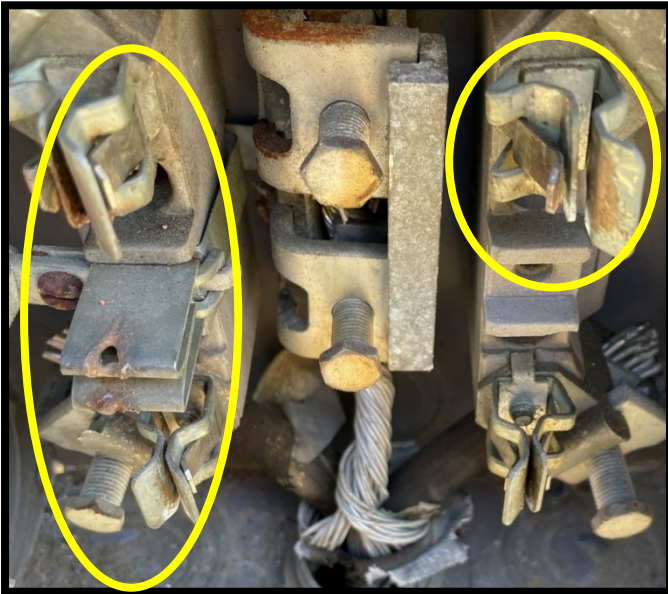
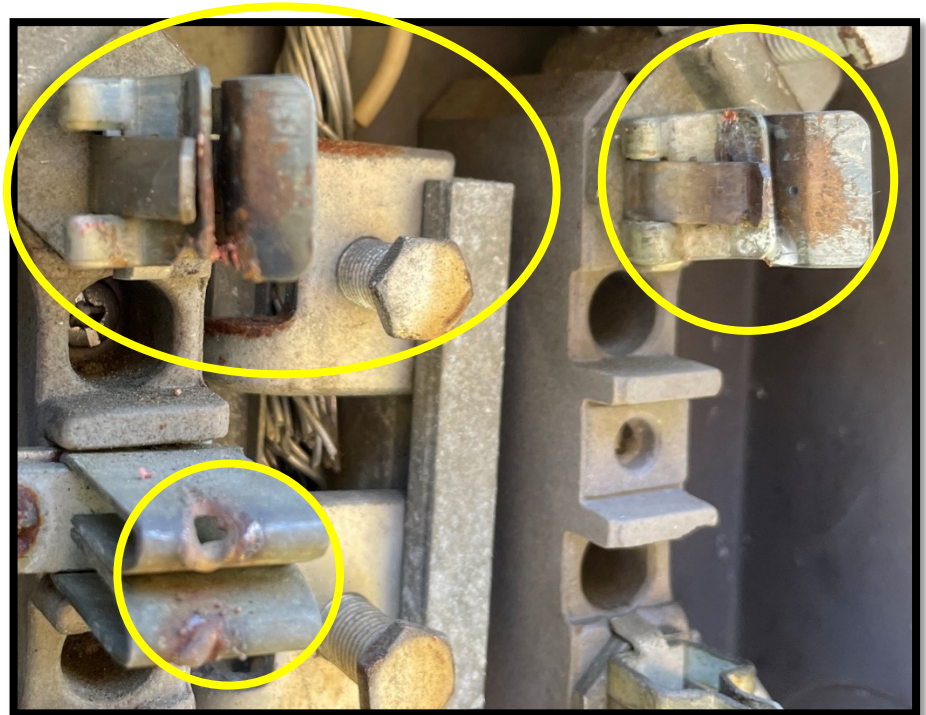
METER 51****26 – METER PAN WITH RECESSED JAWS

- Days on report with >100 Max Arc Count: 18
- Average arc count: 278
- Max Arc Count: 539
- Arc Sense Priority Level 3
- No previous reports of overheating or rise in temperature
- Recessed springs and discoloration on the jaws
- Damaged neutral (as if someone tried to fix the jaws and an uninsulated screwdriver made contact between phase/neutral)

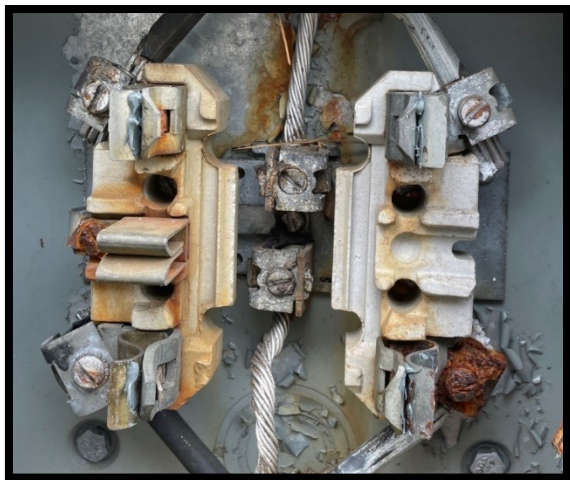
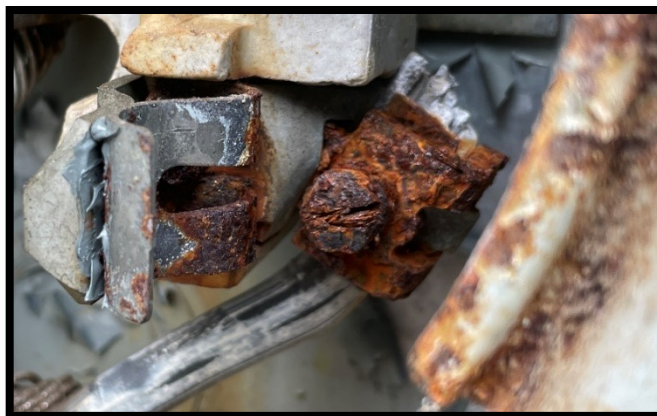
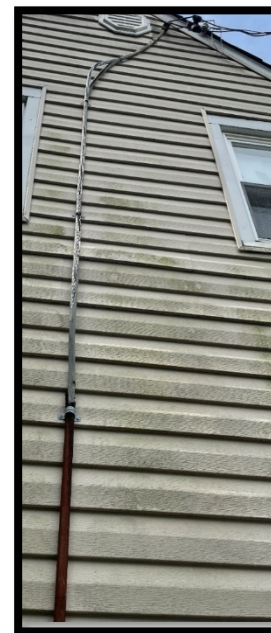
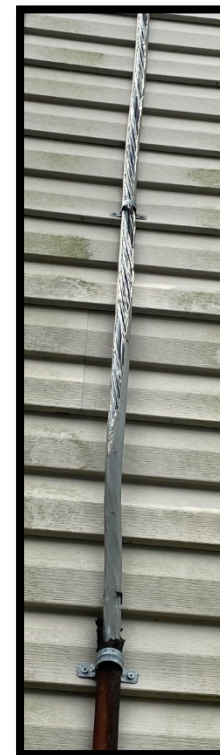
METER 51****14 – CONDUIT ALLOWING WATER

- Days on report with >100 Max Arc Count: 43
- Average arc count: 233
- Max Arc Count: 473
- Arc Sense Priority Level 1
- No previous reports of overheating or rise in temperature
- Conduit allowed water to enter into the meter pan
- Screw terminal at C-phase load side was rusted and deteriorating
- Meter produced arcs when reinstalled

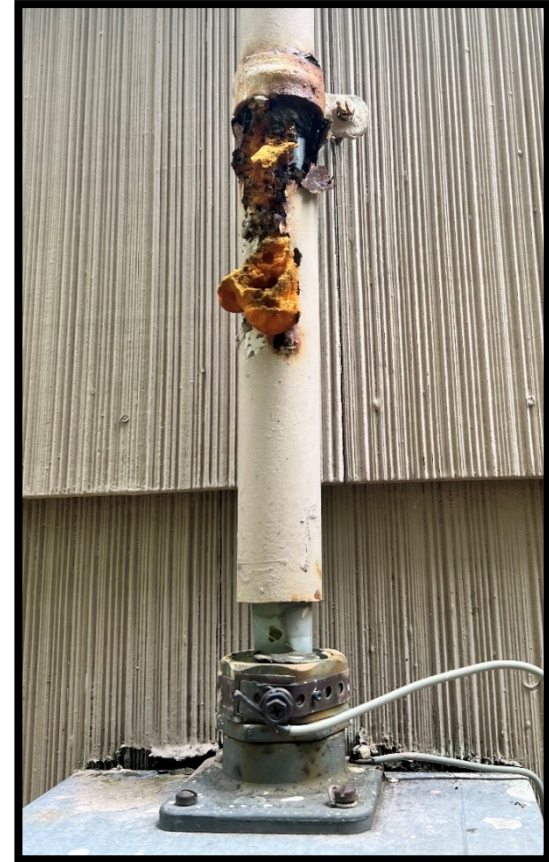
METER 51****55 – WEATHER-HEAD CONDUIT DAMAGE

- Days on report with >100 Max Arc Count: 35
- Average arc count: 355
- Max Arc Count: 1601
- Investigation Priority Level: 2*
 - Moved to priority 1 based on recent top arc counts
- No previous reports of overheating or rise in temperature
- Meter not removed because customer was not home and it was a non-bypass pan
- Technician found damage to weather-head conduit

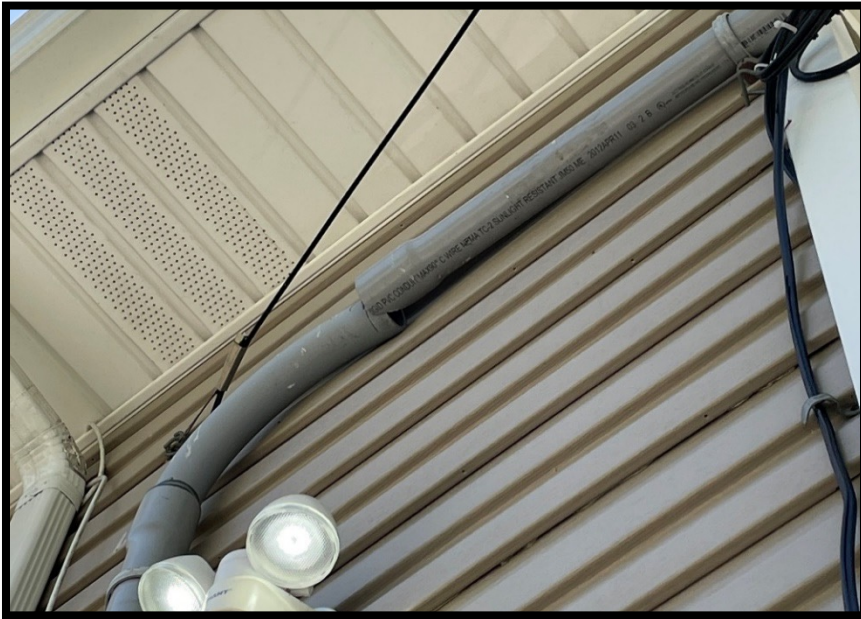
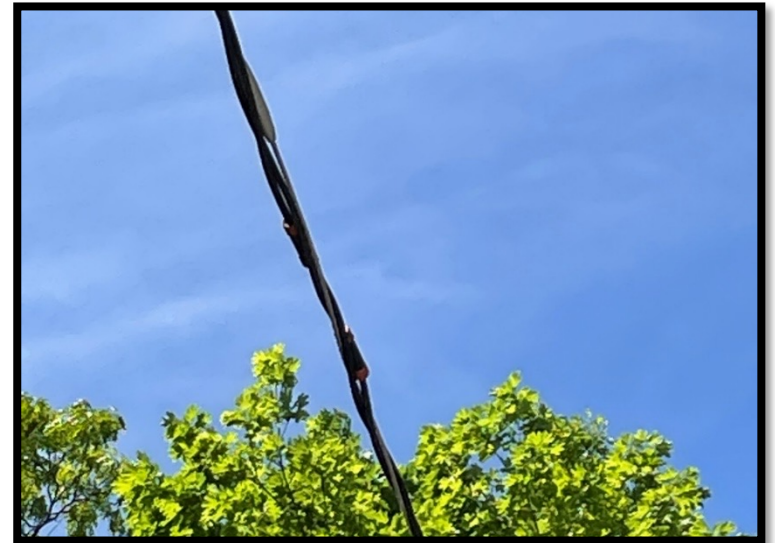
METER 51****25 – WEATHER-HEAD + WIRE REPAIR POINTS

- Days on report with >100 Max Arc Count: 56
- Average arc count: 247
- Max Arc Count: 625
- Arc Sense Priority Level 1
- No previous reports of overheating or rise in temperature
- Damage at weather-head conduit
- Found repair points on neutral at triplex to house

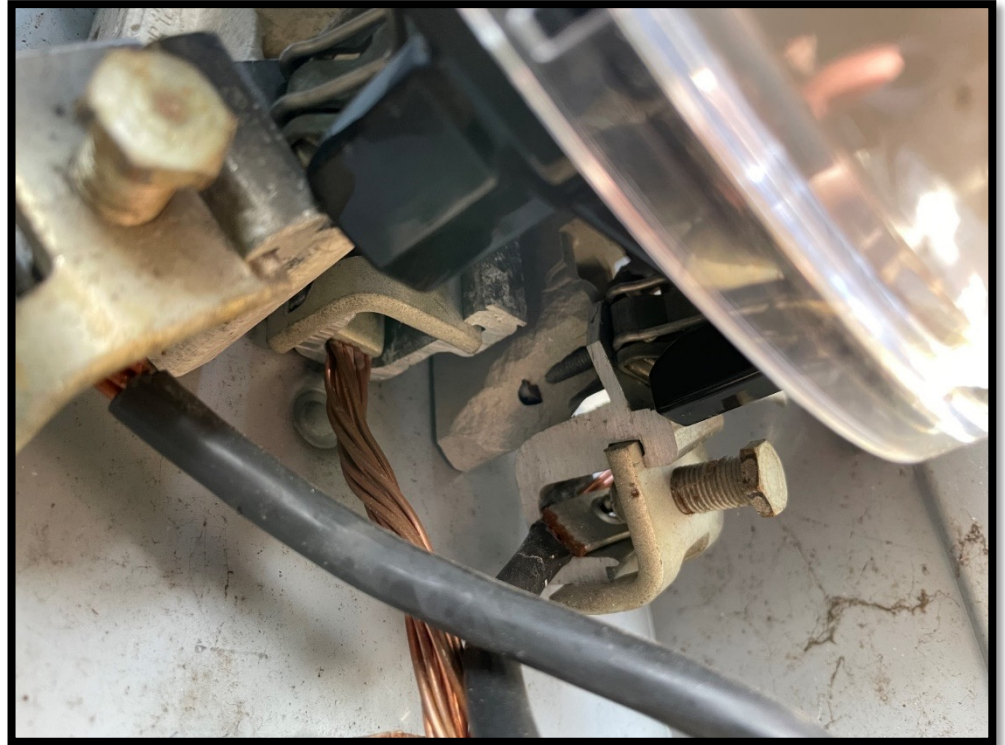
METER 51****25 – BROKEN CERAMIC INSIDE METER PAN

- Days on report with >100 Max Arc Count: 93
- Average arc count: 236
- Max Arc Count: 349
- Arc Sense Priority Level 1
- No previous reports of overheating or rise in temperature
- Technician found broken ceramic on the foundation inside the meter pan

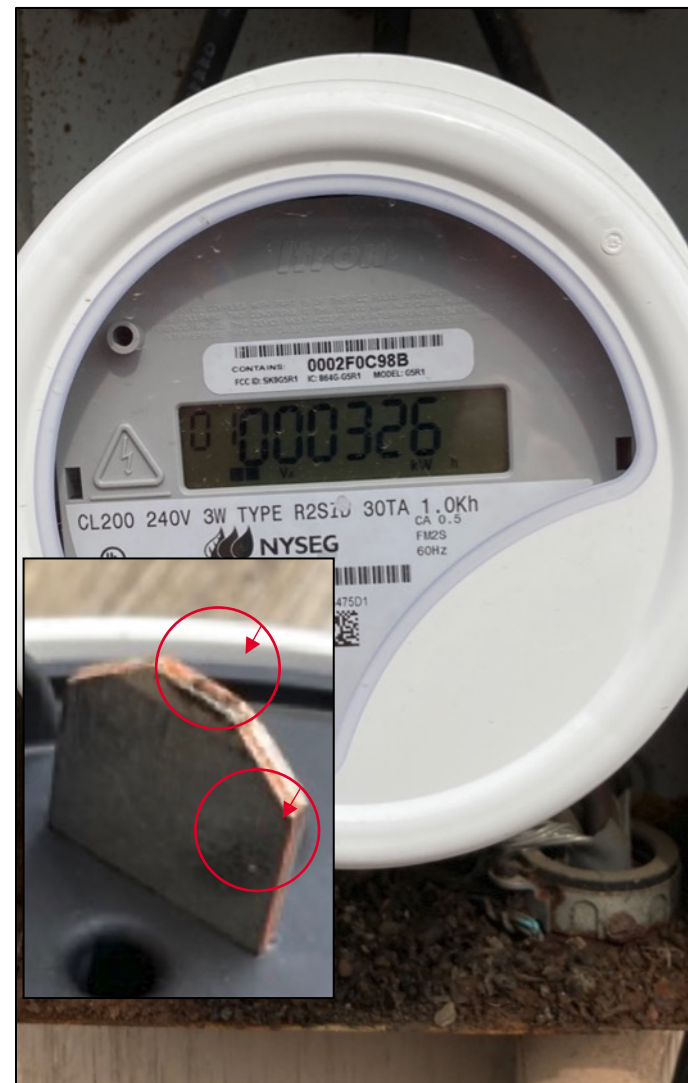
AVANGRID – METER 1 FIELD FINDINGS

- The meter technician confirmed the presence of small burn marks and slight discoloration on the meter blade (picture below).
- He confirmed all service terminations were tight and he tested socket jaw tension using the Tesco Hot Socket Gap Indicator tool.
 - Jaw tension was good.
- Based on photo, it appeared meter was misaligned; after field visit and reinsertion of the meter, report showed zero incremental arc counts, on all six counters.

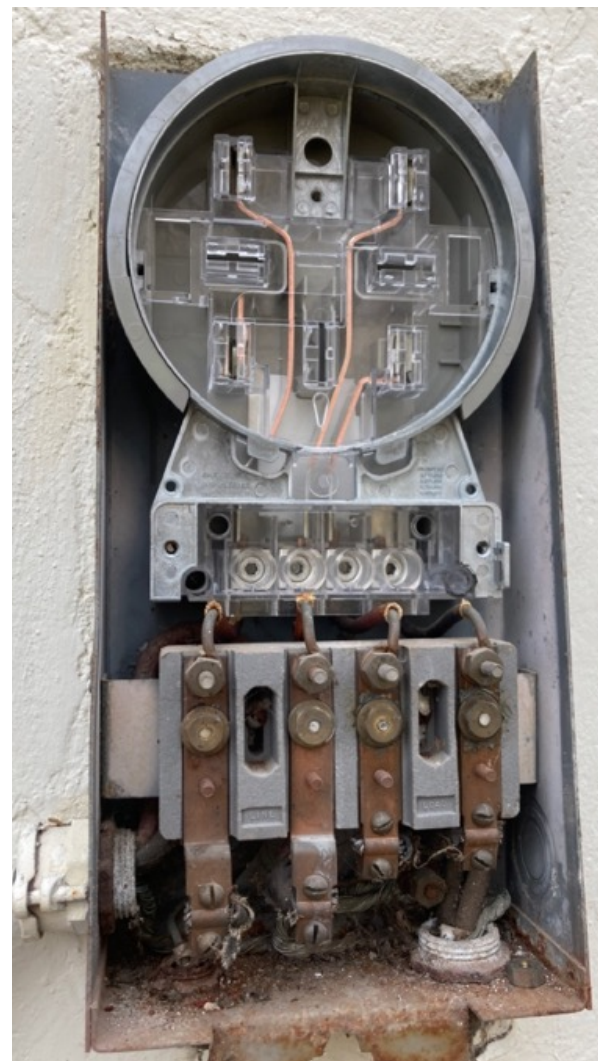
AVANGRID – METER 2 FIELD FINDINGS

- A-Base to socket adapter
 - The adapter is new and was installed when the new AMI meter was set
- The meter technician said he used a magnifying glass to inspect the meter blades but didn't see any pit marks.
- He checked all external service connections and everything seemed to be OK (i.e. no loose connections, etc.).
- He used the TESCO Hot Socket Gap Indicator tool on the adapter and jaw tension looked good.
- Expected arcing occurring in older connection base to new socket adapter; arc passing through meter channel.
 - Additional inspection discovered a failing weather head where broken strands were creating arcs.

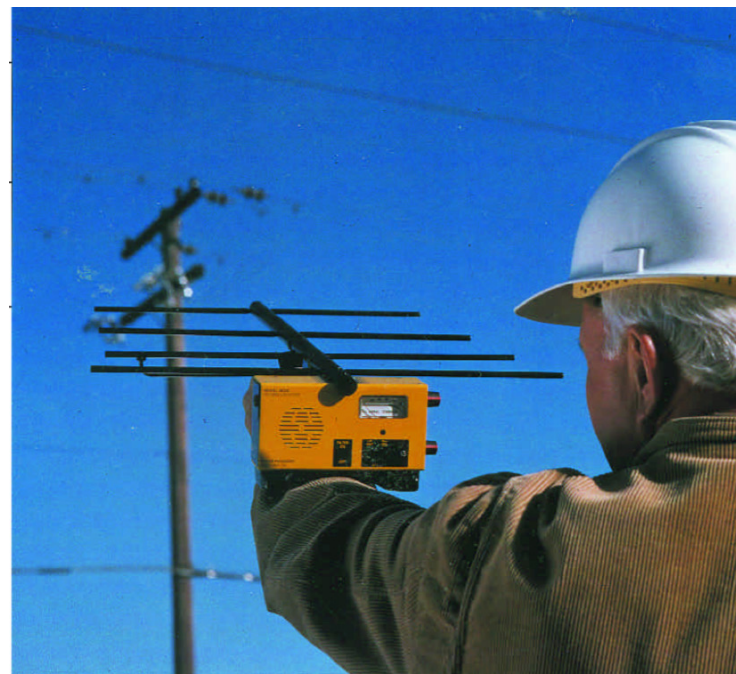
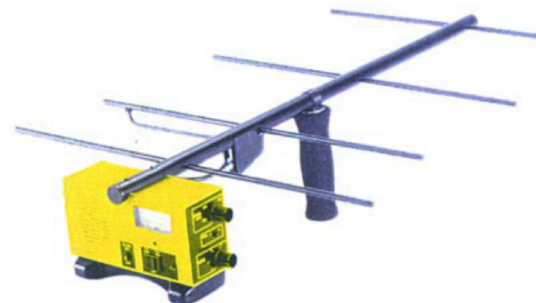
AVANGRID – UNEXPECTED FINDINGS

- What was unexpected was the ability to the detection circuit to pick other safety or operational (or both) issues that could be addressed prior to leading to a catastrophic failure.

- Failing distribution transformer
 - Broken strands at weather head – near separation of weather head
 - Failing equipment on the customer side of the Main service box in the house

- The adapter is new and was installed when the new AMI meter was set
- These are just three of several examples. The common theme was arcing on the line and a direct line into the meter that was relatively close to the meter. These issues were only ever reported by one meter and not a series of neighboring meters.

- Finding these issues required the use of additional RF detection equipment by the field technician.
- New protocols and checklists were recommended for field investigations of significant arc reports from the field
