TESCO METERING

Nighthawk Issues Resolved and in Progress

TESCO's Meter School
TESCOOL
July 20-23, 2025

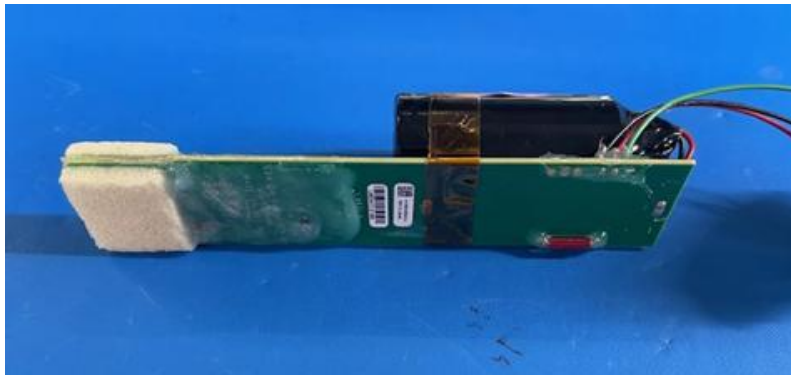
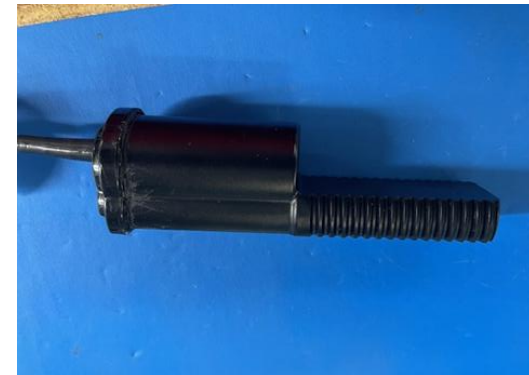
- Conclusions
 - After review of original design specifications and R+D reports, we found that the potting process required a great deal of cleanliness of the board surface. The degree of cleanliness required (i.e. no finger touch or solder-process residue) was not easily achievable in a production environment.

- The partial failure of the potting compound not setting up at the surface of the PCB caused long term semi-liquification of the compound. The compound in this state exhibits a low, but non-zero electrical conductivity, which could lead to a partial shorting of the battery.

- After review of original design specifications and R+D reports, we also found that the battery being used did not have an integrated storage capacitor that assists in maintaining long battery life by minimizing times of high current draw, as would be the case when the WEP “wakes up” to communicate to the hub.

- Replace potting material – We've tested a new, silicon-based material that will cure in less than pristine environments and at room temperature, reducing the possible heat risks to the components on the board. We have tested samples of this material on new PCBs sitting in a bucket of water and were able to prove out the material as having adequate waterproofing capabilities.

- Replacement of the battery – Though this is likely less-impactful, we decided to replace the Xeno battery with a Tadiran battery TLP-93311/A/SM, PulsePlus Battery packs. These batteries include the patented hybrid layer capacitor, making it perfect for this application where current draw is mostly quite low, followed by short bursts of high current draw.

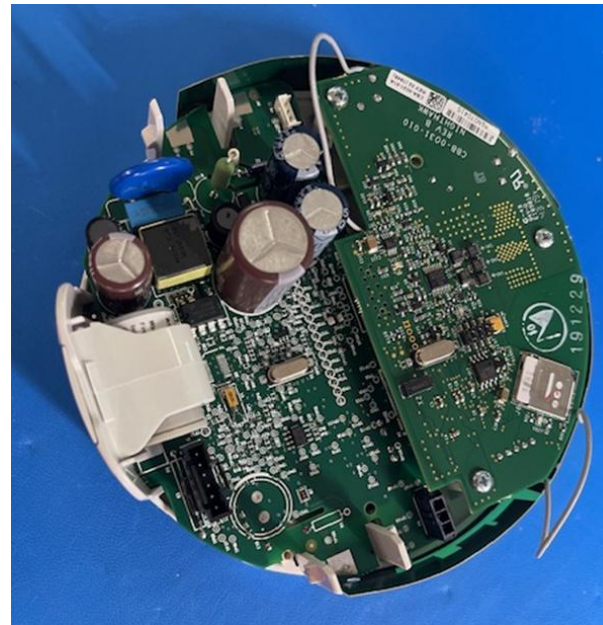
- Outage Notification Failures
 - Meters are failing to send “last gasp” messages during outages. A battery-related failure is the suspected root cause, preventing the meter from broadcasting its outage status.
 - TESCO field services is actively replacing the batteries onsite for impacted customers.
- Outage Restoration Delay
 - Meters often remain flagged as being in an outage even after power has been restored. Manual intervention using the Check Status command in Meter Soul is currently required to update the meter's status in the AMI Headend.

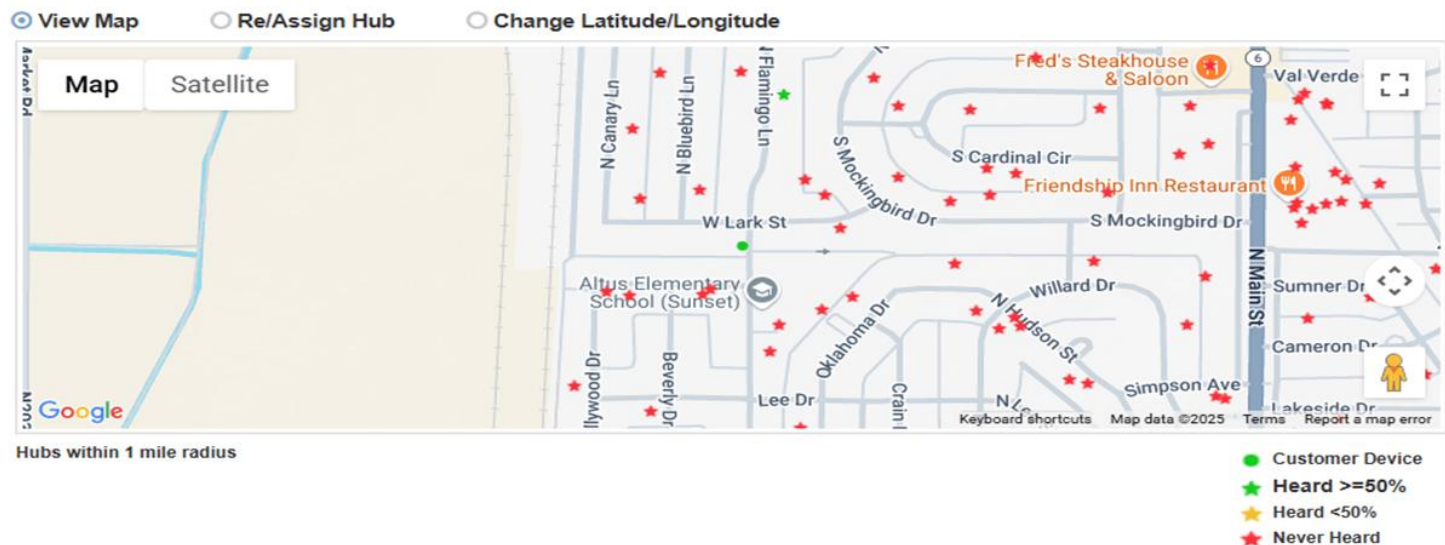
Interval Upload Failure

Some devices have been found to stop uploading interval data while daily register data is uploading.

Interval data can be requested from the meter using
Meter Control Options

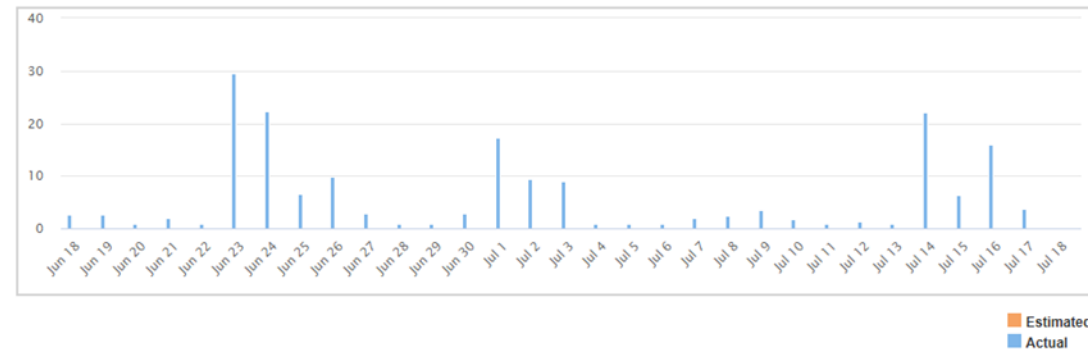
- Interval voltage data is currently not available from kV2c meters. This limits the ability to perform voltage profiling and compromises visibility into power quality trends over time.
- Currently we can only see Voltage snapshot values at the time of a Register Reading.
- Missing Here

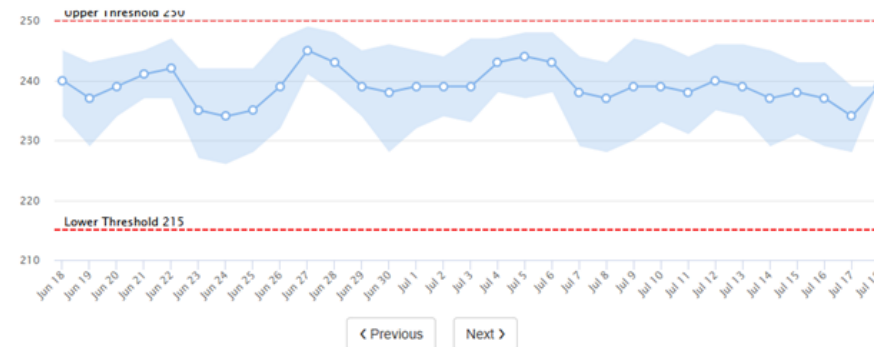
- Interval voltage data is currently not available from kV2c meters. This limits the ability to perform voltage profiling and compromises visibility into power quality trends over time.
- Currently we can only see Voltage snapshot values at the time of a Register Reading.
- Shown Here

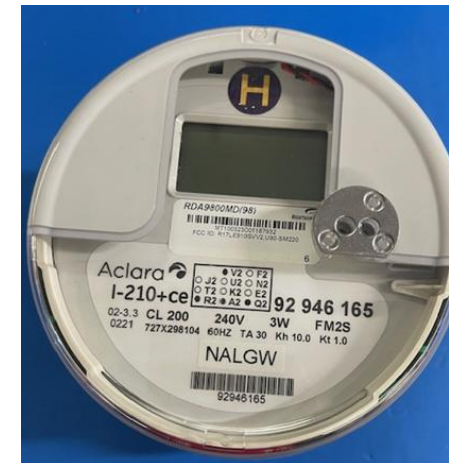
- Mismatched Snap Address
- A manufacturing process swapped the internal Radio ID and Meter ID between a few pairs of devices
- Billy and Chris were dispatched to manually replace devices with incorrect or mismatched Snap addresses. The issue has been successfully resolved.
