Emergency Response Practices to Meter Alarms

Jeff Chiucchi, PECO, Sr. Engineer

Perry Lawton, TESCO, NE Regional Manager

TESCO's Meter School
TESCOOL
July 20-23, 2025

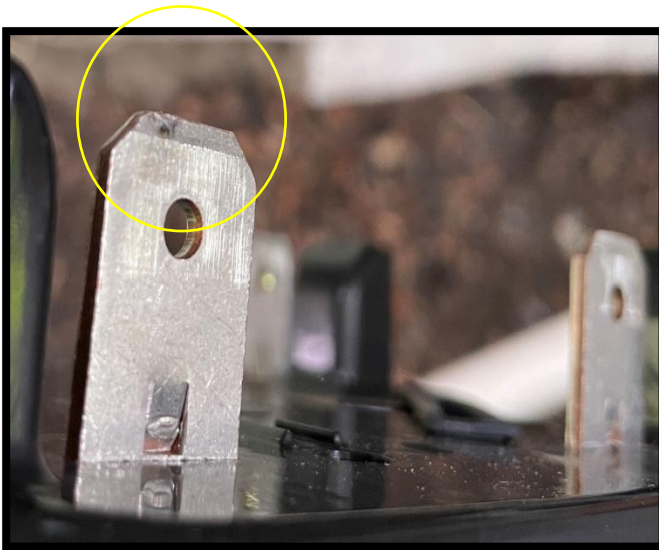
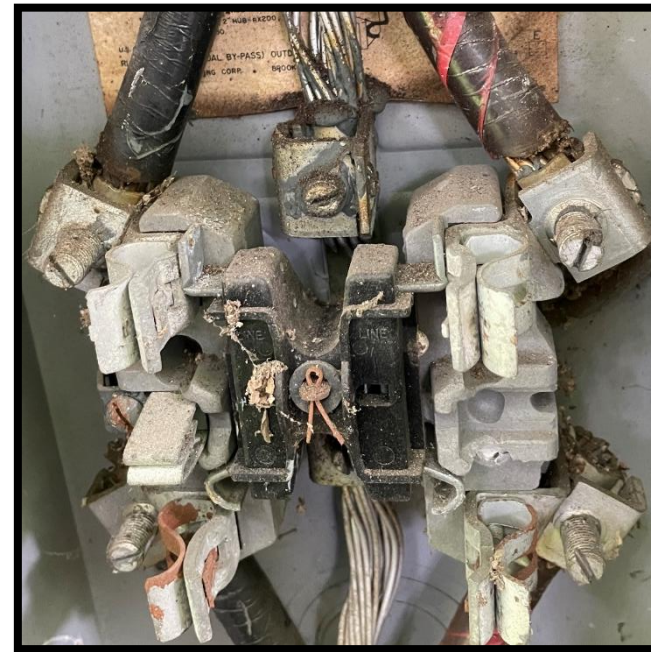
METER 51****48 – DISCOLORATION ON METER BLADE

- Days on report with >100 Max Arc Count: 16
- Average arc count: 160
- Max Arc Count: 320
- Arc Sense Priority Level 3

- No previous reports of overheating or rise in temperature
- Pitting on meter blade
- Meter pan did not show any signs of damage or excessive weathering

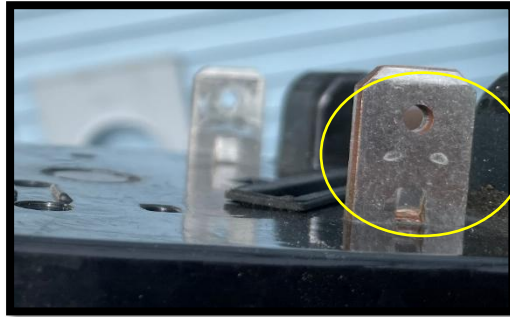
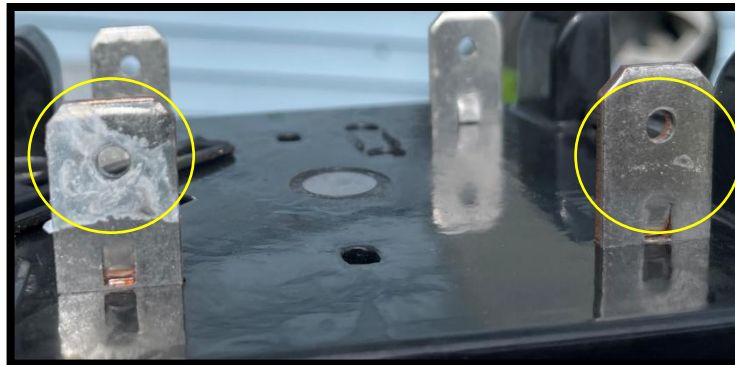
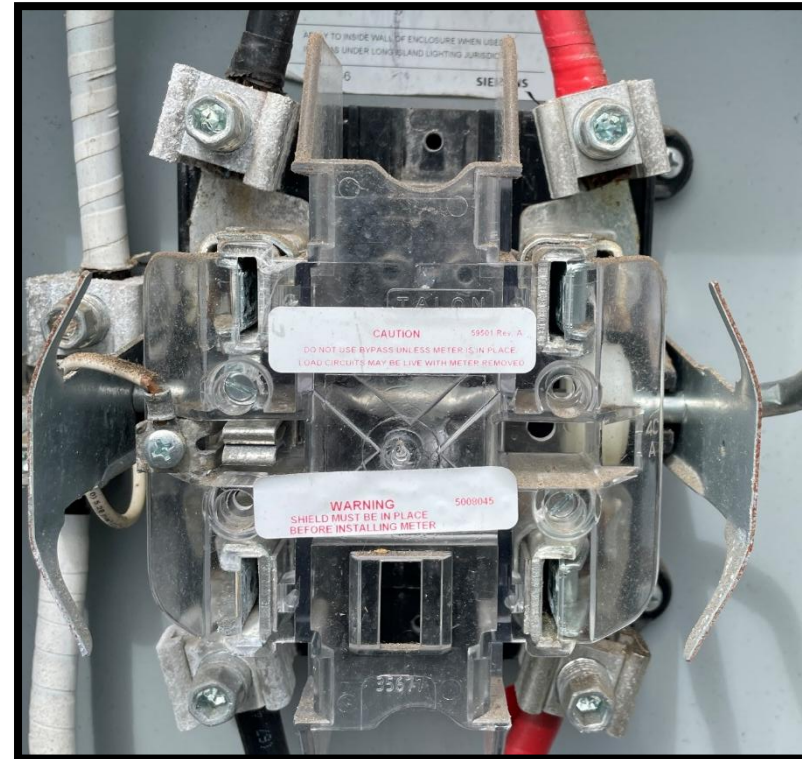
METER 51****35 – DISCOLORATION ON METER BLADE

- Days on report with >100 Max Arc Count: 43
- Average arc count: 305
- Max Arc Count: 534
- Arc Sense Priority Level 1
- No previous reports of overheating or rise in temperature

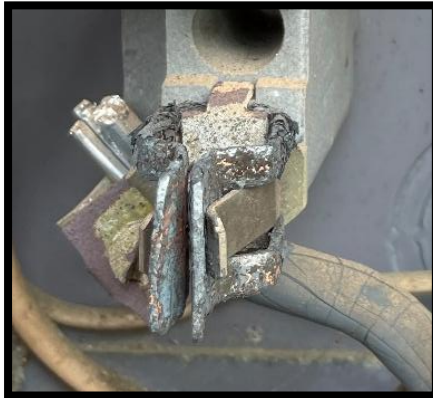
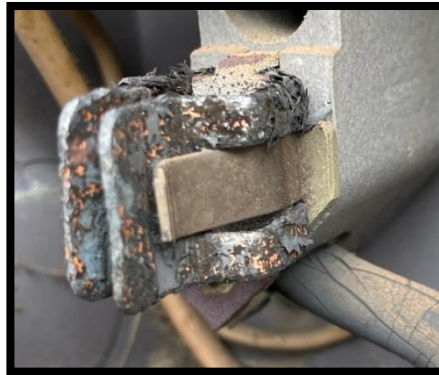
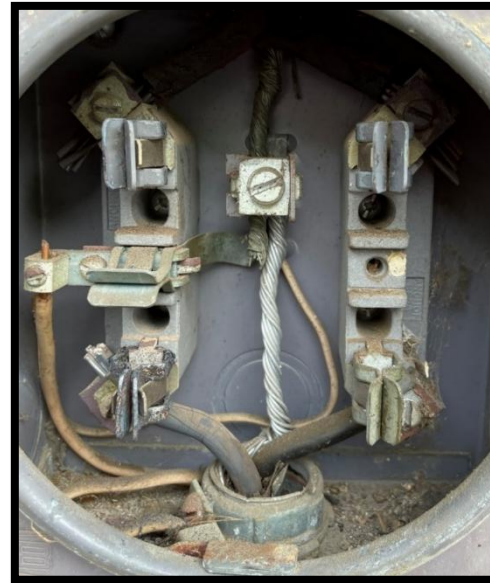
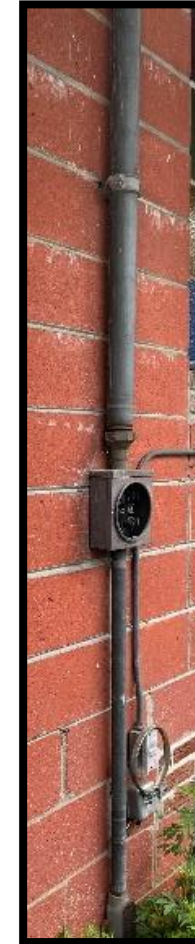
METER 51****18 – HIGH TEMPERATURE ALERTS

- Originally a non-Arc Sense meter was at property
- Meter was reported by Analyst to indicate high temperature alerts
- Arc Sense meter was installed in Spring 2022 after high temperature alerts
- Arc count and temperature readings were high enough to warrant investigation
- Found brittle jaws inside meter pan; meter pan was replaced as a result

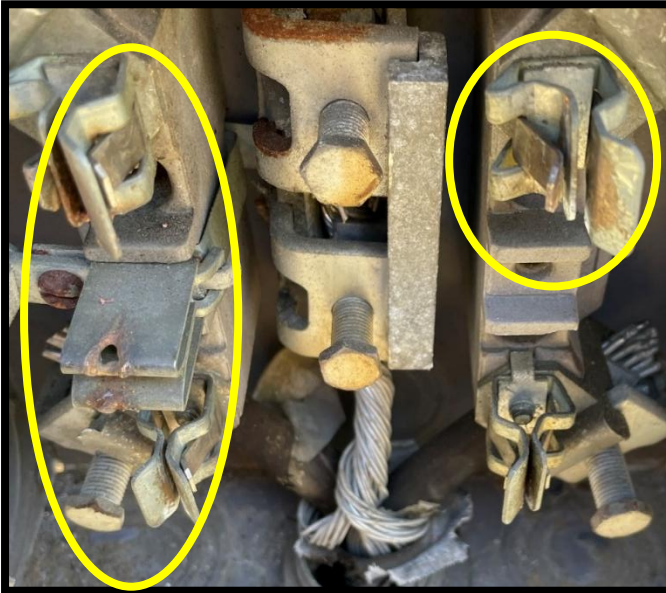
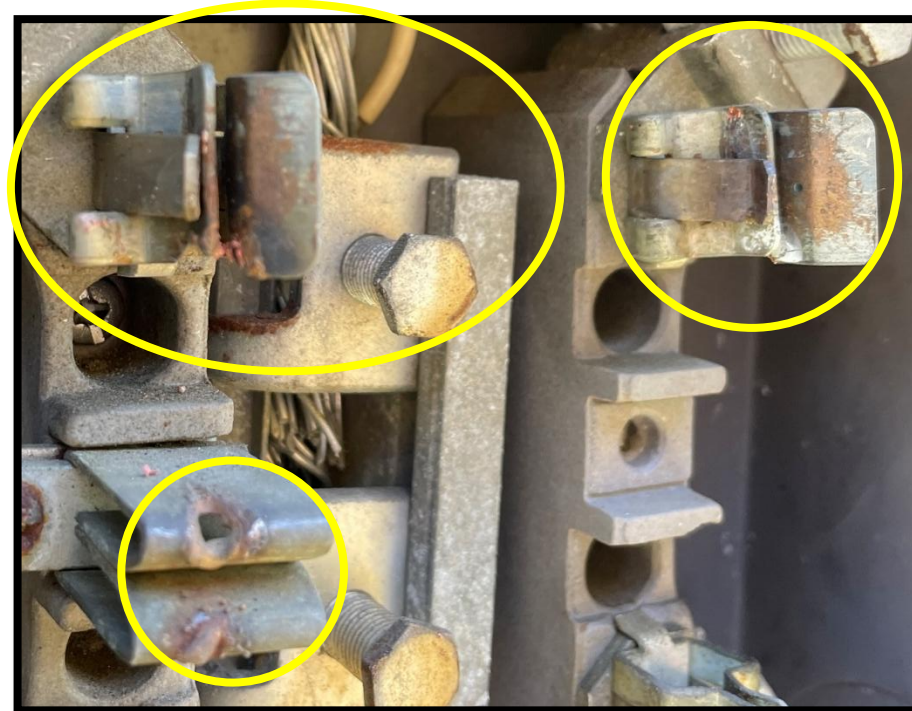
METER 51****26 – METER PAN WITH RECESSED JAWS

- Days on report with >100 Max Arc Count: 18
- Average arc count: 278
- Max Arc Count: 539
- Arc Sense Priority Level 3

- No previous reports of overheating or rise in temperature
- Recessed springs and discoloration on the jaws
- Damaged neutral (as if someone tried to fix the jaws and an uninsulated screwdriver made contact between phase/neutral)

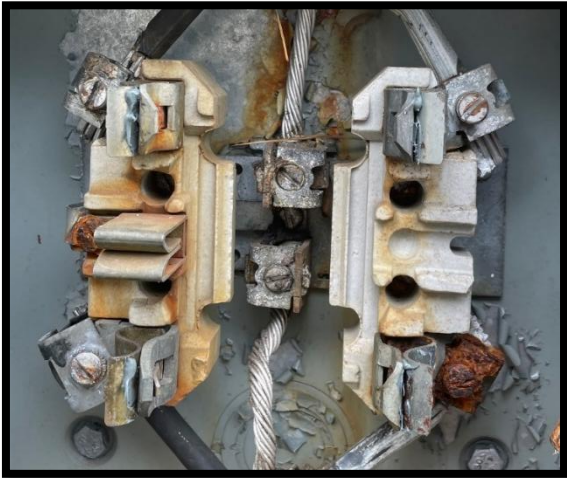
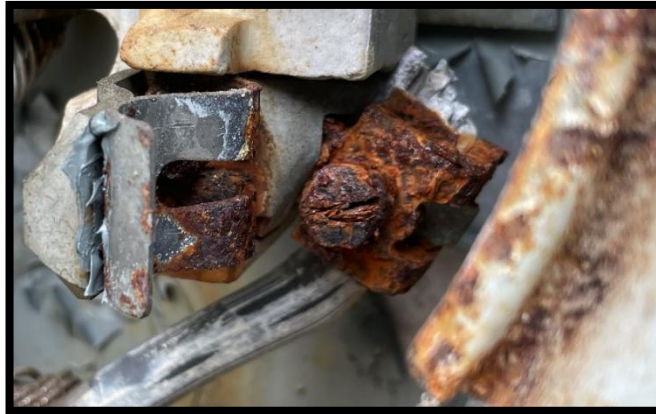
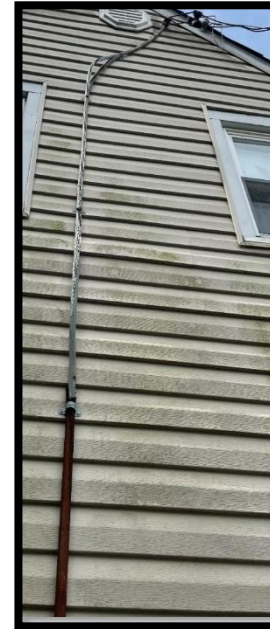
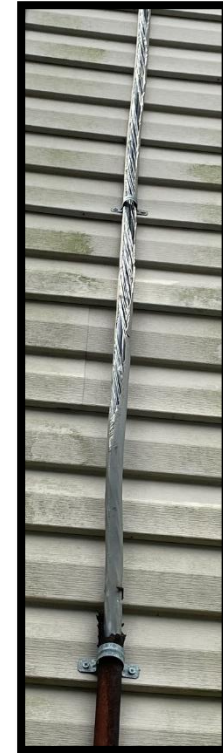
METER 51****14 – CONDUIT ALLOWING WATER

- Days on report with >100 Max Arc Count: 43
- Average arc count: 233
- Max Arc Count: 473
- Arc Sense Priority Level 1

- No previous reports of overheating or rise in temperature
- Conduit allowed water to enter into the meter pan
- Screw terminal at C-phase load side was rusted and deteriorating
- Meter produced arcs when reinstalled

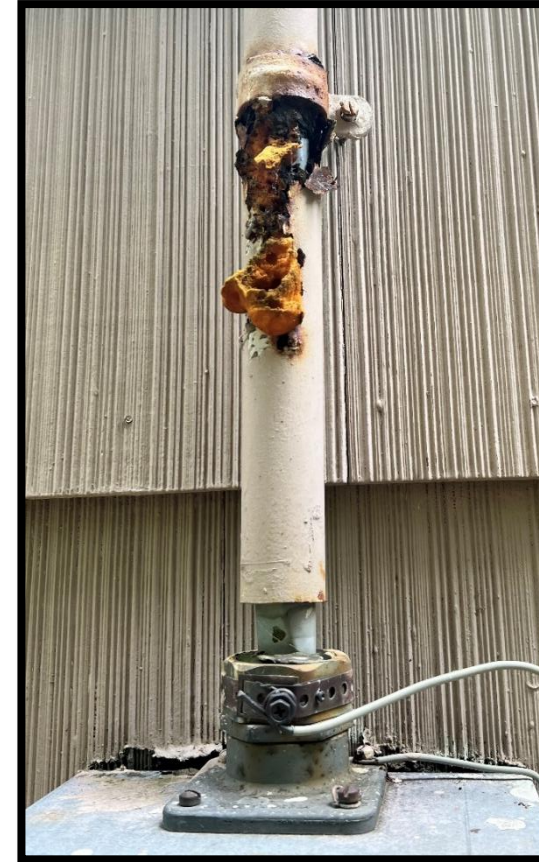
METER 51****55 – WEATHER-HEAD CONDUIT DAMAGE

- Days on report with >100 Max Arc Count: 35
- Average arc count: 355
- Max Arc Count: 1601
- Investigation Priority Level: 2*
 - Moved to priority 1 based on recent top arc counts
- No previous reports of overheating or rise in temperature
- Meter not removed because customer was not home and it was a non-bypass pan
- Technician found damage to weather-head conduit

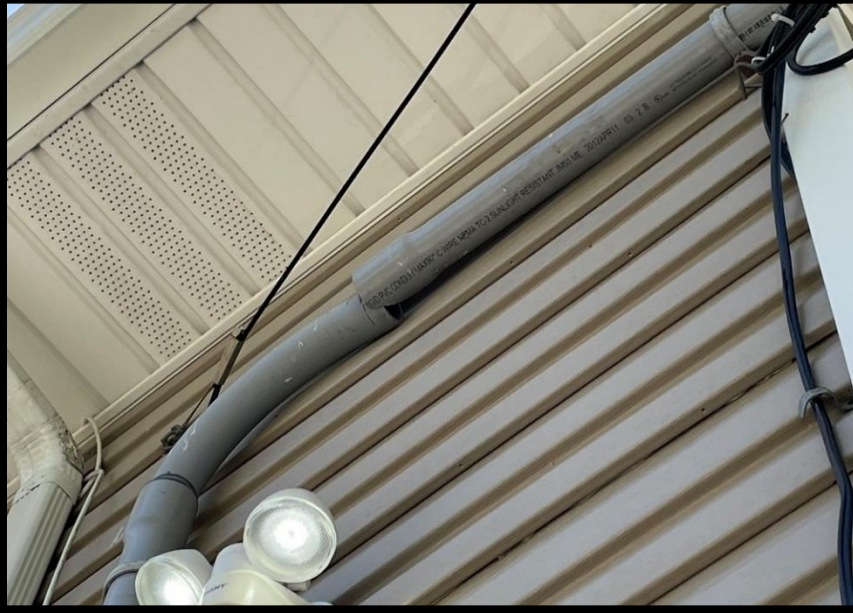
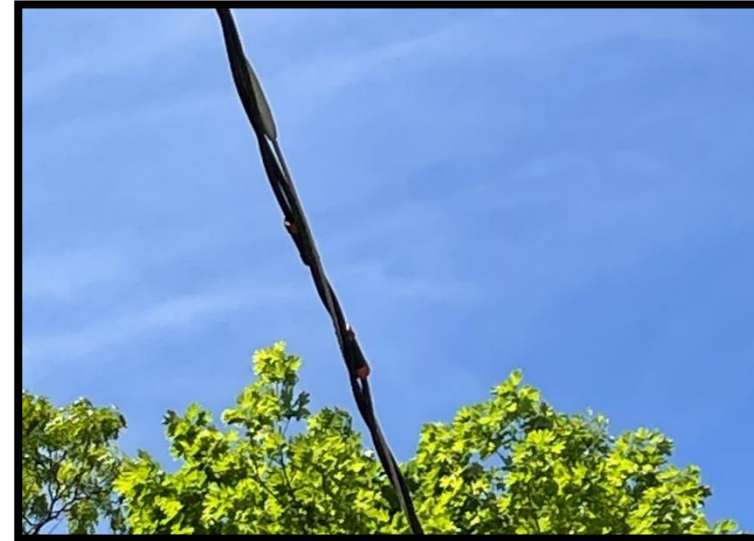
METER 51****25 – WEATHER-HEAD + WIRE REPAIR POINTS

- Days on report with >100 Max Arc Count: 56
- Average arc count: 247
- Max Arc Count: 625
- Arc Sense Priority Level 1

- No previous reports of overheating or rise in temperature
- Damage at weather-head conduit
- Found repair points on neutral at triplex to house

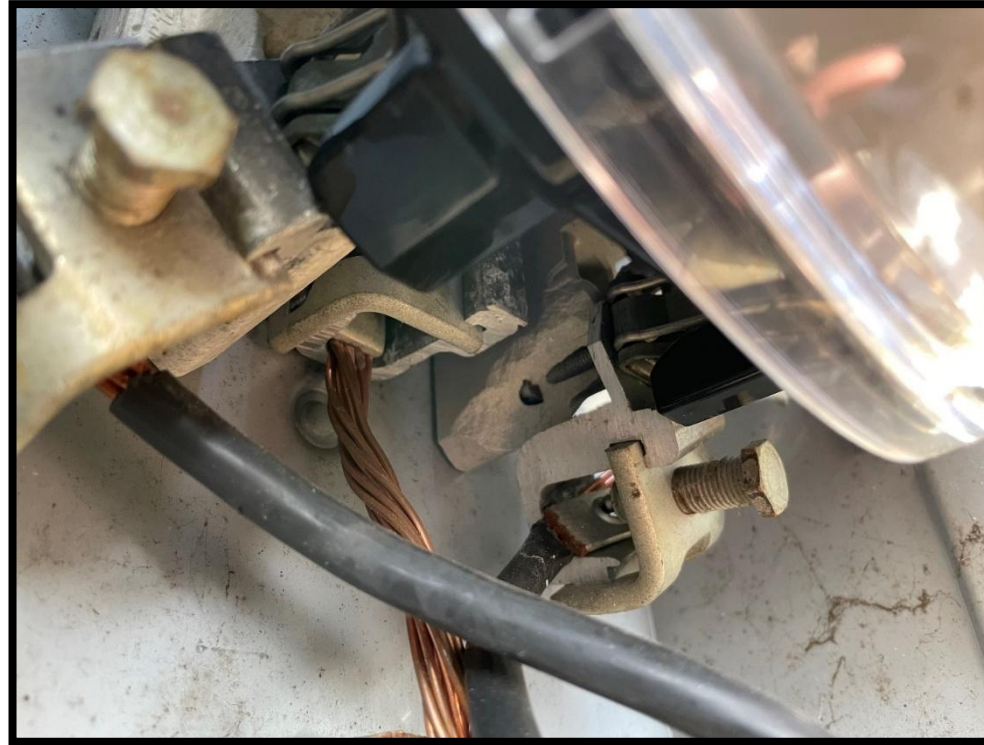
METER 51****25 – BROKEN CERAMIC INSIDE METER PAN

- Days on report with >100 Max Arc Count: 93
- Average arc count: 236
- Max Arc Count: 349
- Arc Sense Priority Level 1
- No previous reports of overheating or rise in temperature
- Technician found broken ceramic on the foundation inside the meter pan

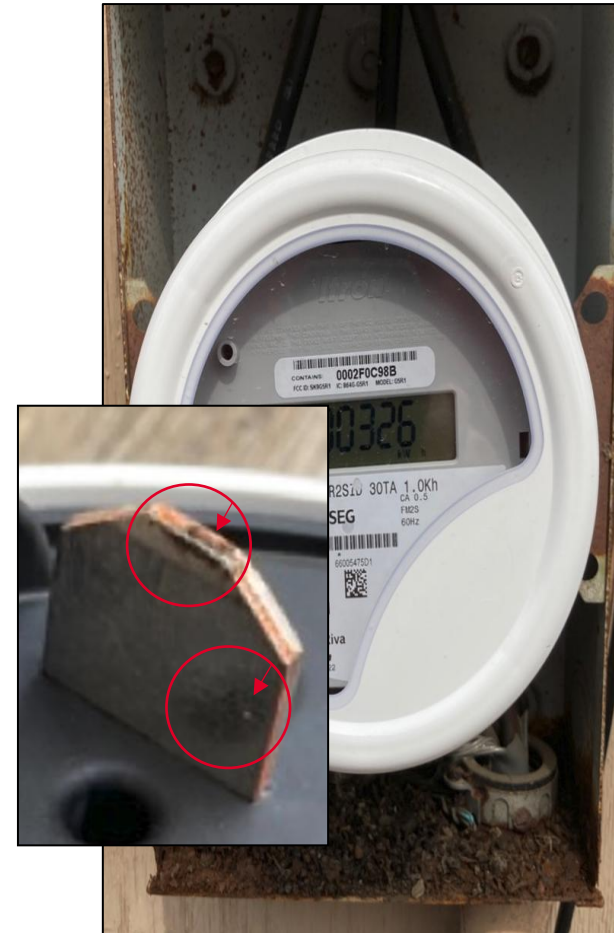
AVANGRID – METER 1 FIELD FINDINGS

- The meter technician confirmed the presence of small burn marks and slight discoloration on the meter blade (picture below).
- He confirmed all service terminations were tight and he tested socket jaw tension using the Tesco Hot Socket Gap Indicator tool.
 - Jaw tension was good.
- Based on photo, it appeared meter was misaligned; after field visit and reinsertion of the meter, report showed zero incremental arc counts, on all six counters.

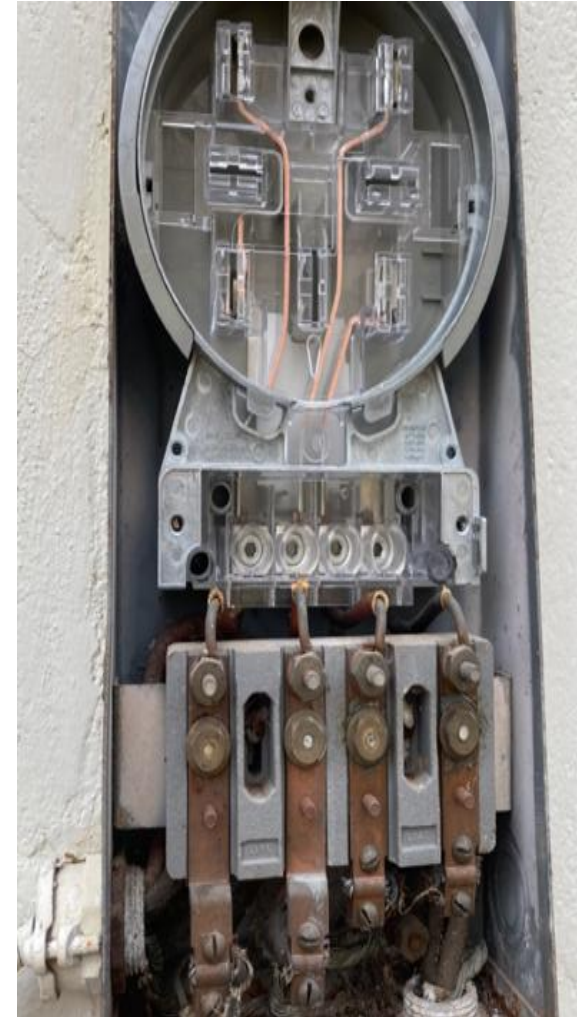
AVANGRID – METER 2 FIELD FINDINGS

- A-Base to socket adapter
 - The adapter is new and was installed when the new AMI meter was set
- The meter technician said he used a magnifying glass to inspect the meter blades but didn't see any pit marks.
- He checked all external service connections and everything seemed to be OK (i.e. no loose connections, etc.).
- He used the TESCO Hot Socket Gap Indicator tool on the adapter and jaw tension looked good.
- Expected arcing occurring in older connection base to new socket adapter; arc passing through meter channel.
 - Additional inspection is ongoing. Meter has continued to arc and show on report after initial investigation
