# ArcSense<sup>®</sup> Study

PSEG Long Island, TESCO, L+G

# ArcSense® Pilot

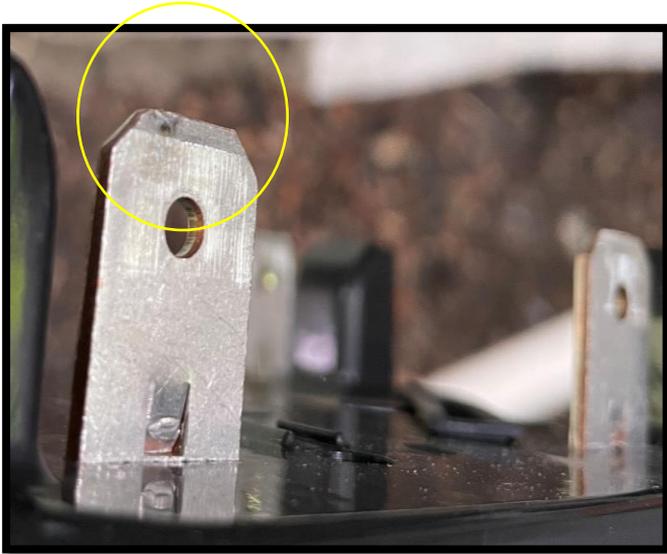
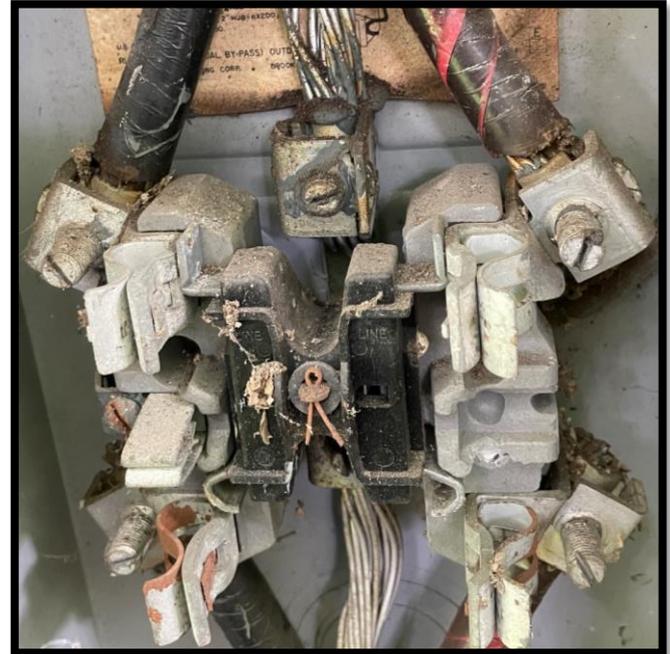
# Meter 51\*\*\*\*48 – Discoloration on Meter Blade

- Days on report with >100 Max Arc Count: 16
- Average arc count: 160
- Max Arc Count: 320
- Arc Sense Priority Level 3
- No previous reports of overheating or rise in temperature
- Pitting on meter blade
- Meter pan did not show any signs of damage or excessive weathering

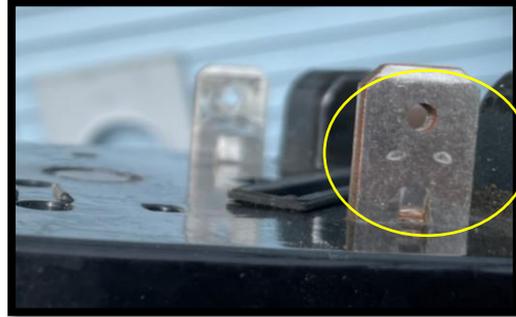
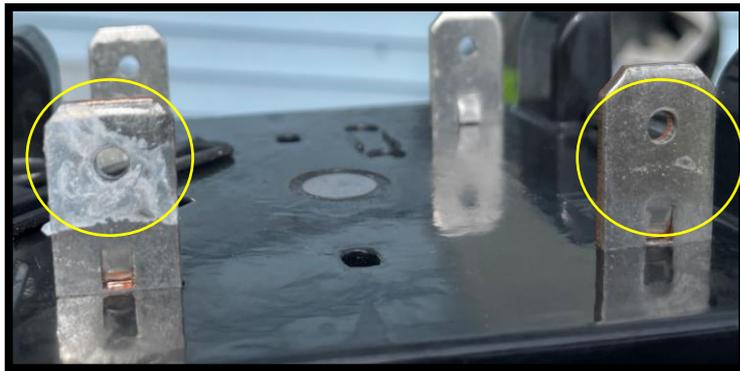
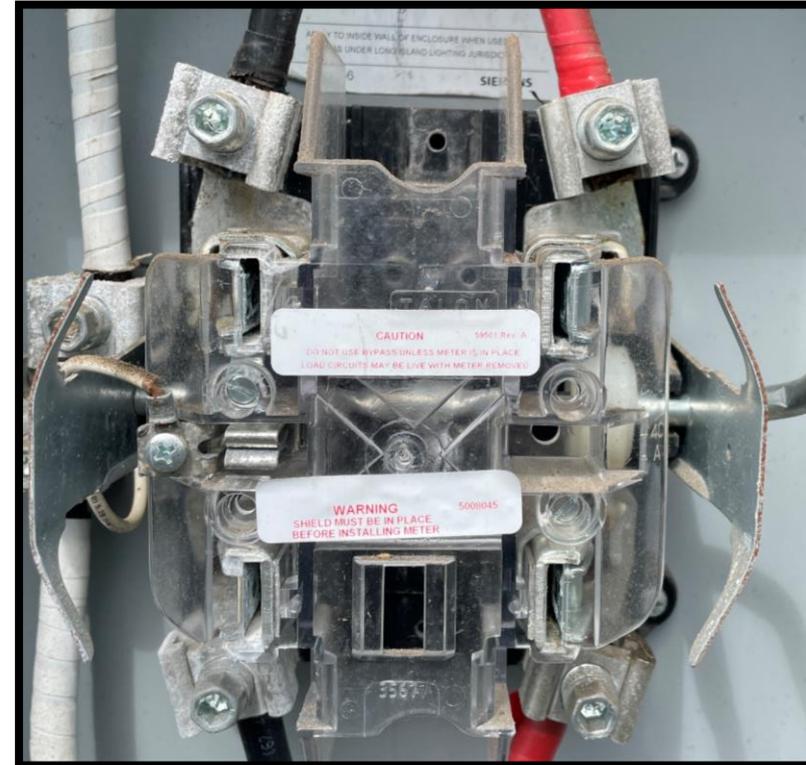
# Meter 51\*\*\*\*35 – Discoloration on Meter Blade

- Days on report with >100  
Max Arc Count: 43
- Average arc count: 305
- Max Arc Count: 534
- Arc Sense Priority Level 1
- No previous reports of overheating or rise in temperature

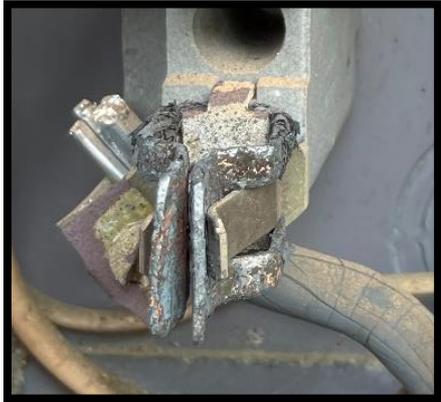
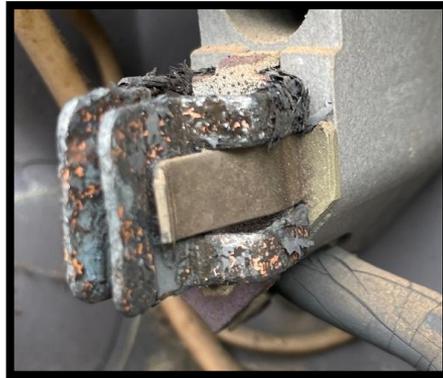
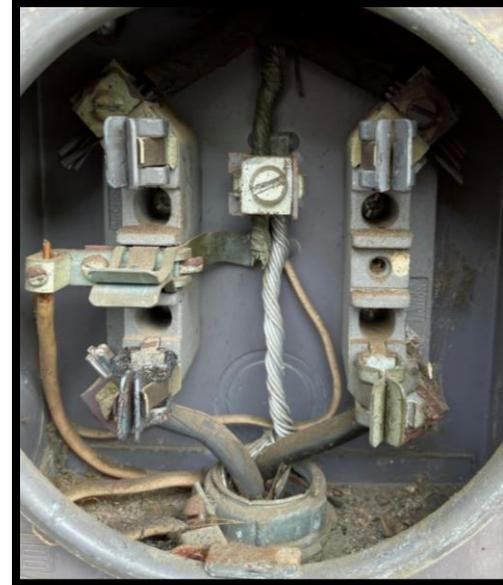
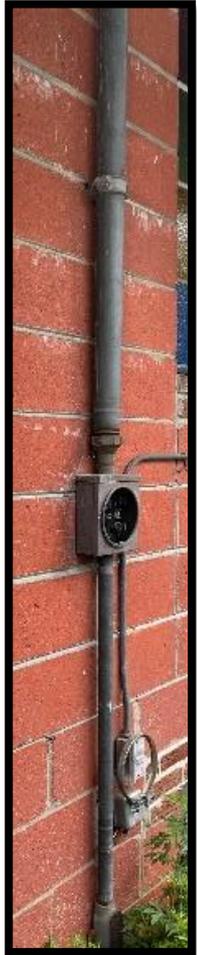
# Meter 51\*\*\*\*18 – High Temperature Alerts

- Originally a non-Arc Sense meter was at property
- Meter was reported by Analyst to indicate high temperature alerts
- Arc Sense meter was installed in Spring 2022 after high temperature alerts
- Arc count and temperature readings were high enough to warrant investigation
- Found brittle jaws inside meter pan; meter pan was replaced as a result

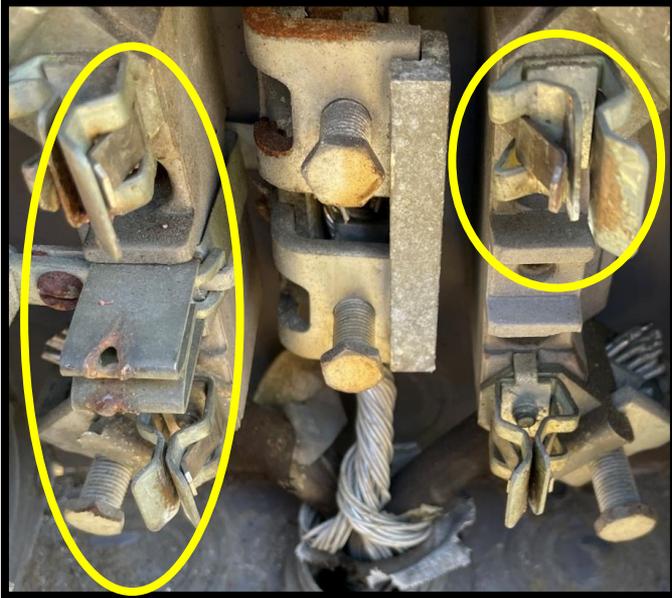
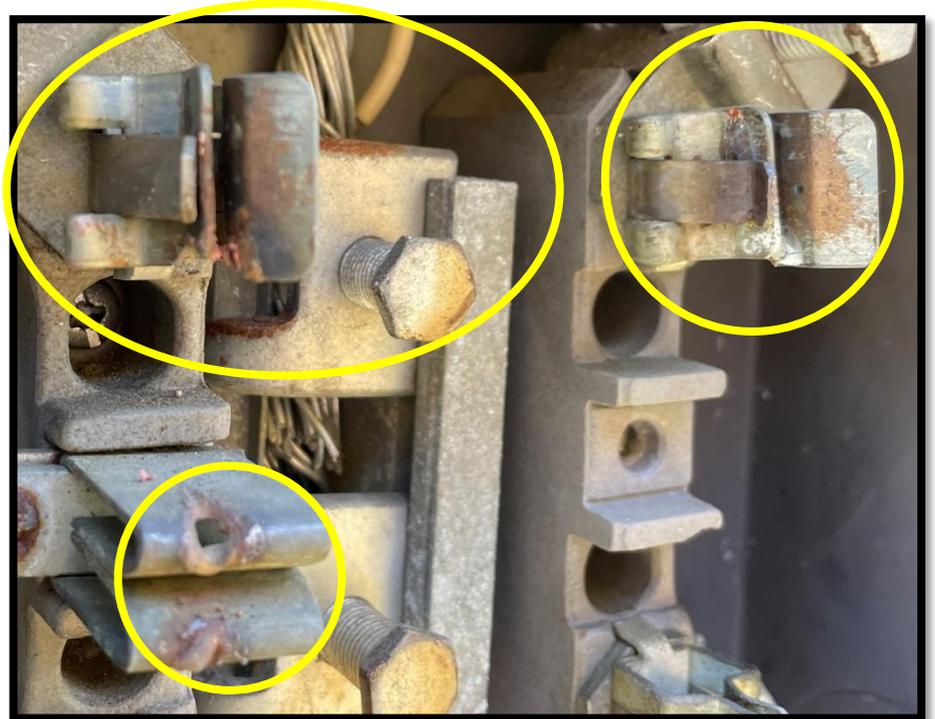
# Meter 51\*\*\*\*26 – Meter Pan with Recessed Jaws

- Days on report with >100 Max Arc Count: 18
- Average arc count: 278
- Max Arc Count: 539
- Arc Sense Priority Level 3
- No previous reports of overheating or rise in temperature
- Recessed springs and discoloration on the jaws
- Damaged neutral (as if someone tried to fix the jaws and an uninsulated screwdriver made contact between phase/neutral)

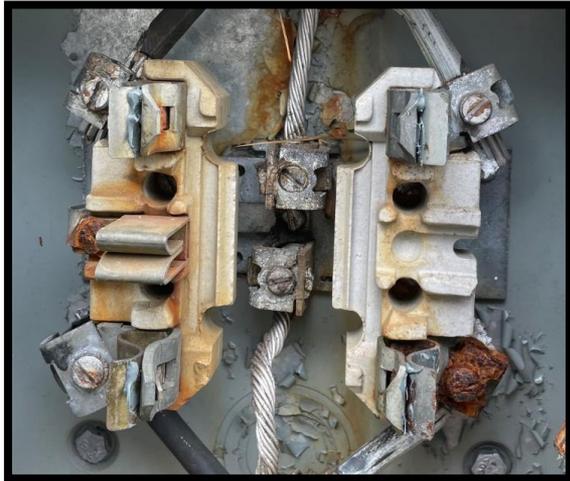
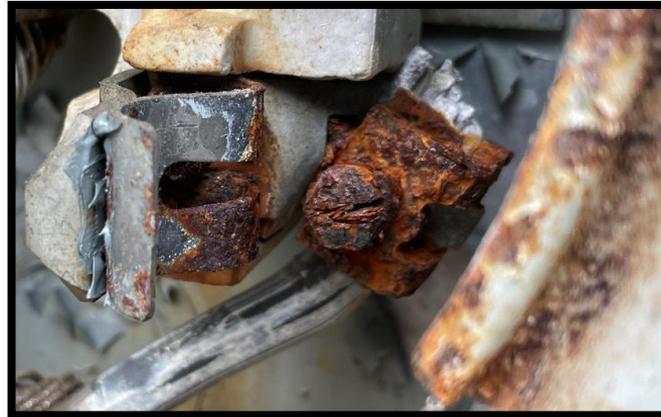
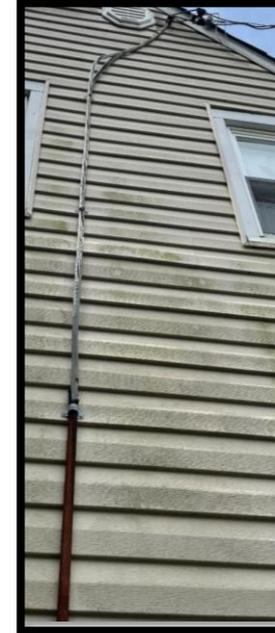
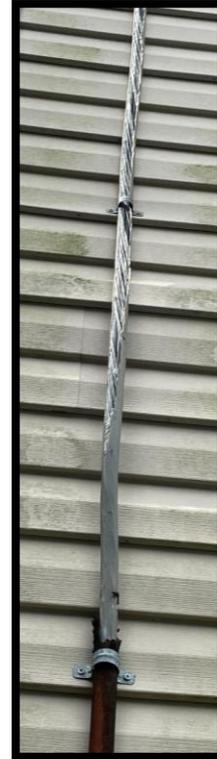
# Meter 51\*\*\*\*14 – Conduit Allowing Water

- Days on report with >100 Max Arc Count: 43
- Average arc count: 233
- Max Arc Count: 473
- Arc Sense Priority Level 1
- No previous reports of overheating or rise in temperature
- Conduit allowed water to enter into the meter pan
- Screw terminal at C-phase load side was rusted and deteriorating
- Meter produced arcs when reinstalled

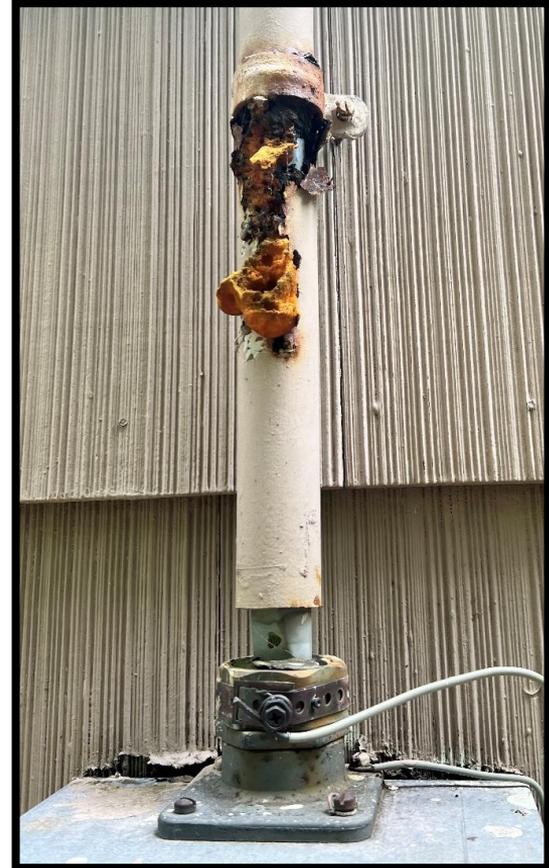
# Meter 51\*\*\*\*55 – Weather-head Conduit Damage

- Days on report with >100 Max Arc Count: 35
- Average arc count: 355
- Max Arc Count: 1601
- Investigation Priority Level: 2\*
  - Moved to priority 1 based on recent top arc counts
- No previous reports of overheating or rise in temperature
- Meter not removed because customer was not home and it was a non-bypass pan
- Technician found damage to weather-head conduit

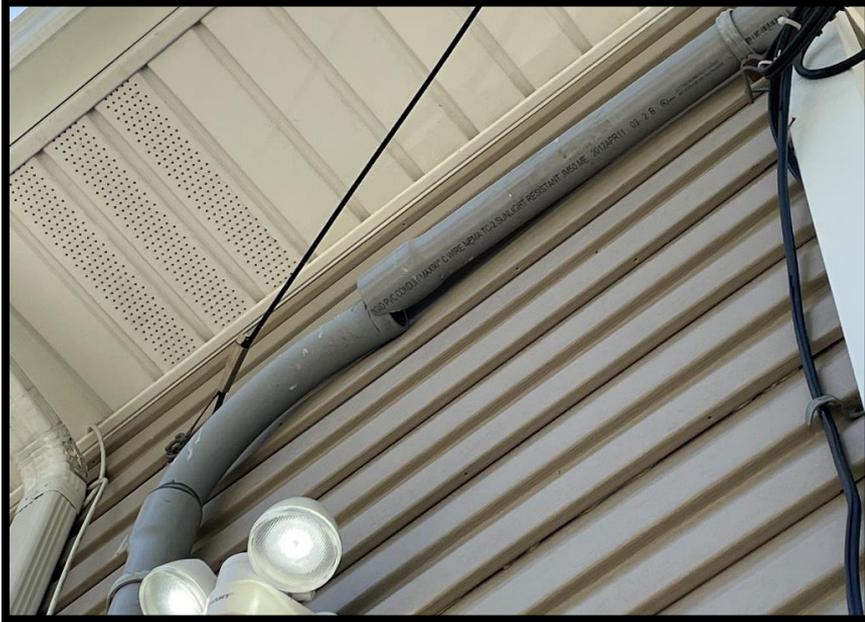
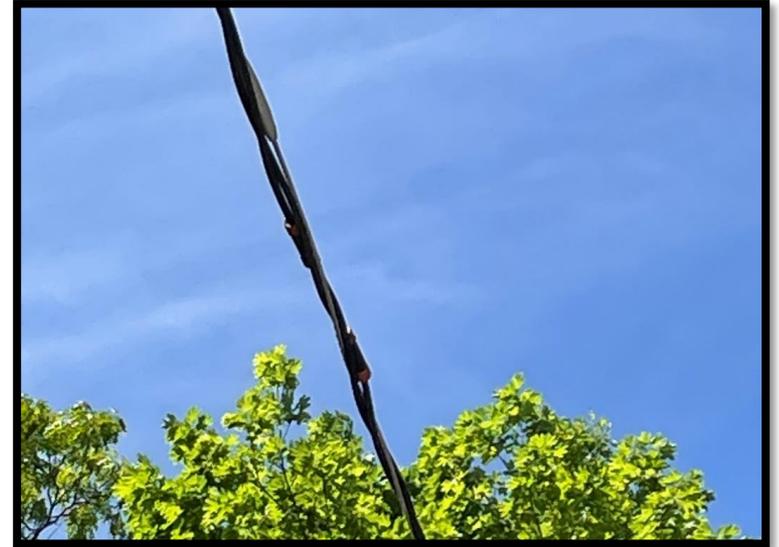
# Meter 51\*\*\*\*25 – Weather-head + Wire Repair Points

- Days on report with >100 Max Arc Count: 56
- Average arc count: 247
- Max Arc Count: 625
- Arc Sense Priority Level 1
- No previous reports of overheating or rise in temperature
- Damage at weather-head conduit
- Found repair points on neutral at triplex to house

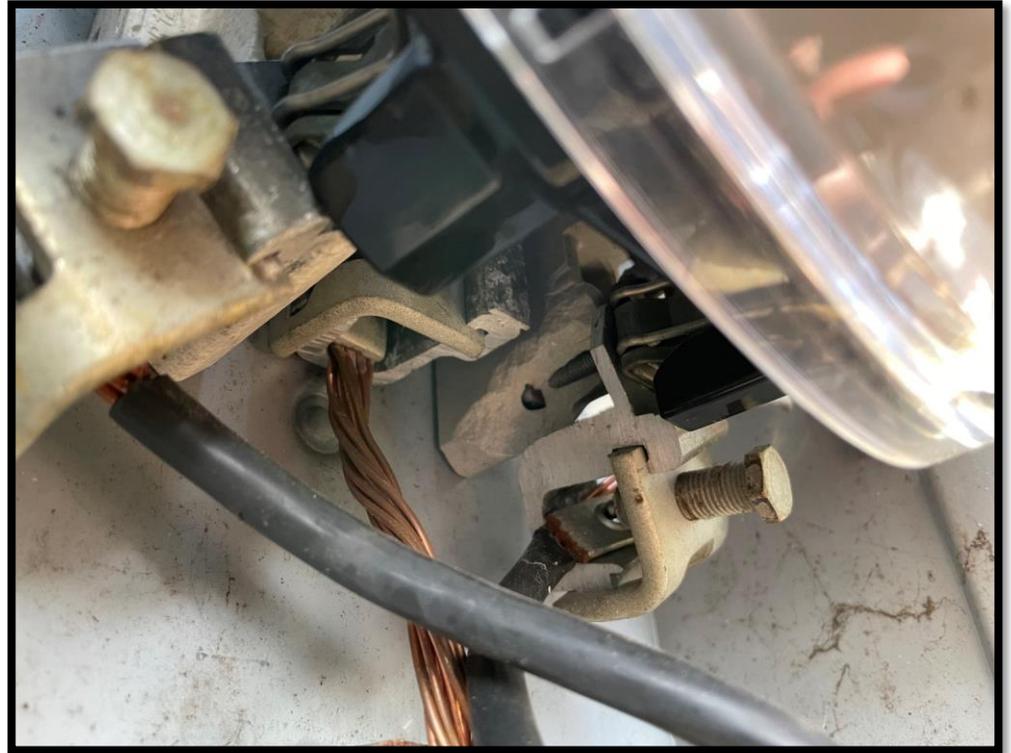
# Meter 51\*\*\*\*25 – Broken Ceramic Inside Meter Pan

- Days on report with >100 Max Arc Count: 93
- Average arc count: 236
- Max Arc Count: 349
- Arc Sense Priority Level 1

- No previous reports of overheating or rise in temperature
- Technician found broken ceramic on the foundation inside the meter pan
