Verifying Transformer Rated Service Installations

Field Meter Testing Using Phantom Load

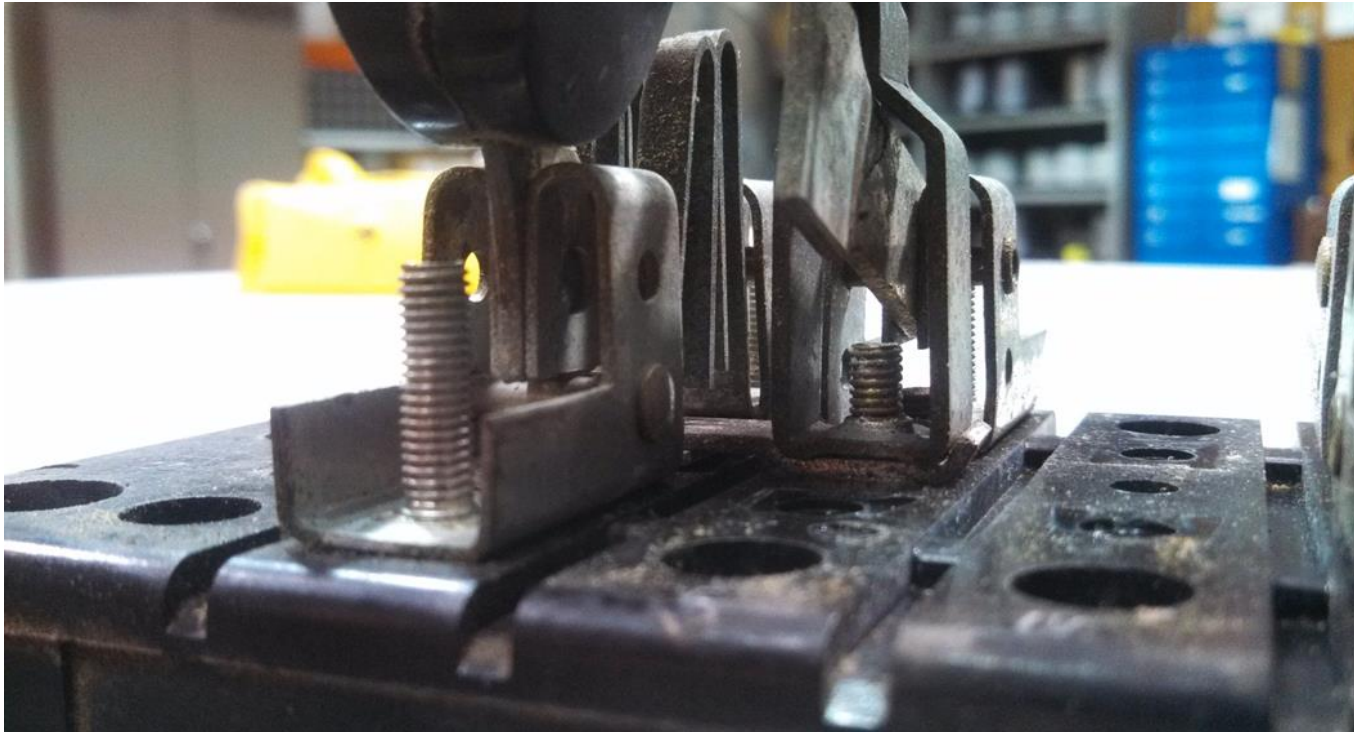
C Phase Current in open position

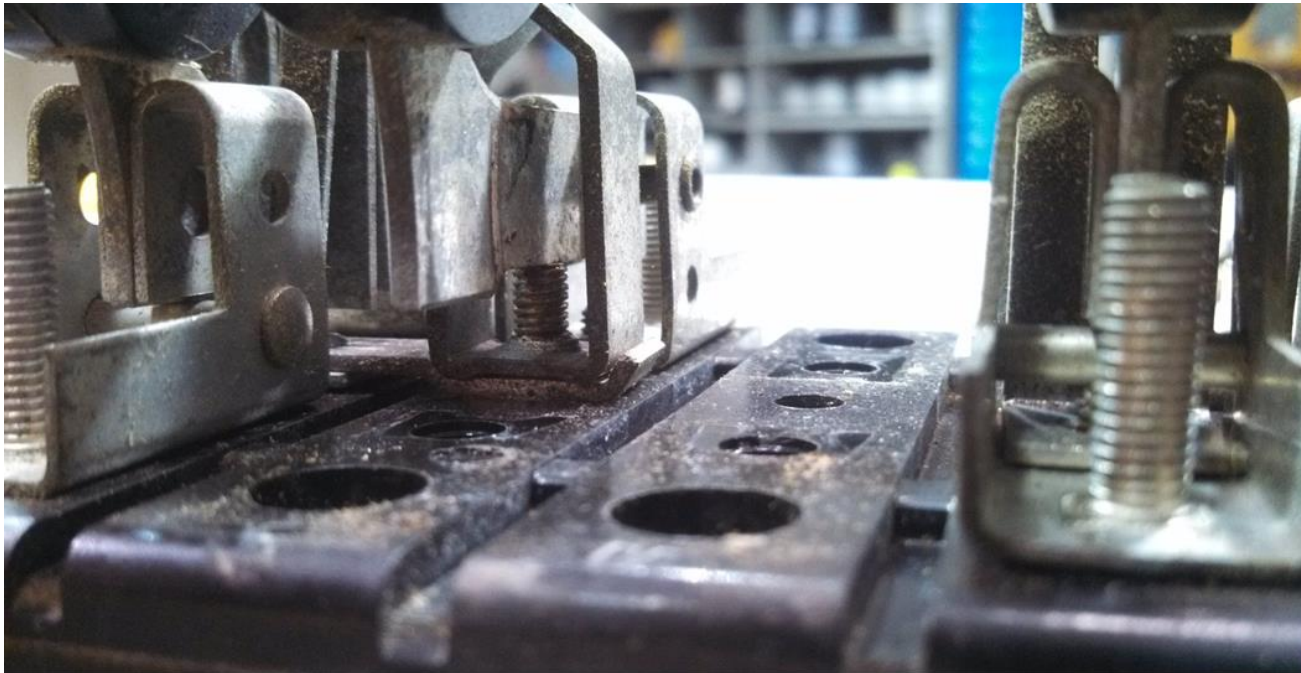
C Phase Current in closed position making contact with attachment screw for shunt buss.

This re-routes current to by pass the meter.

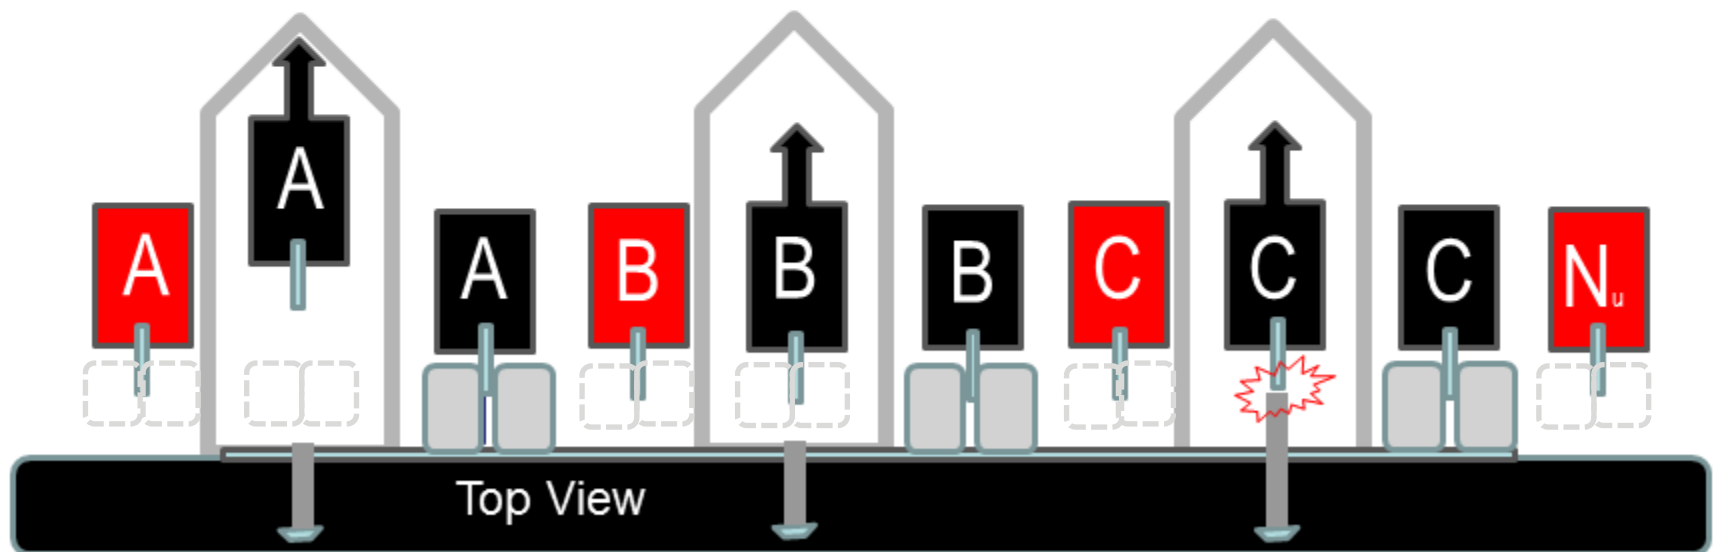
CURRENT RETURN SWITCHES

Test switch A in the open position, current circuit is shorted- meter bypassed

Test switch B in the closed position

Test switch C in the closed position, long screw makes improper contact, current circuit is shorted- meter bypassed

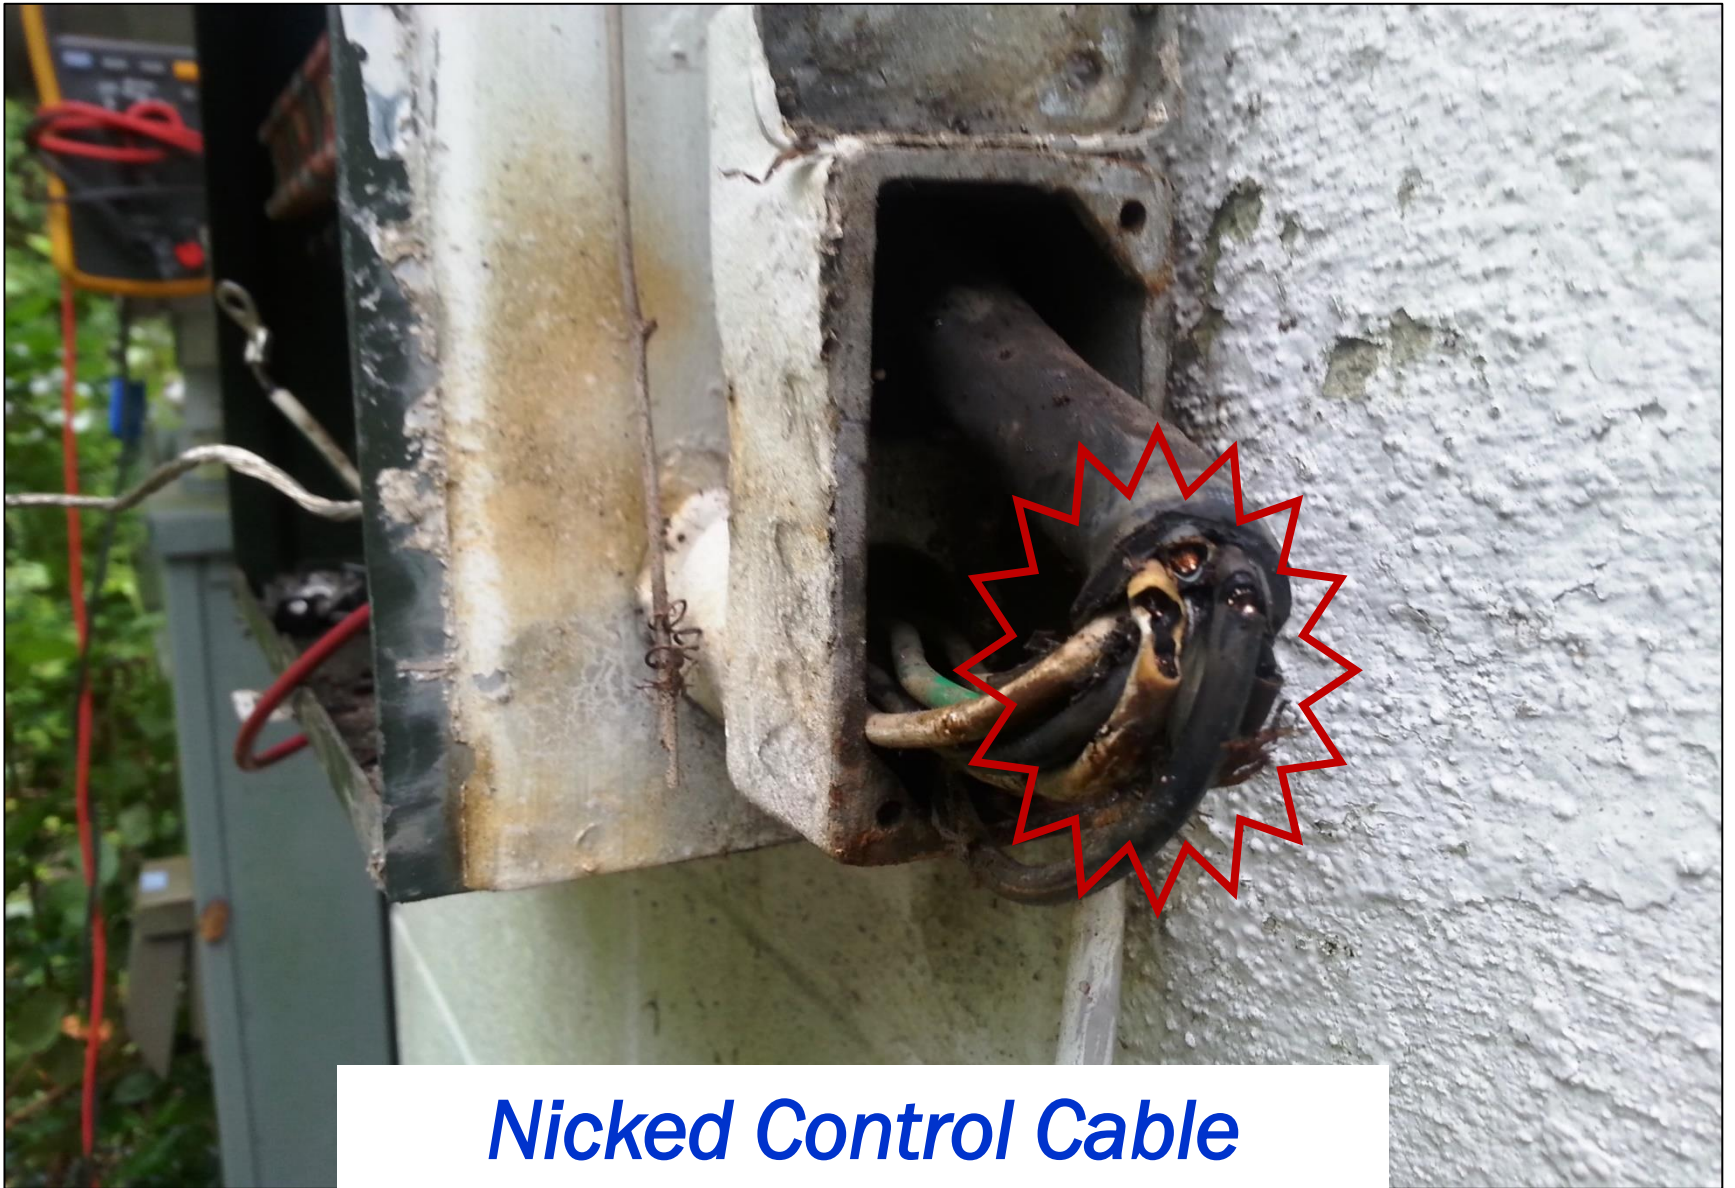
Nicked Control Cable

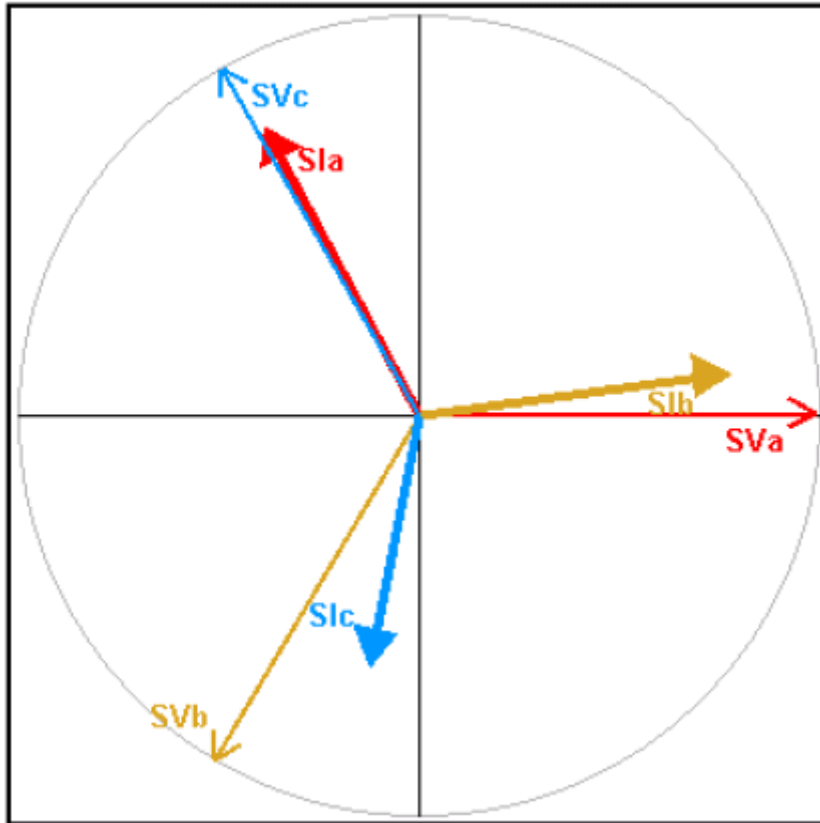
Meter Vector Diagram

4 Wire Wye Service at Unity Power Factor

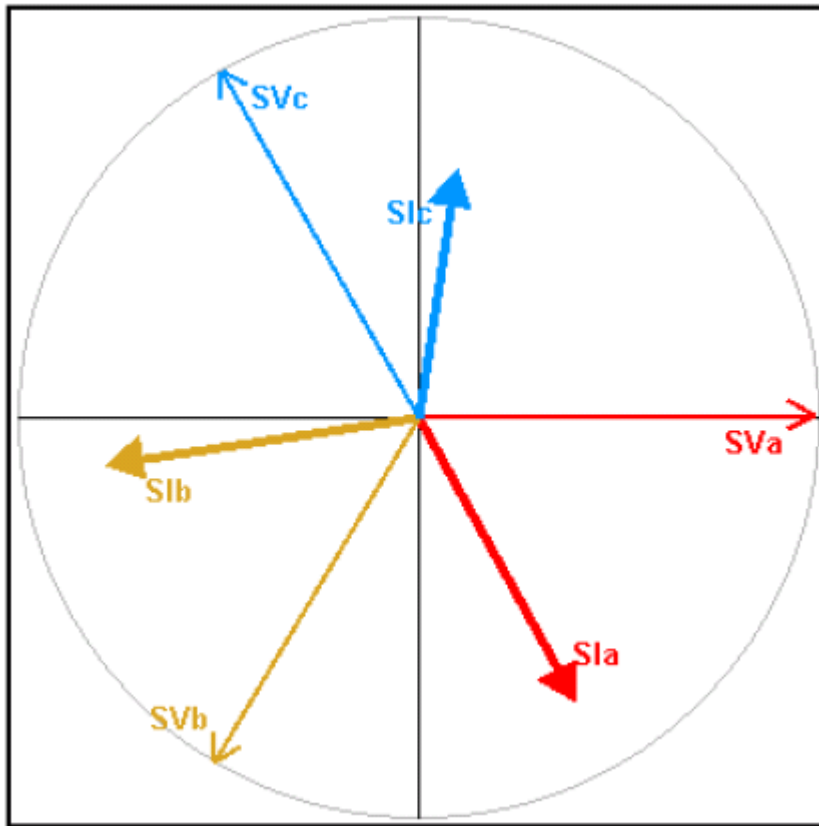
Meter Vector Diagram

4 Wire Wye Service at 50% Power Factor

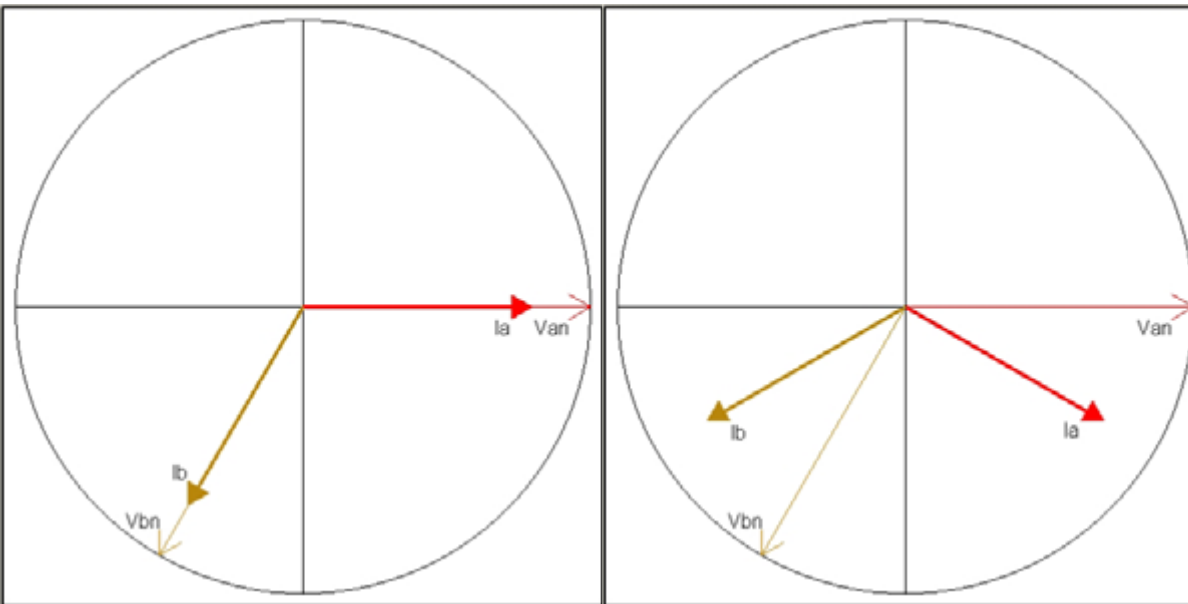
Three Wire Three Phase Network Service

No Lag (1.00 PF)

30° Lag (0.866 PF)

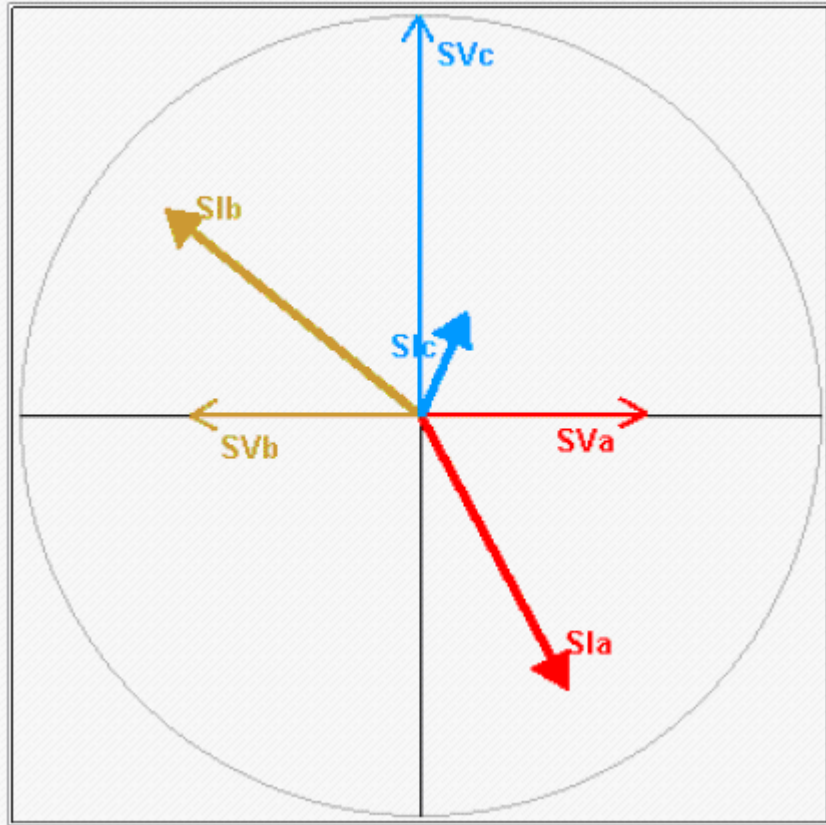
Meter Vector Diagram

Delta Service at 50% Power Factor

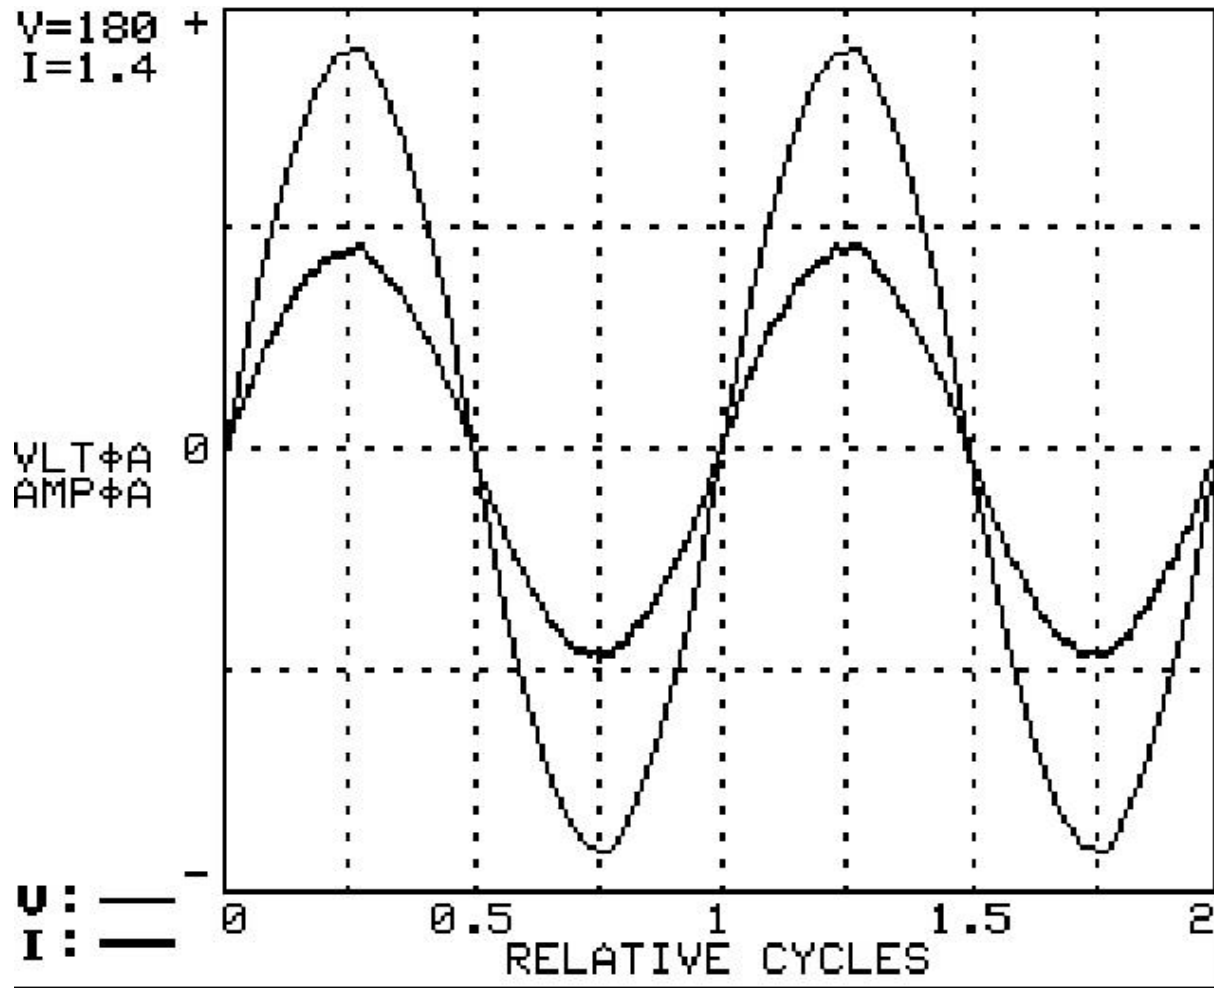
INCANDESCENT BULB

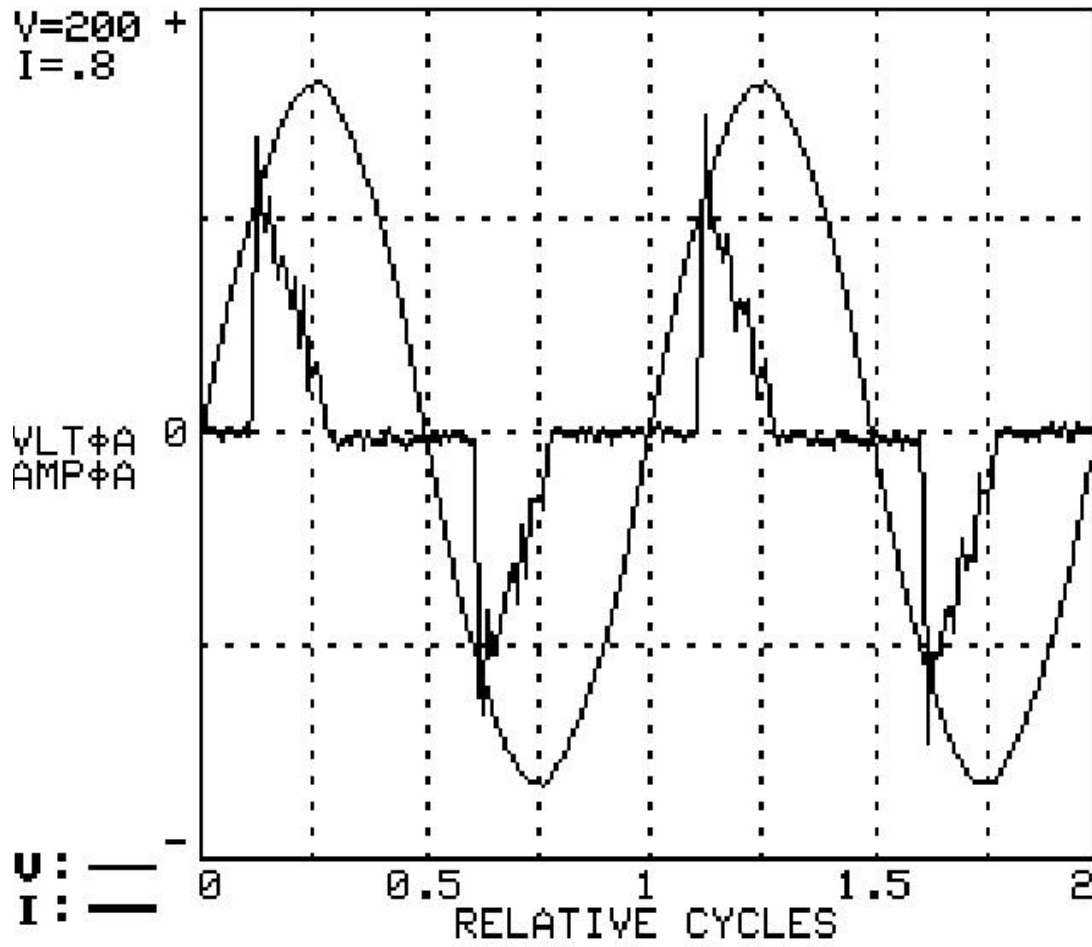
COMPACT FLUORESCENT BULB

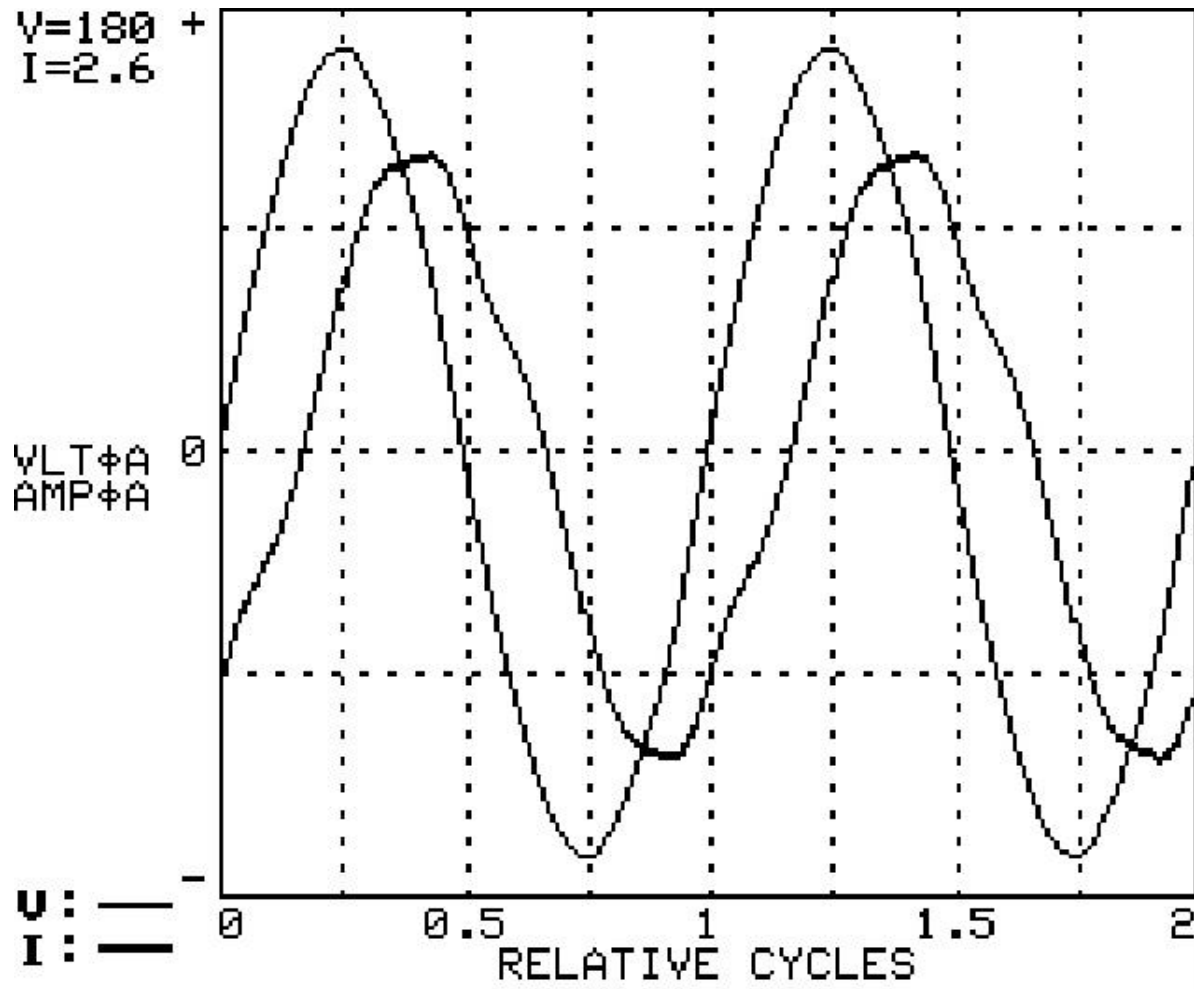
MOTOR

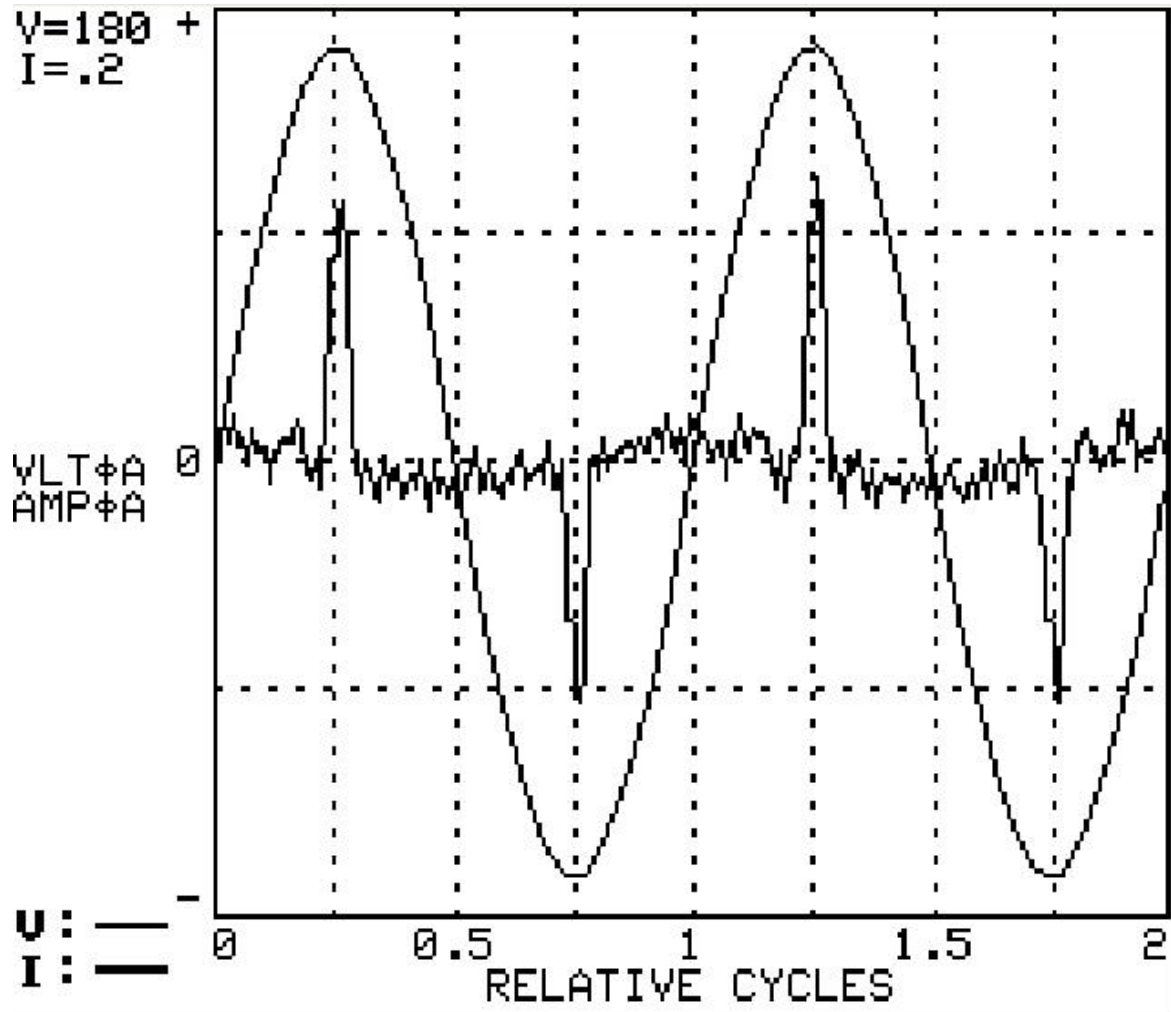
POWER SUPPLY FOR LAP TOP COMPUTER

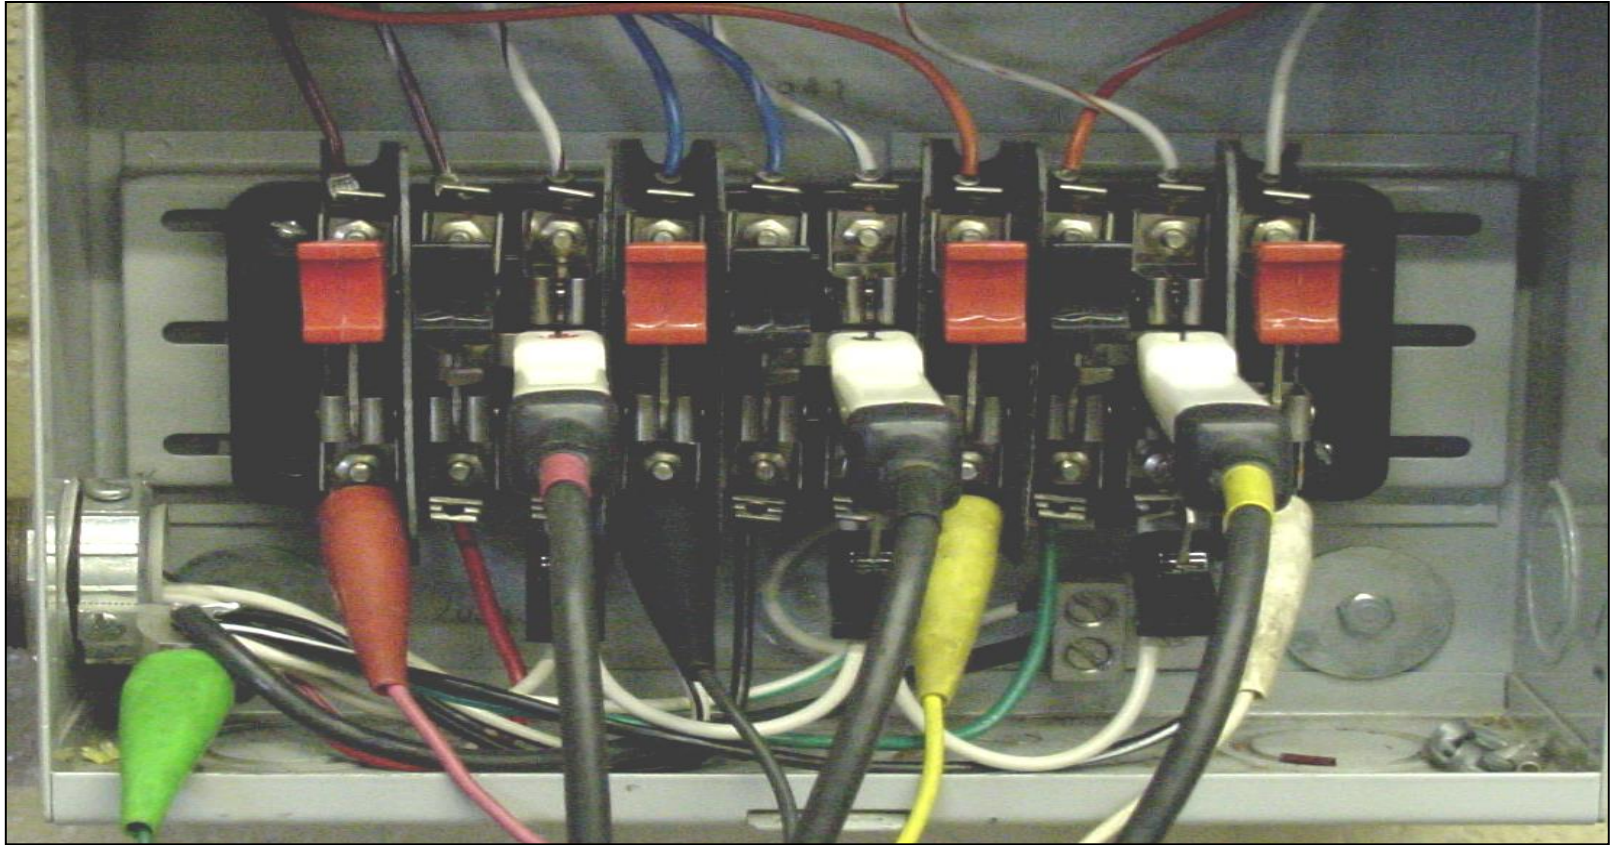
MEASURING SECONDARY CURRENT

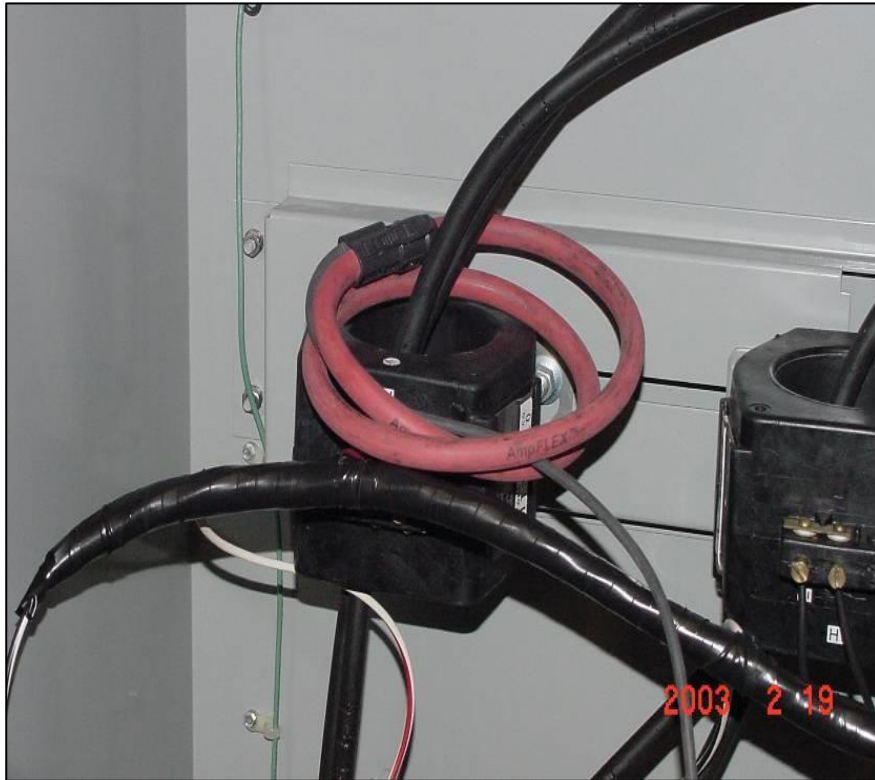
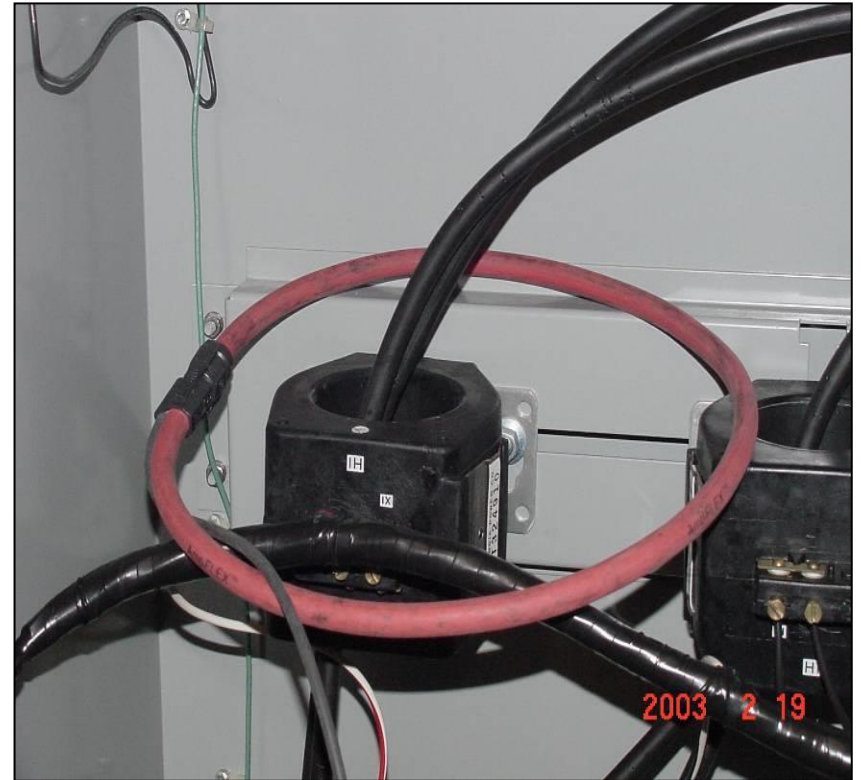
VERIFYING CT ACCURACY ON 600 VOLTS OR LESS

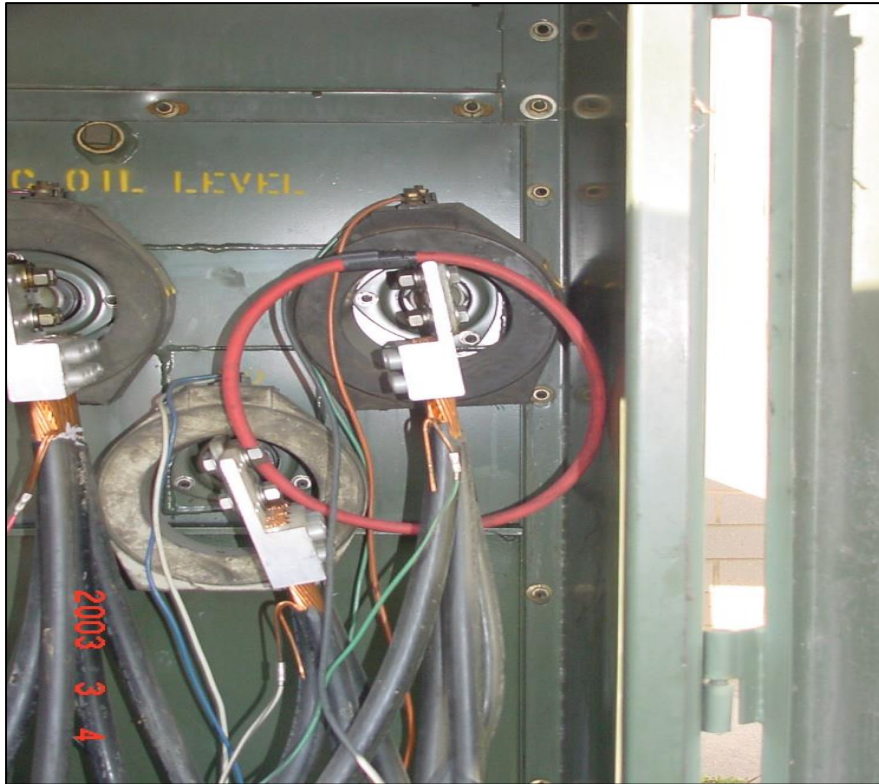
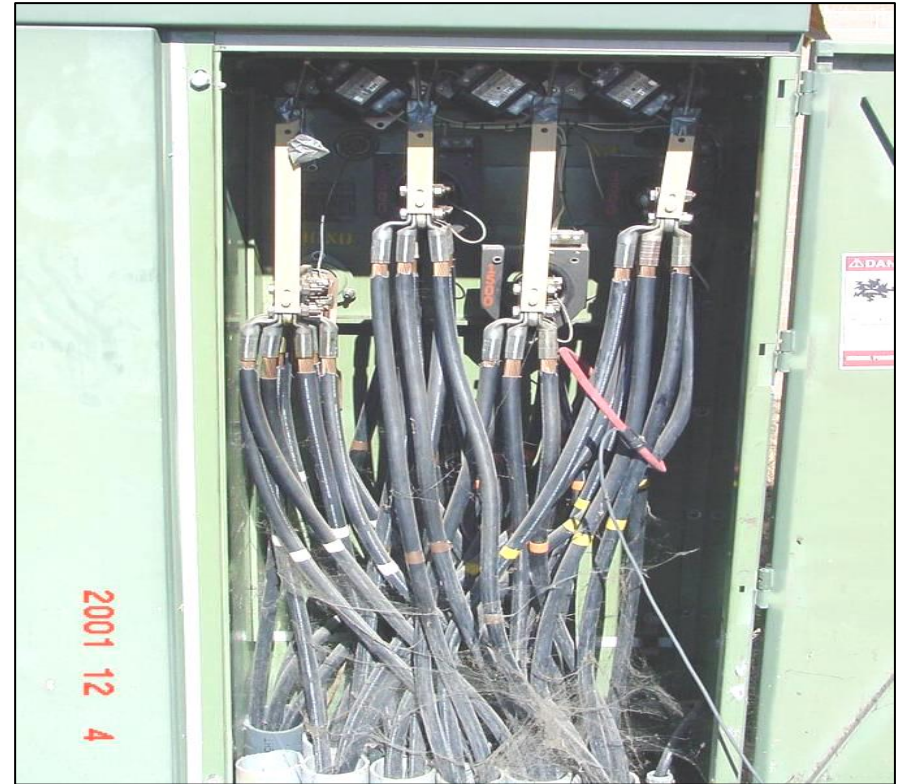
FLEX PROBE MEASURING CT'S "PRIMARY" CURRENT IN AN U.G. TRANSFORMER

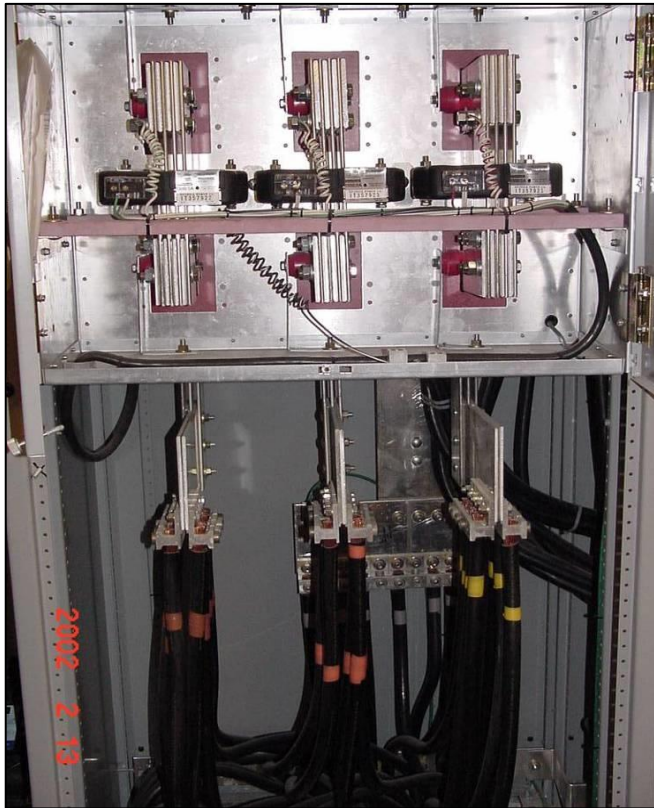
FLEX PROBE MEASURING CT'S "PRIMARY" CURRENT IN SWITCHGEAR

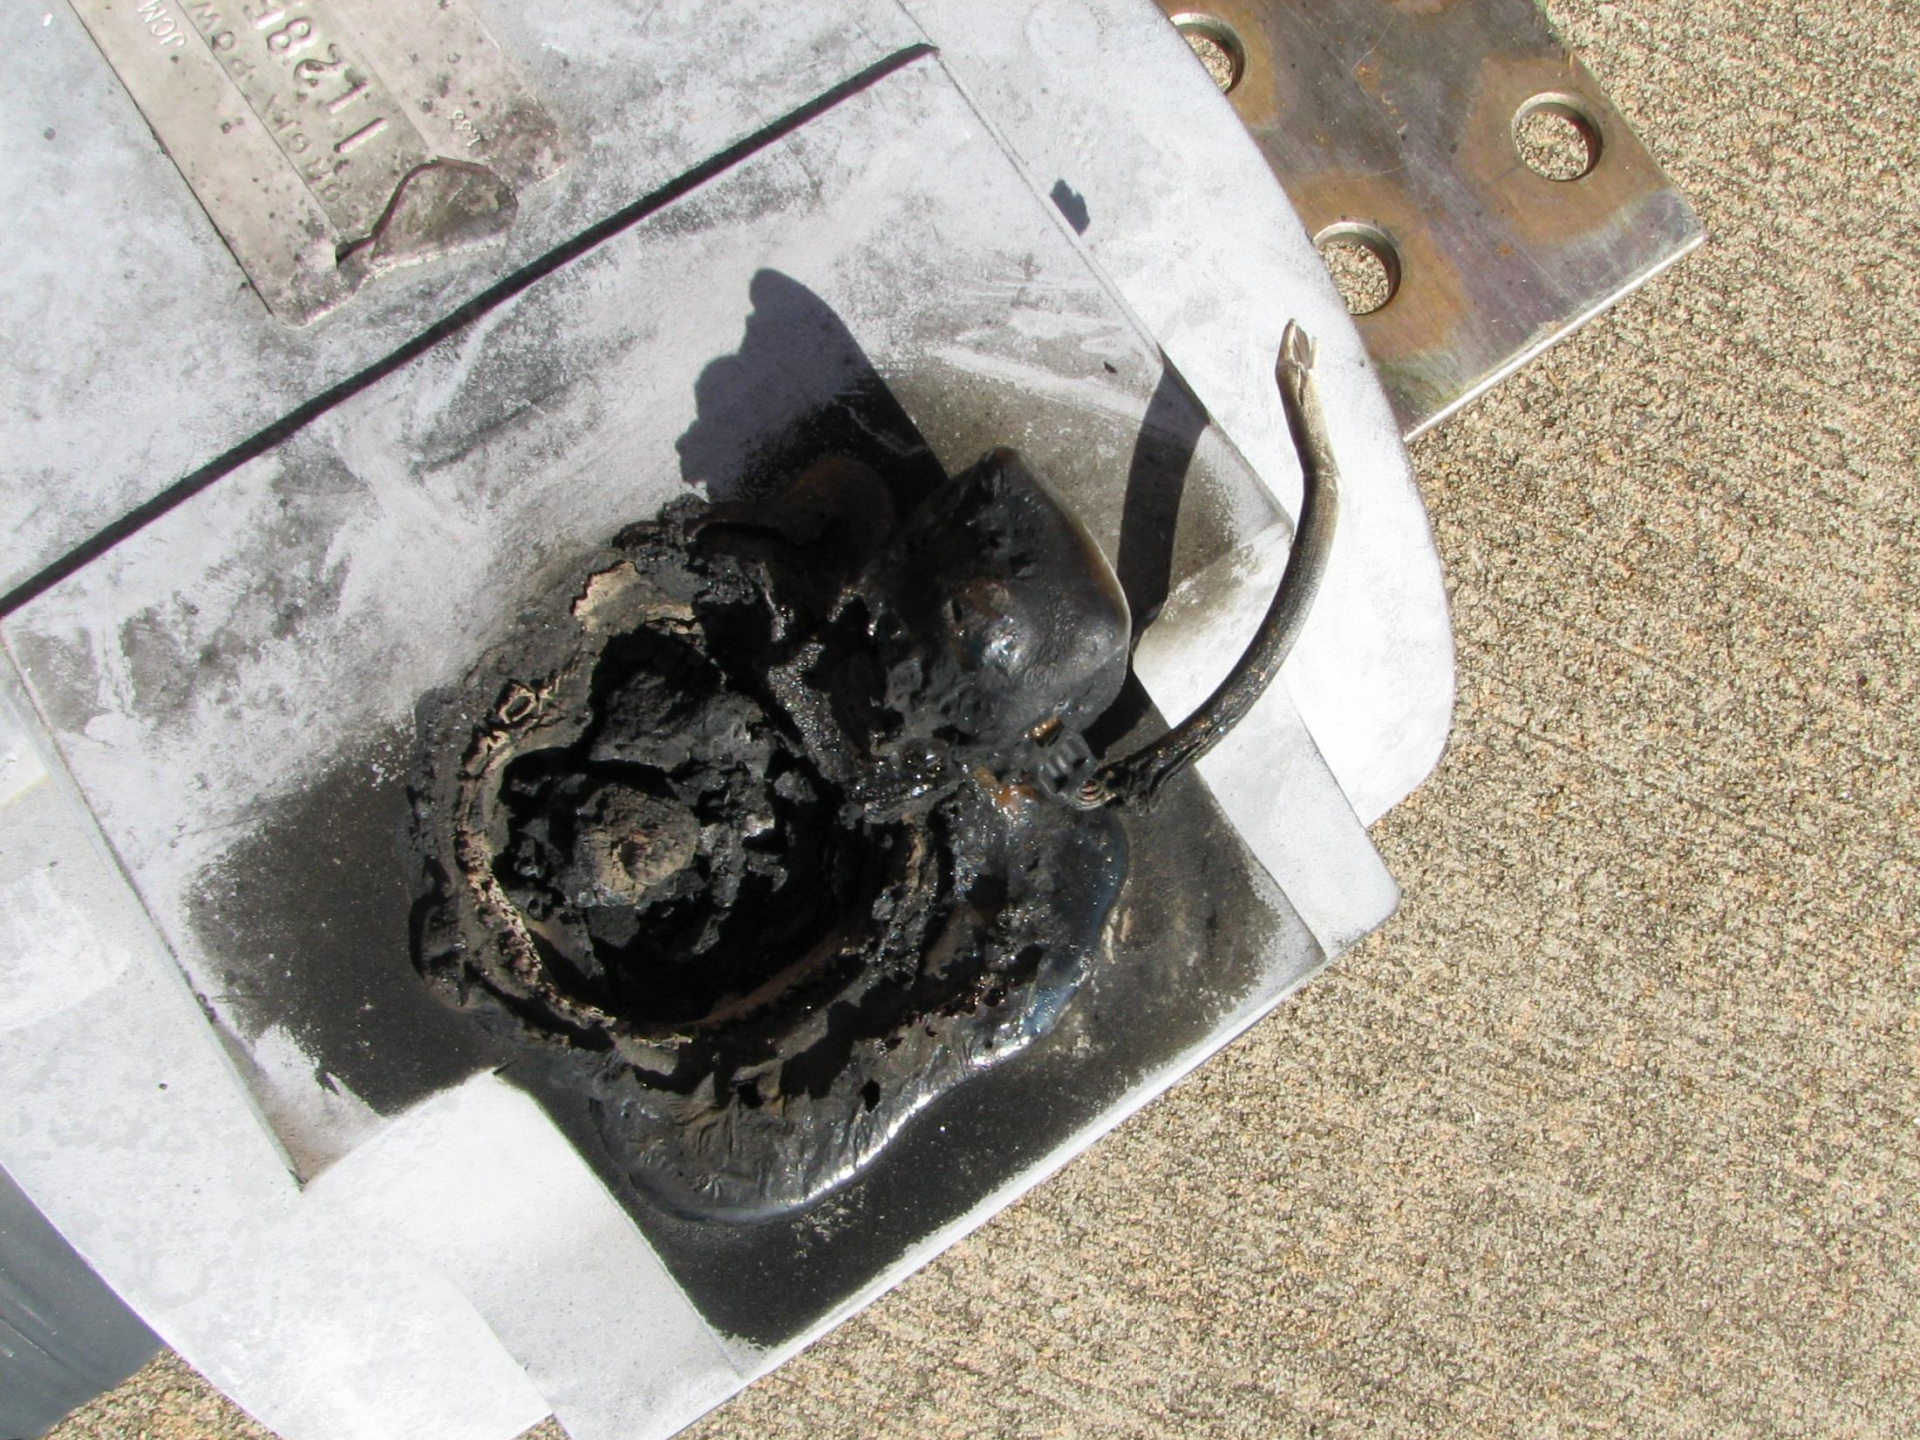
Fiber Optic Horseshoe Probe used on Primary Service (above 600 volts)

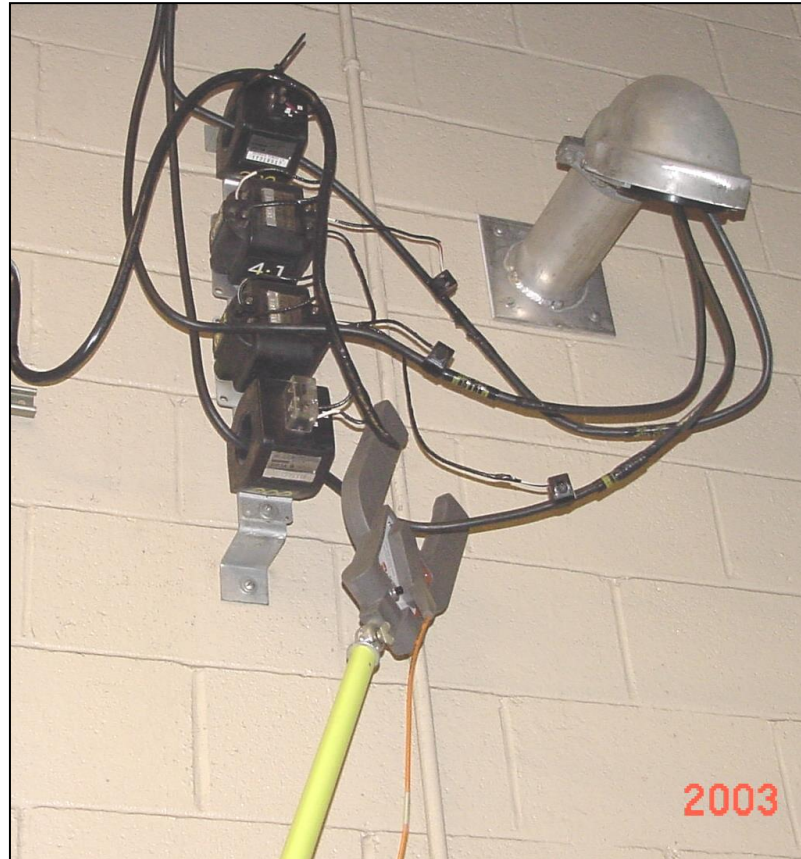
Fiber Optic Horseshoe Probe can also be used on Over Head Secondary Service

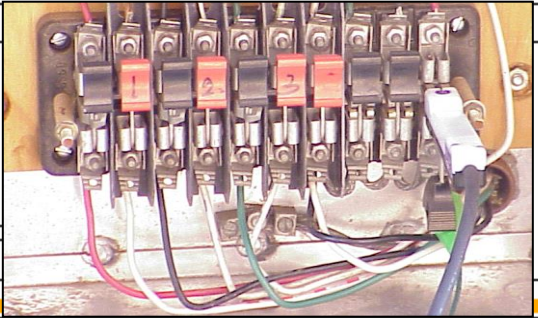
Possible Errors will be in **RED**, this appears to be a CT running backwards.

If you didn't check the vector before starting, this is probably your probe installed in reverse. Check the probe and retest the phase in question.

CT Testing Results		Selected Site: TEST WCM			
Measured Ratio: 99.84		FAIL	A		
Nameplate Ratio: 100 : 5		Primary Amps: 50.54			
Ratio Error (%): -0.16%		Secondary Amps: 2.531			
Phase Error (degrees): 179.844°		Phase Error (minutes): 179° 50' 38"			
Measured Ratio: 99.77

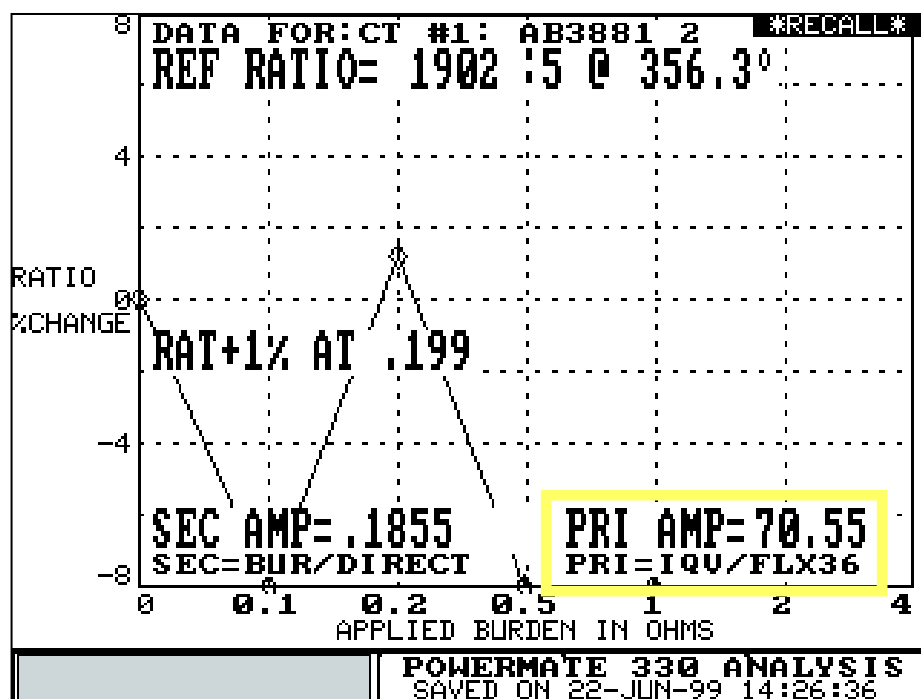
Ratio Should Be 200 : 5

No, Just A Bad Electrician

Additional run of wire installed and pulled through Two CTs backwards

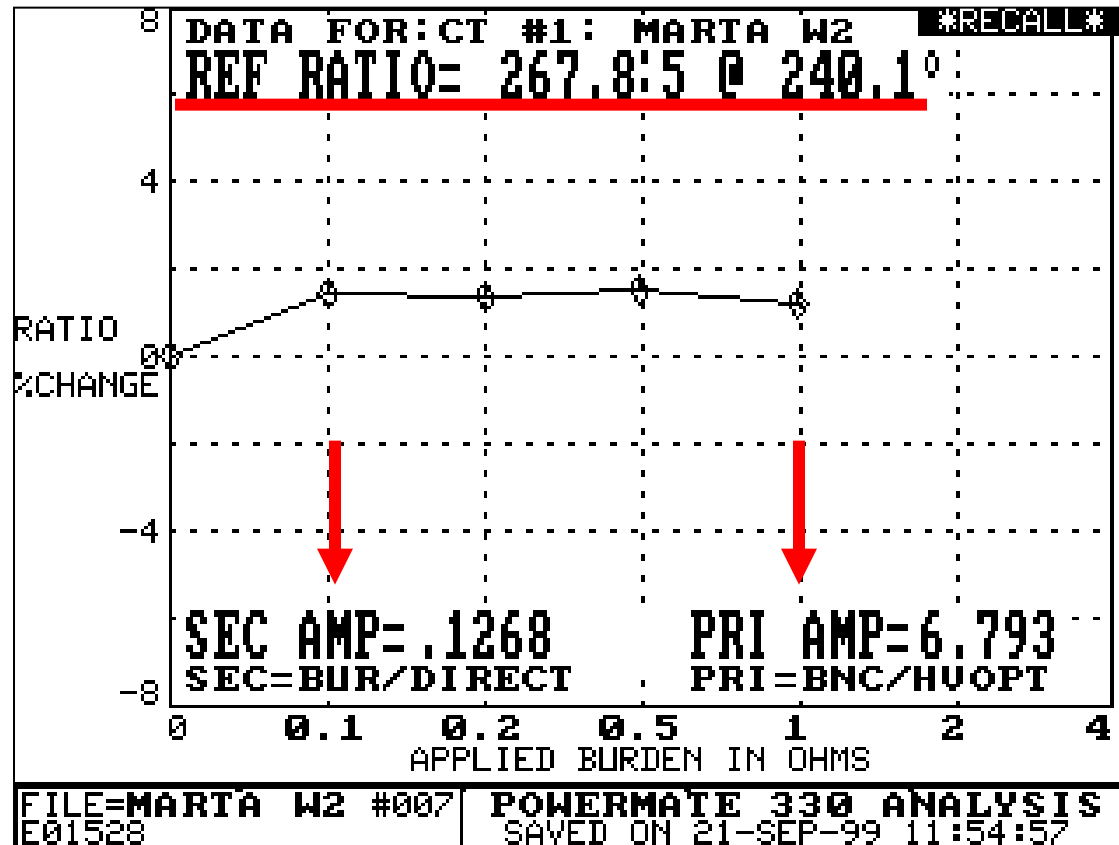
300 : 5 Primary CTs Ratio Results at 112%
