Verifying Transformer Rated Service Installations

Field Meter Testing Using Phantom Load

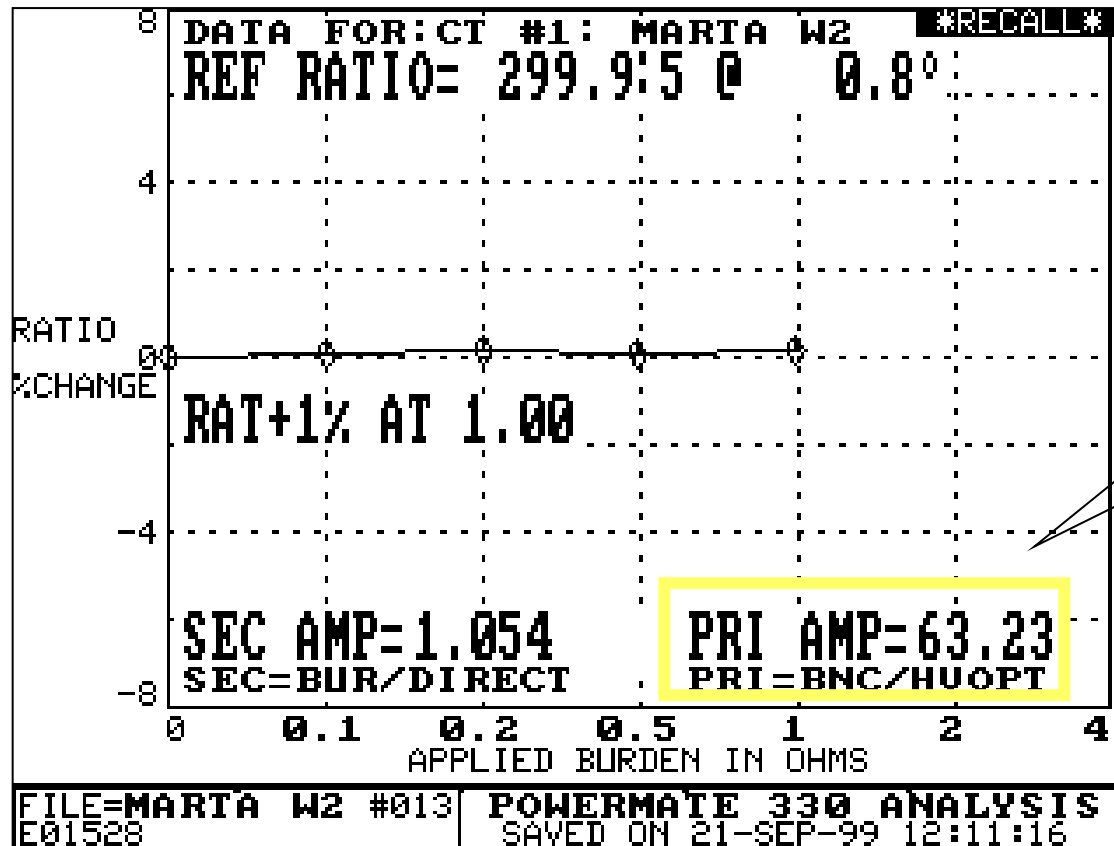
Same CT 15 Minutes Later

What Happened ?

Best Resolution Achieved If Secondary Amps
Are At Least 10% of CT Value

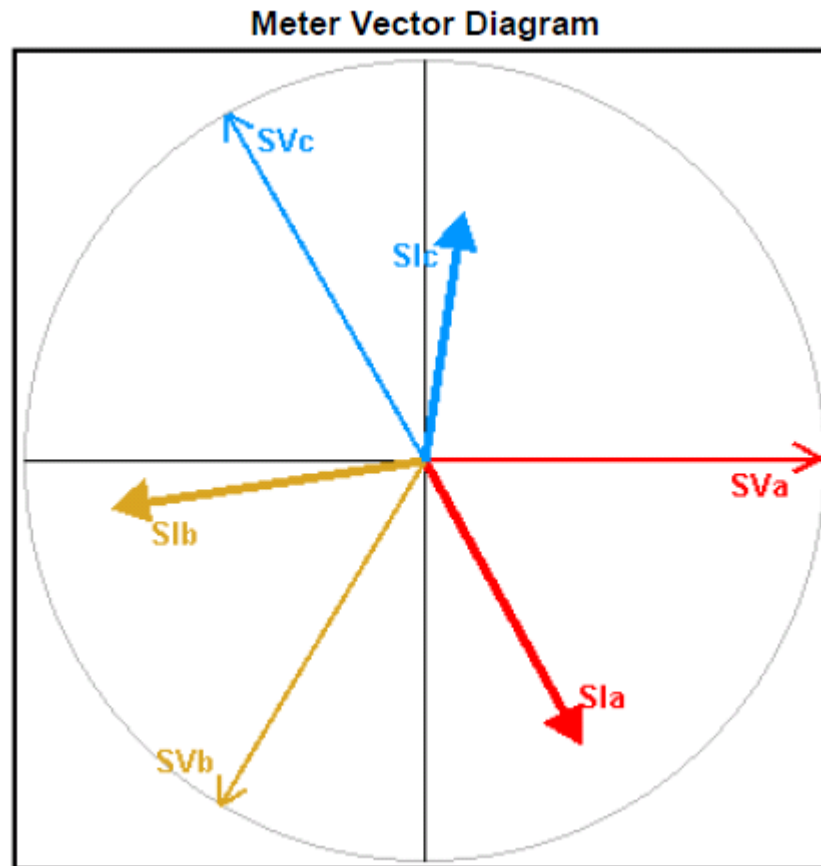
Typical WYE Service

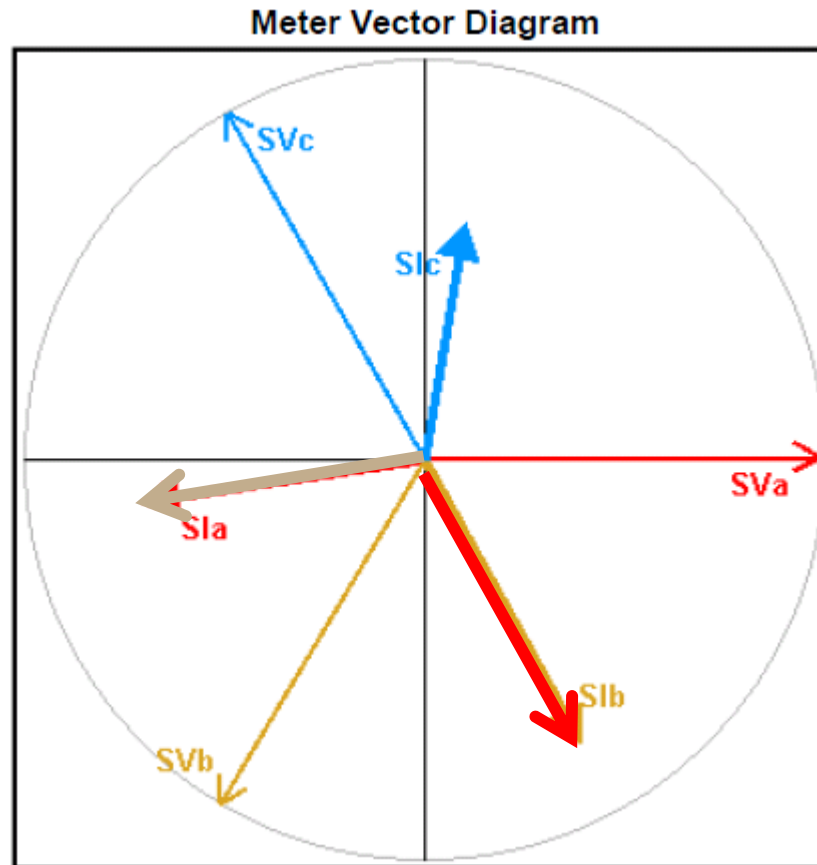
A Phase and B Phase Current Crossed

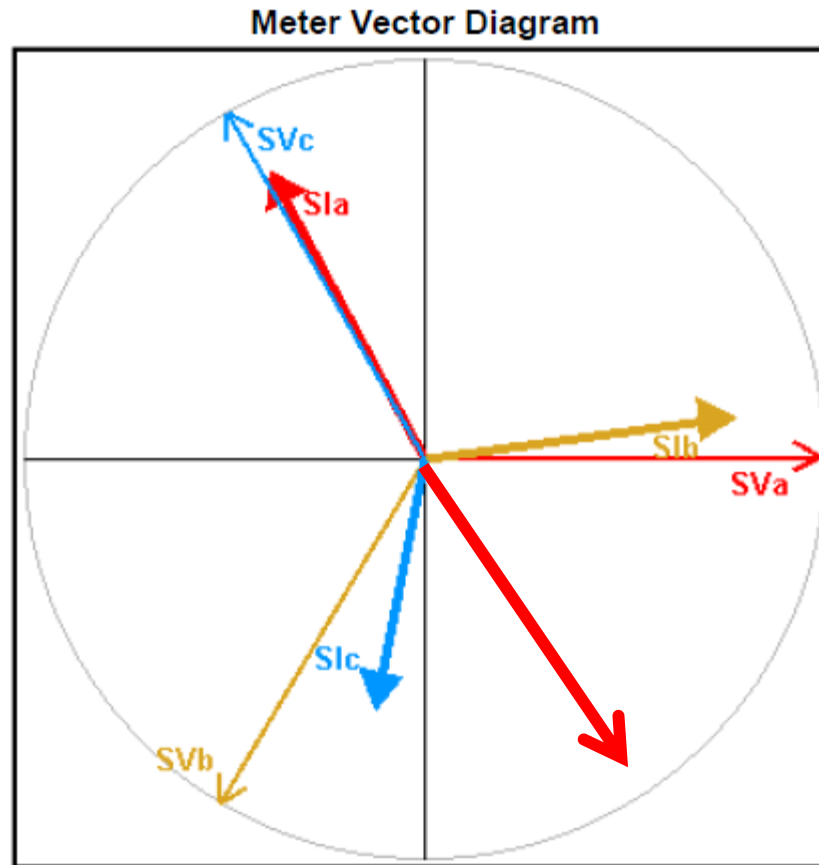
CTs Wired Backwards

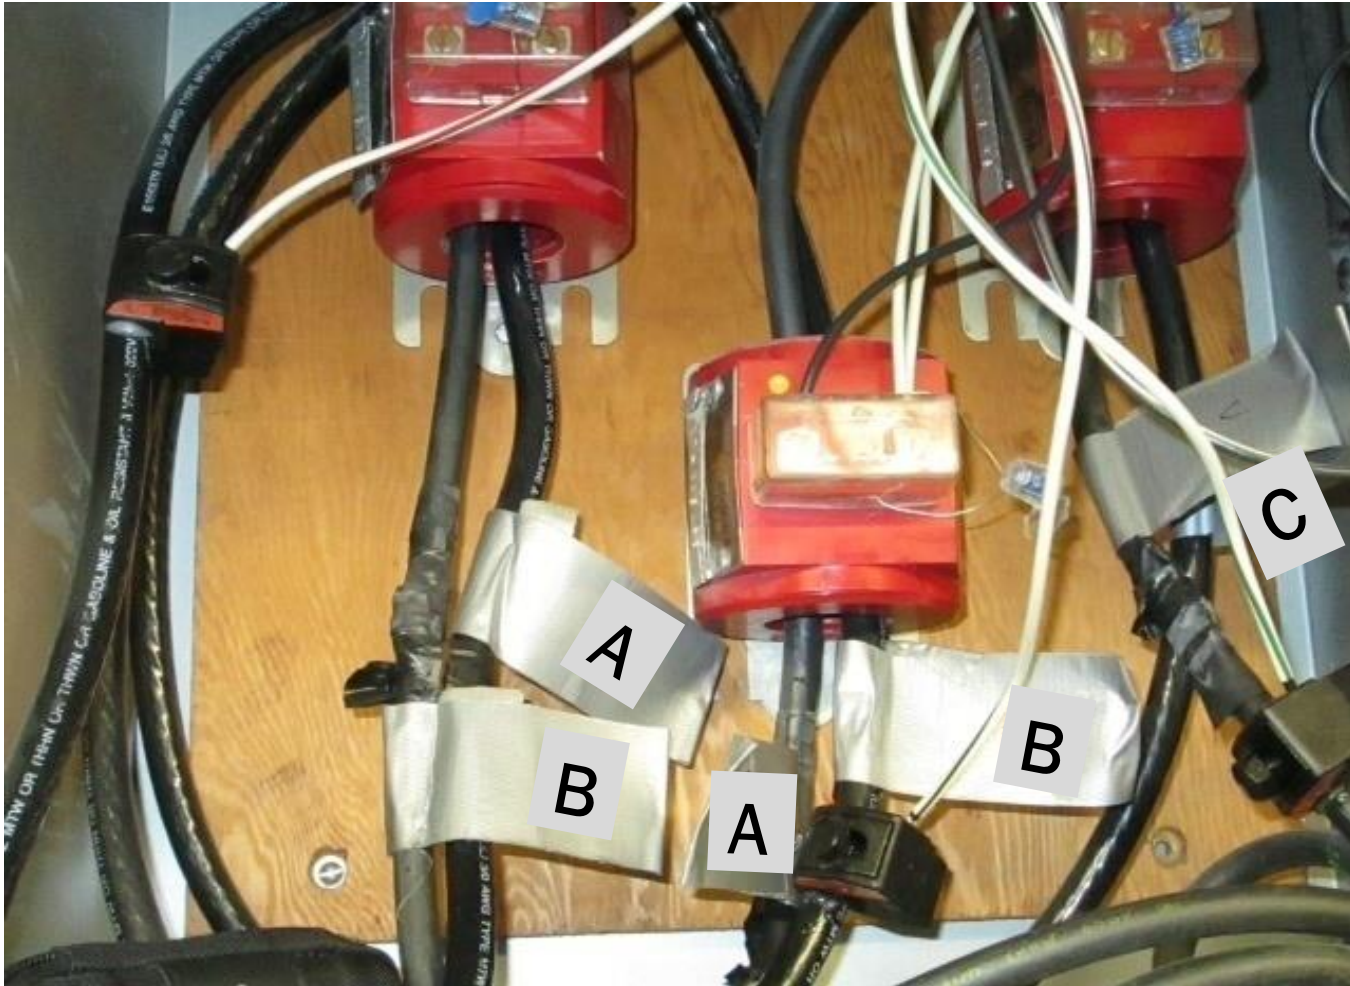
The actual problem was found to be non-brothered service conductors through two of the current transformers. Phase-C current transformer on the far right was correct.

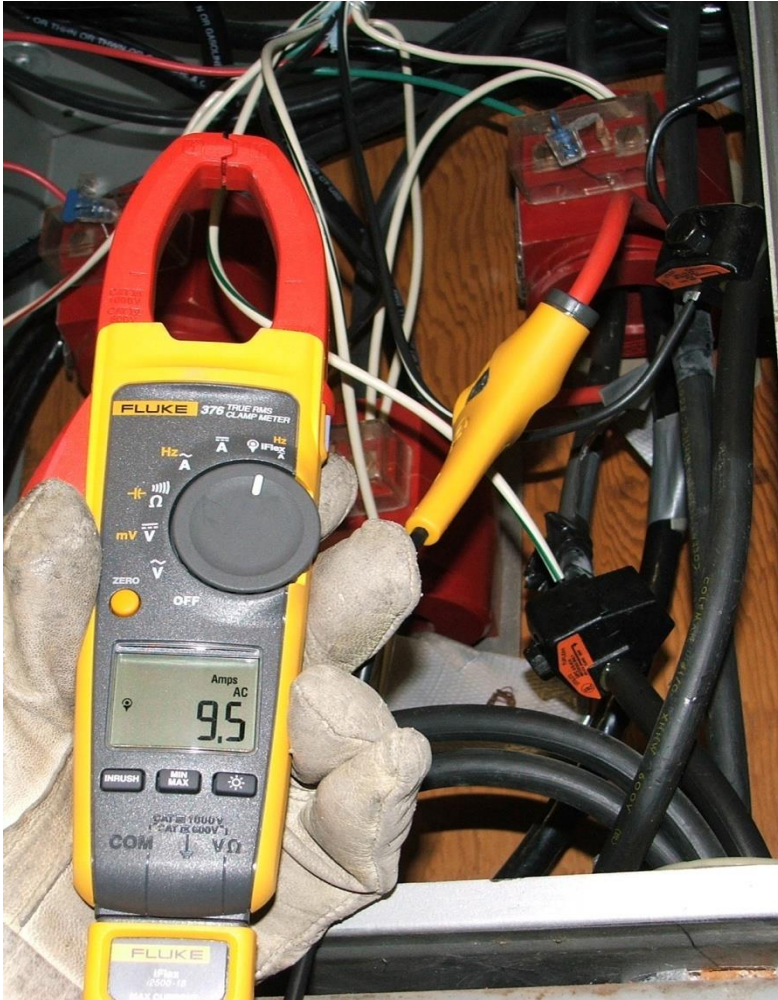
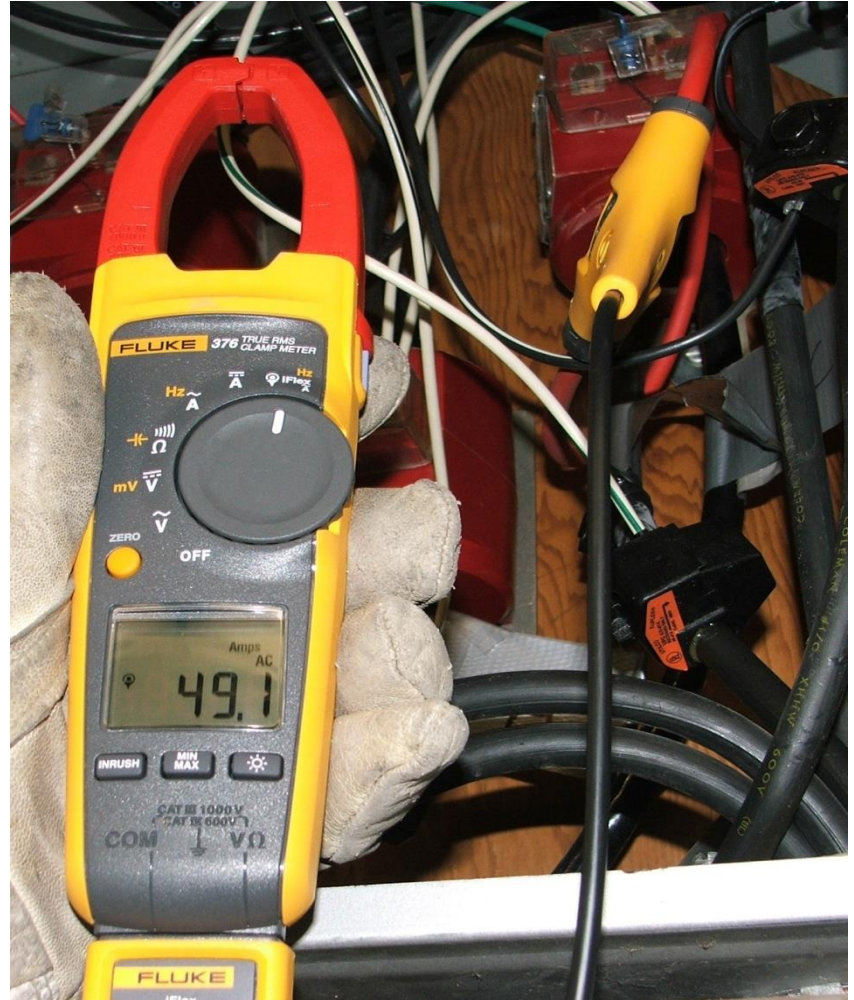
C-phase CT

Measured 9.5 amps and 49.1 amps

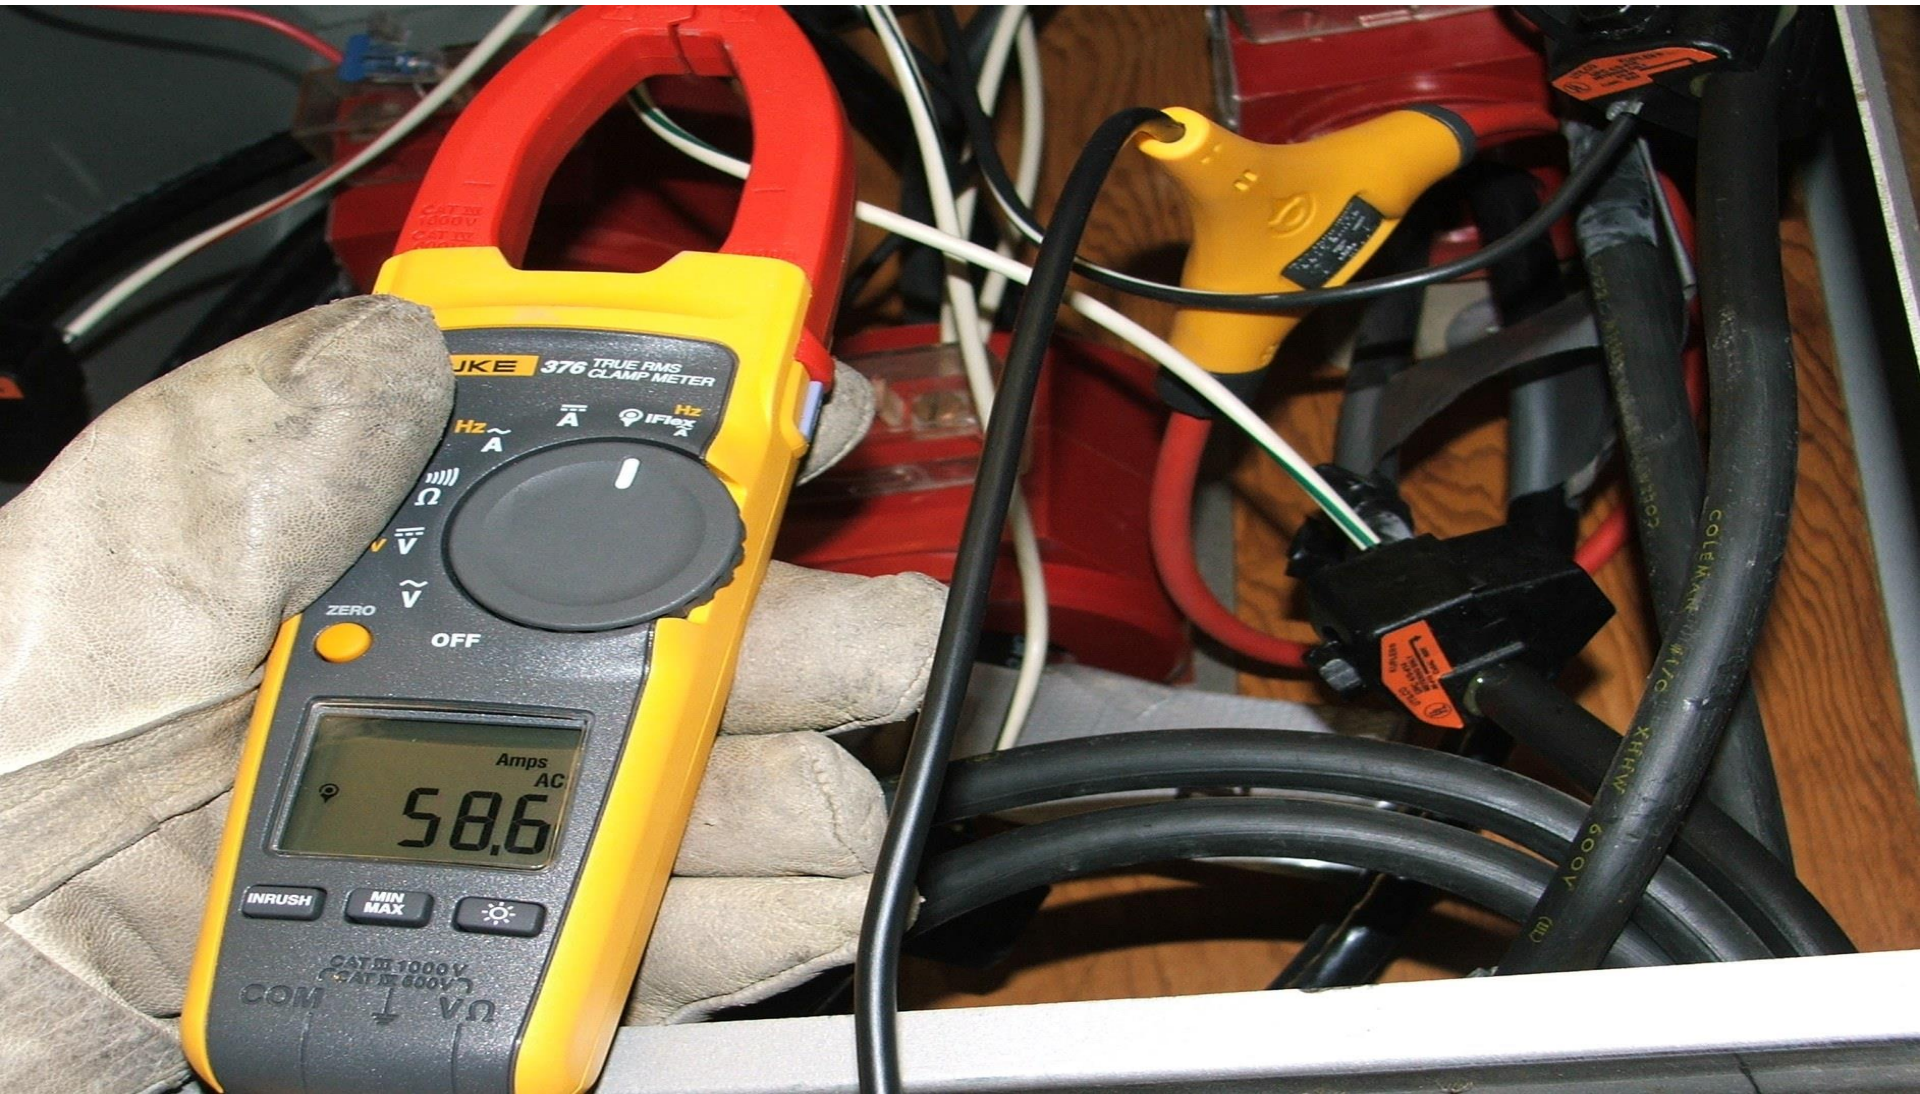
Total current measured by C-phase CT was 58.6 amps

Vectors with the same angle simply add together

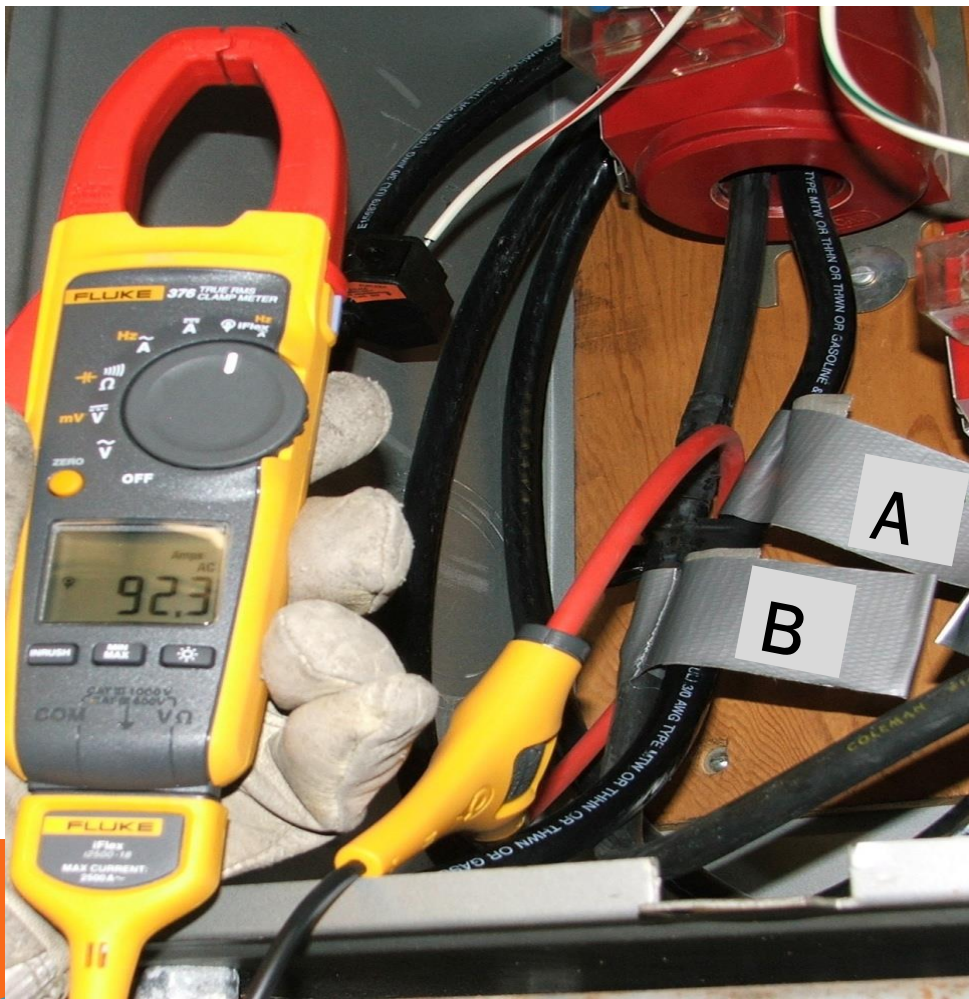
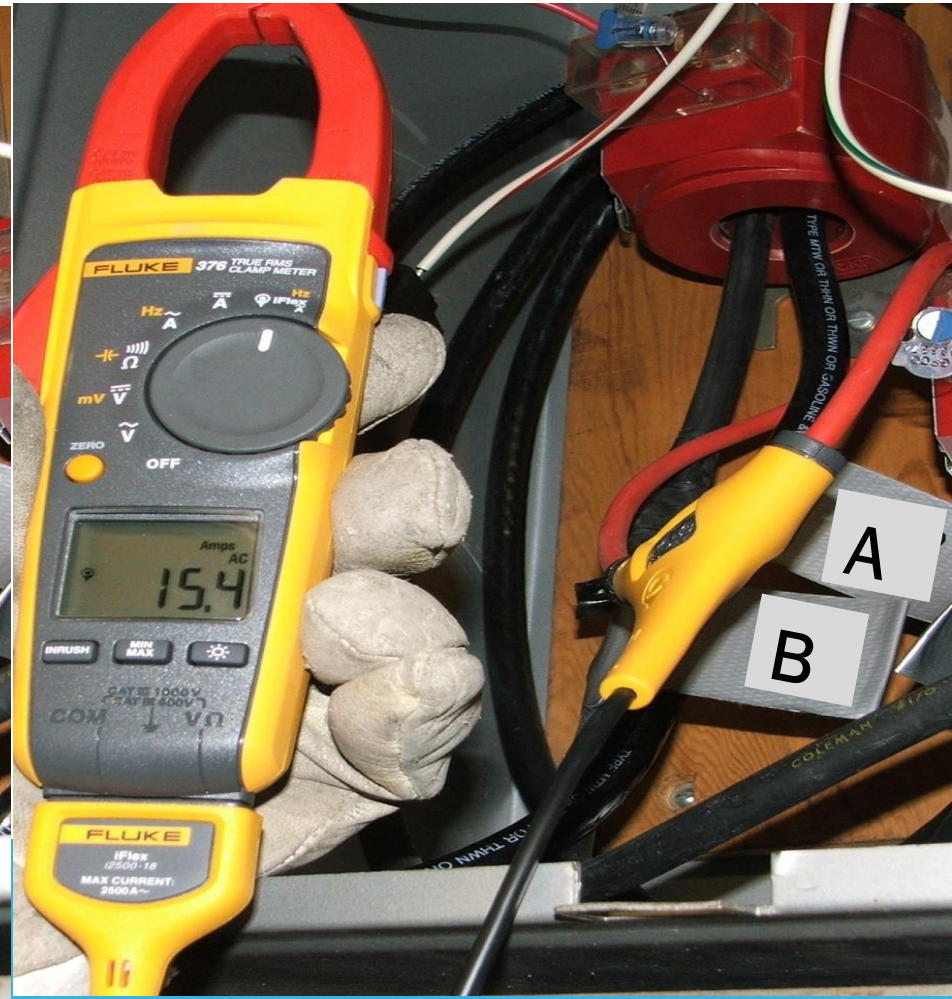
A-phase CT

Measured 92.3 amps on B-phase and 15.4 amps on A-phase

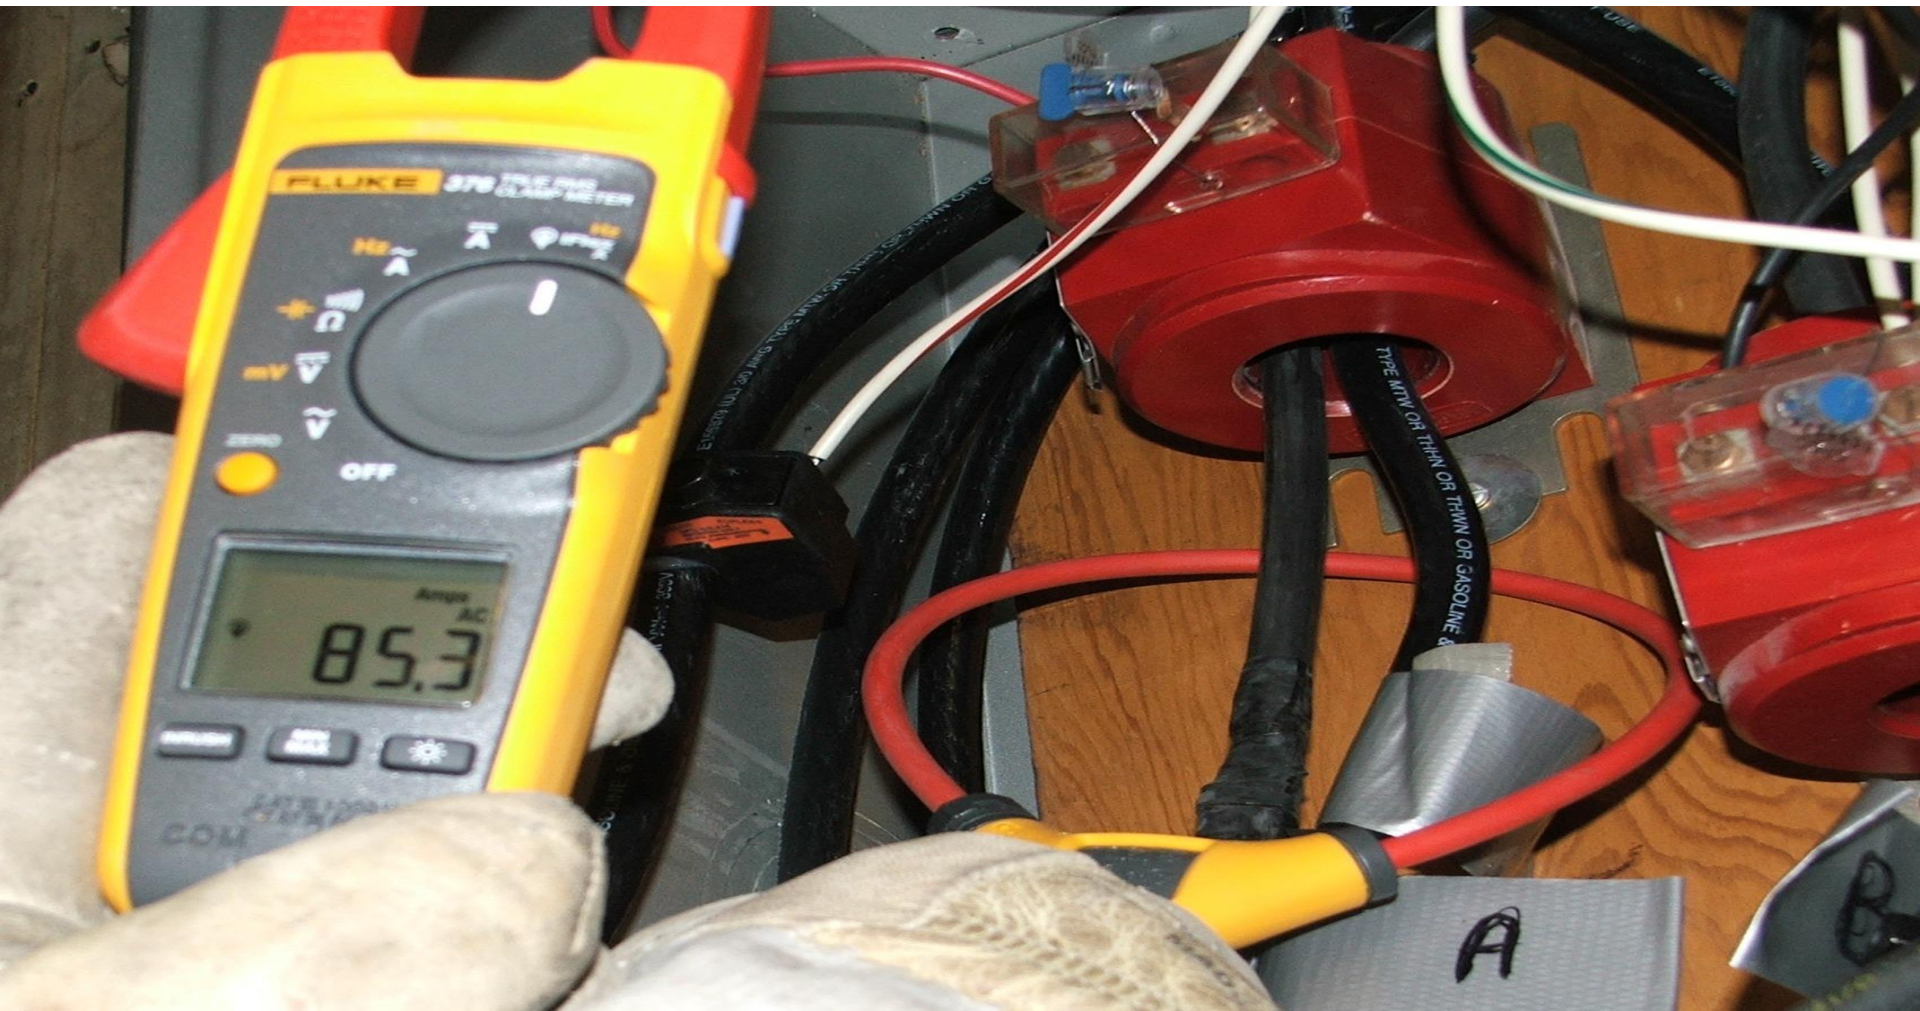
Total current measured by A-phase CT was 85.3 amps

How does 92.3 and 15.4 add up to be 85.3 ?

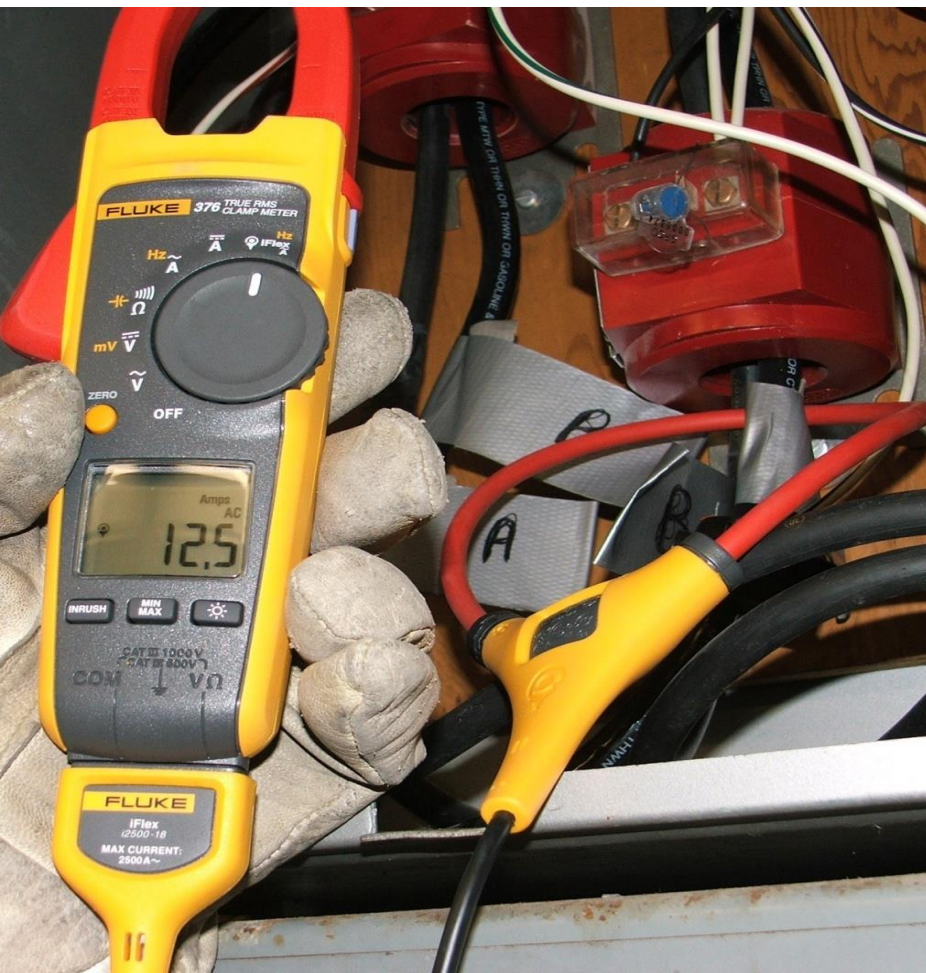
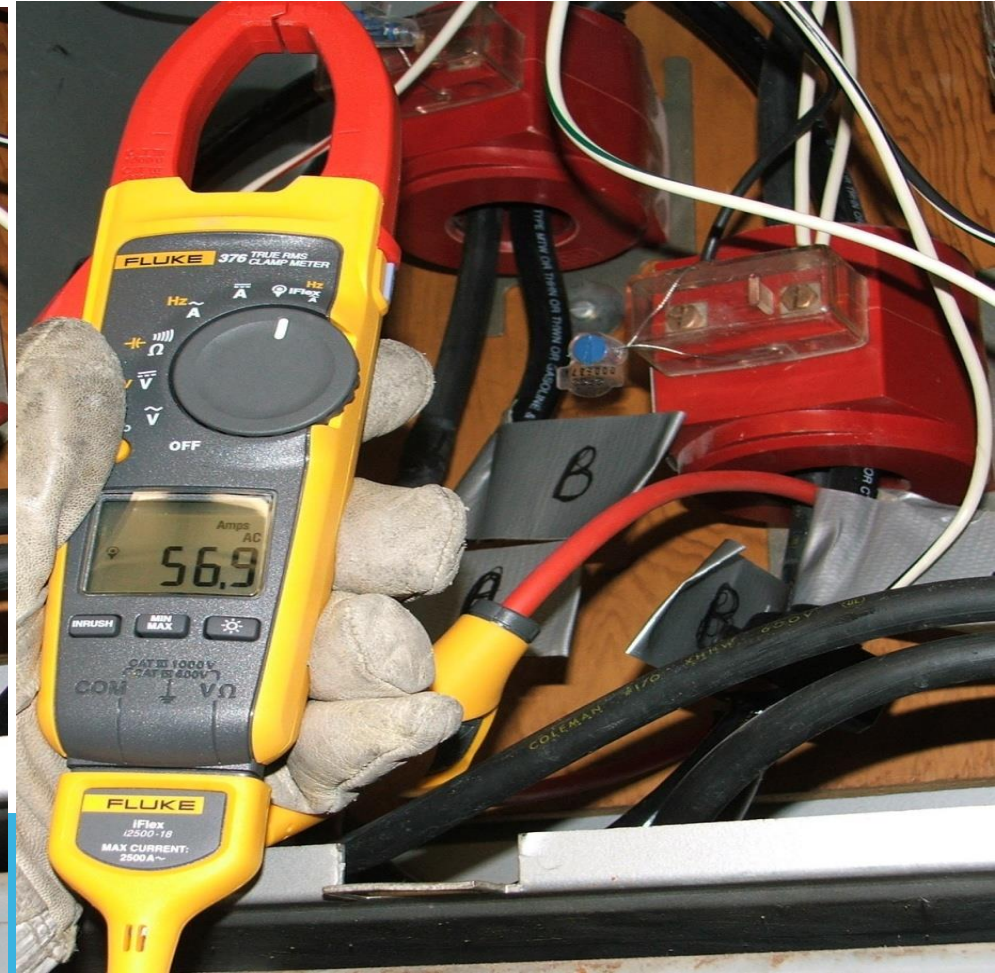
B-phase CT

Measured 12.5 amps on B-phase and 56.9 amps on A-phase

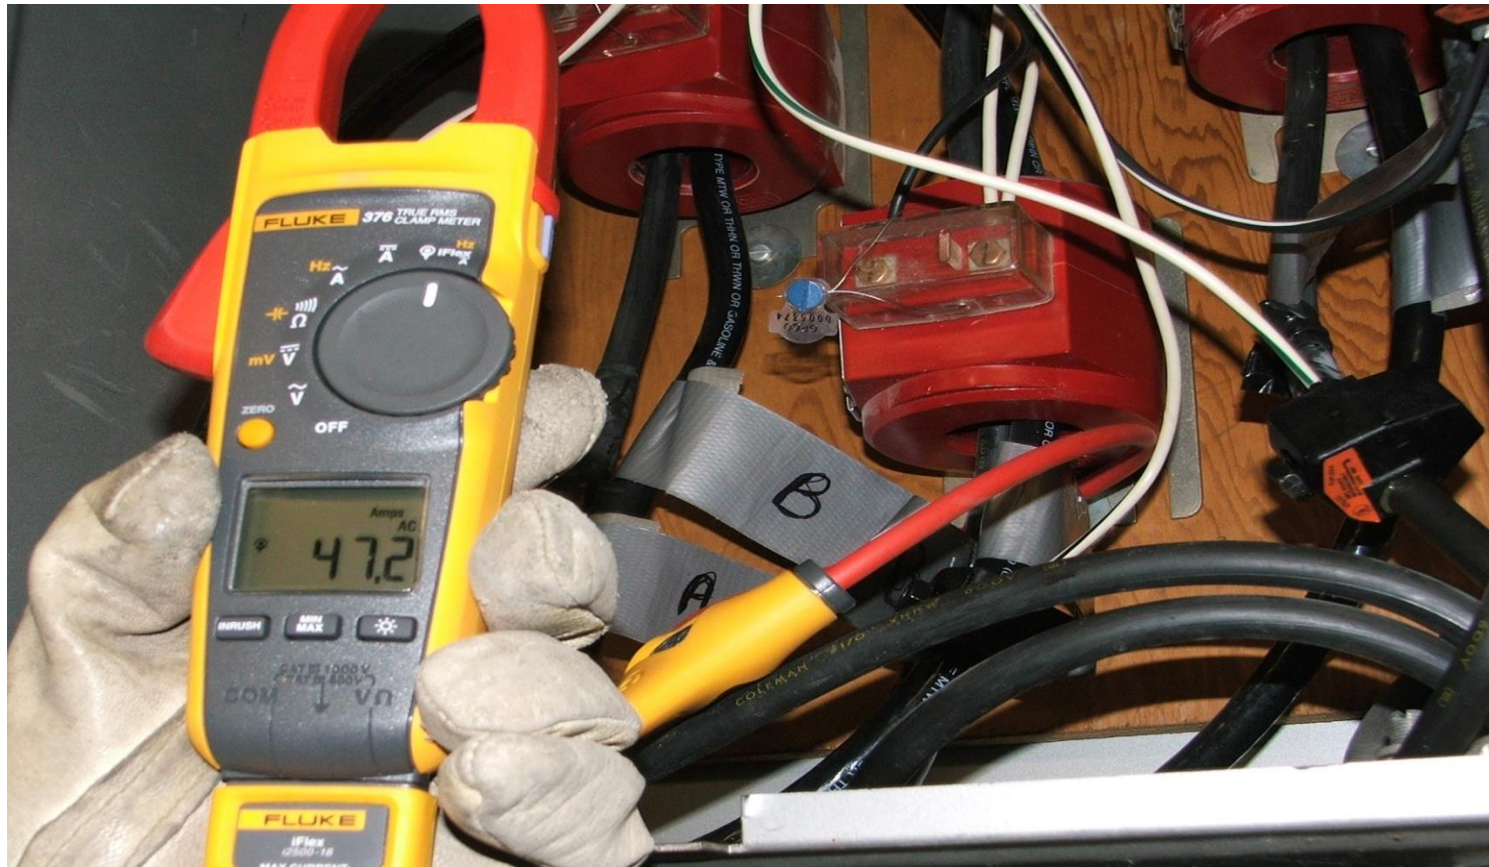
Total current measured by A-phase CT was 47.2 amps

How does 12.5 and 56.9 add up to be 47.2 ?

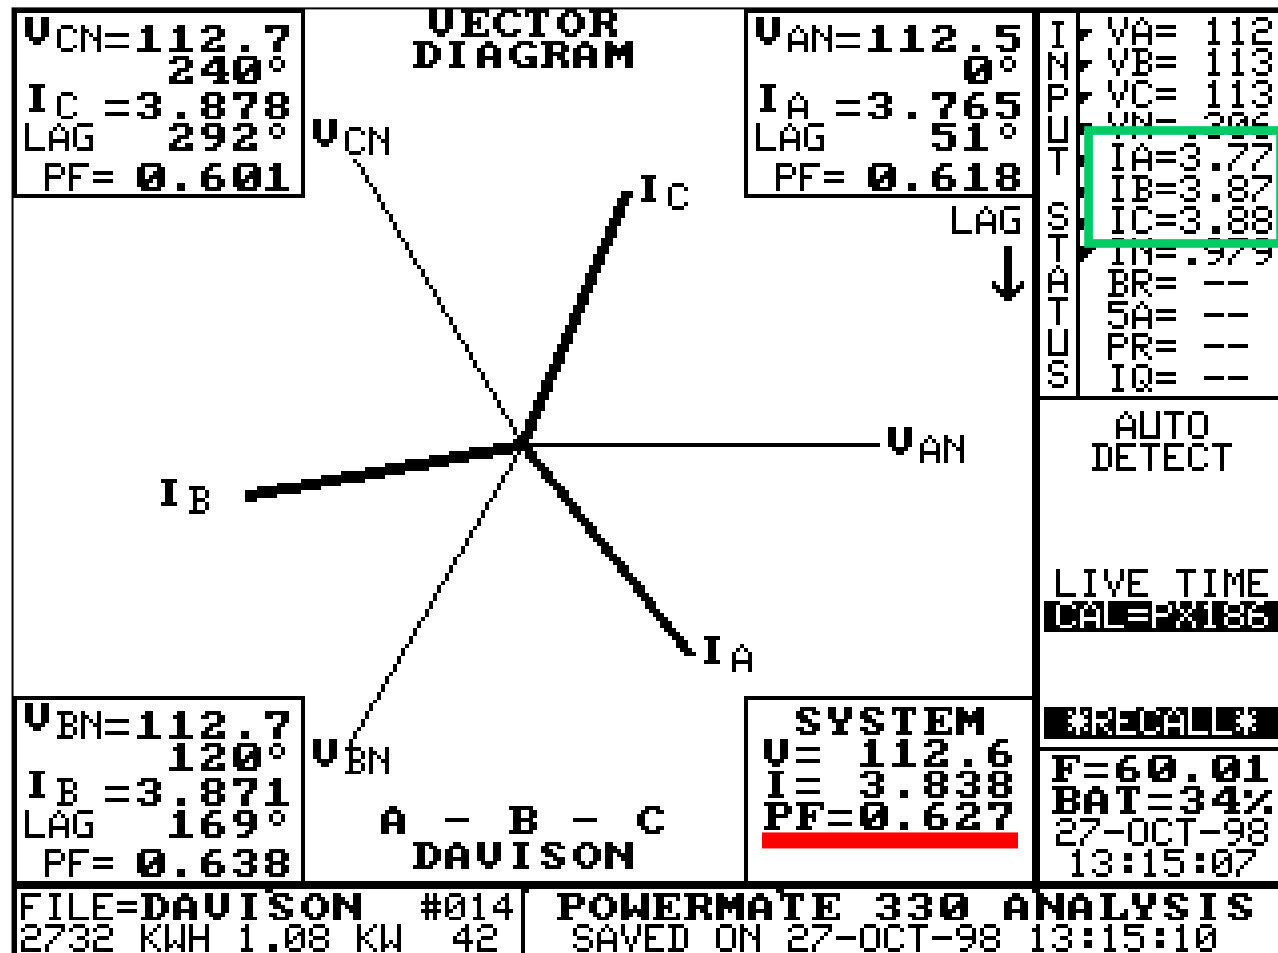
Opportunity to Bill for Excessive Reactive Load

Bad Power Factor

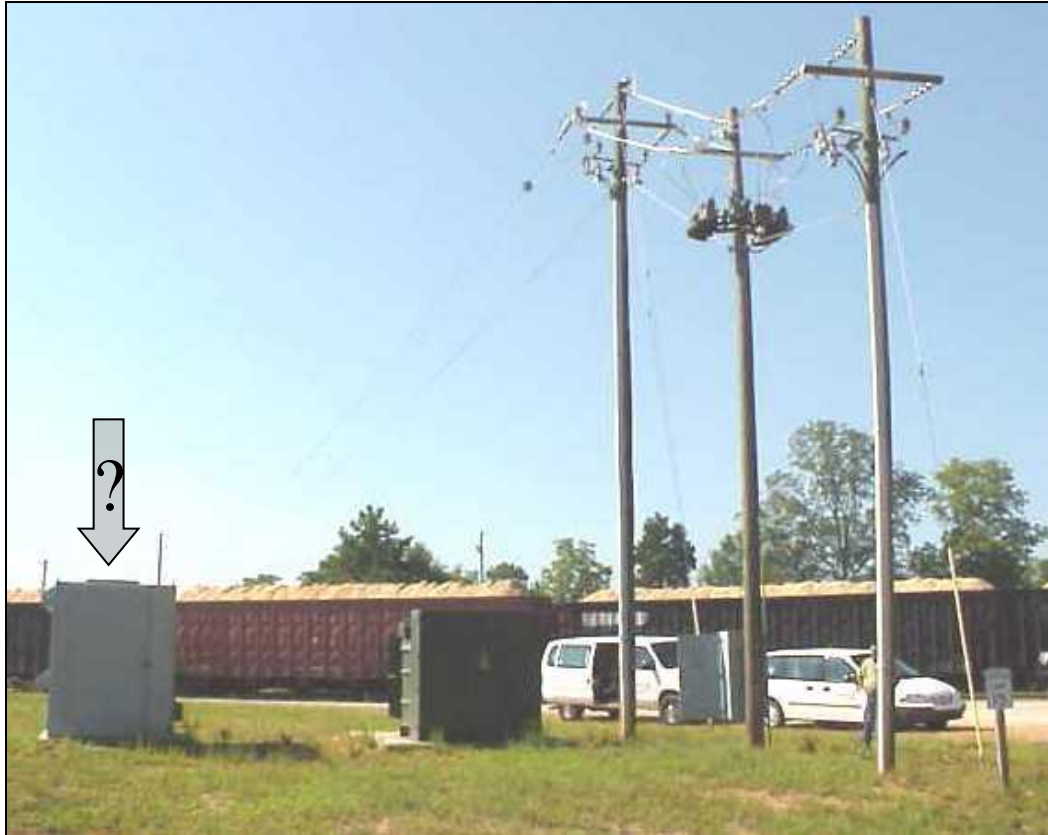
VARs Compensator
