**Vol. 38 No. 1 June 2021**

# Forensic Identification and Root Causes of Hot Socket Problems Found in Electrical Meters

By David J. Icove, PhD, PE, DFE (NAFE 899F) and Thomas A. Lawton, BSME

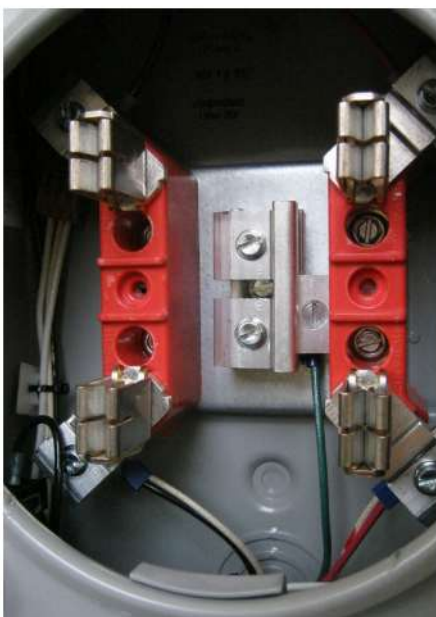
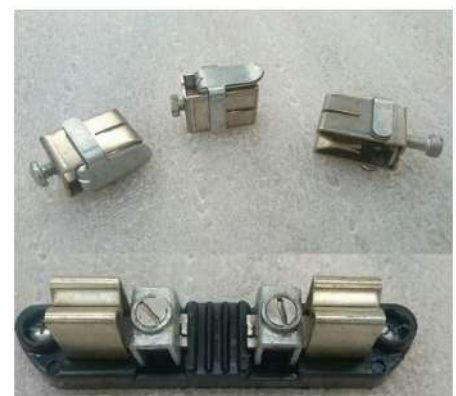
**Figure 1**

Typical meter socket base, meter socket, and jaws (left to right). Source: TESCO – The Eastern Specialty Company, Bristol, Pa; reprinted with permission.

socket, the blades on the rear of the meter are inserted directly into the gripping jaws of the socket (**Figure 1**). The unit is locked in place by a retaining ring or by the meter socket cover, neither of which can be secured unless the blades are inserted into the jaws completely<sup>8</sup>.
