TESCO METERING

Nighthawk Issues Resolved and in Progress

TESCO's Meter School
TESCOOL
July 20-23, 2025

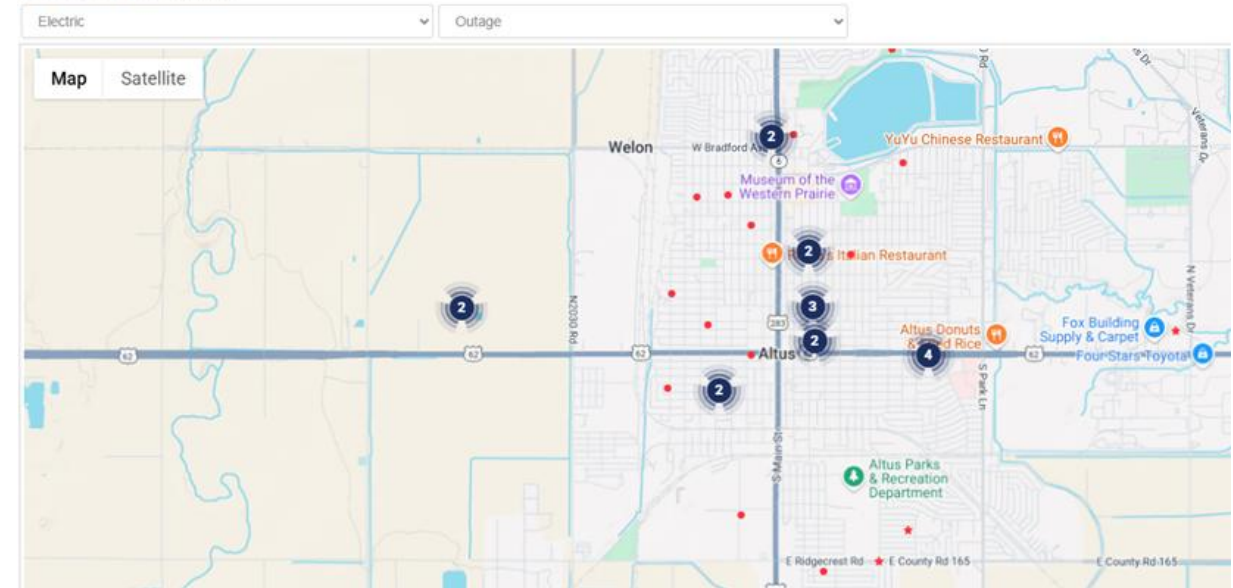
Device Monitor

- Outage Notification Failures
 - Meters are failing to send “last gasp” messages during outages. A battery-related failure is the suspected root cause, preventing the meter from broadcasting its outage status.
 - TESCO field services is actively replacing the batteries onsite for impacted customers.
- Outage Restoration Delay
 - Meters often remain flagged as being in an outage even after power has been restored. Manual intervention using the Check Status command in Meter Soul is currently required to update the meter's status in the AMI Headend.

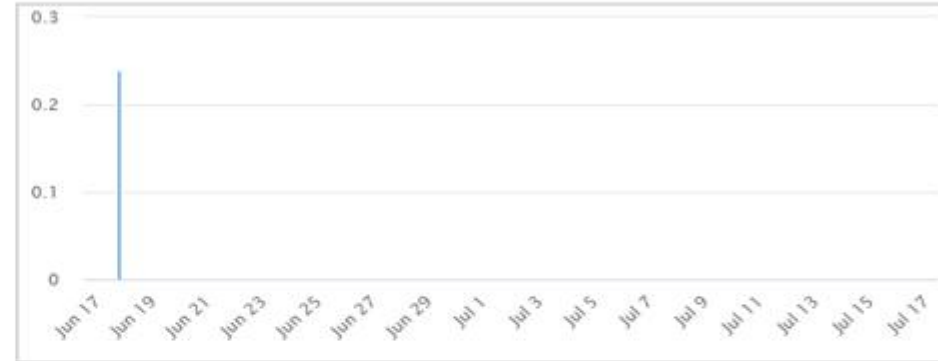
Daily Consumption (kWh)

Some devices have been found to stop uploading interval data while daily register data is uploading.

Interval data can be requested from the meter using
Meter Control Options
